# Architectural Analysis of Slave Dwellings at Oatlands Plantation, Loudoun County, Virginia

Douglas W. Sanford and Dennis J. Pogue

Virginia Slave Housing Project, Inc.

1/8/19 [Revised]

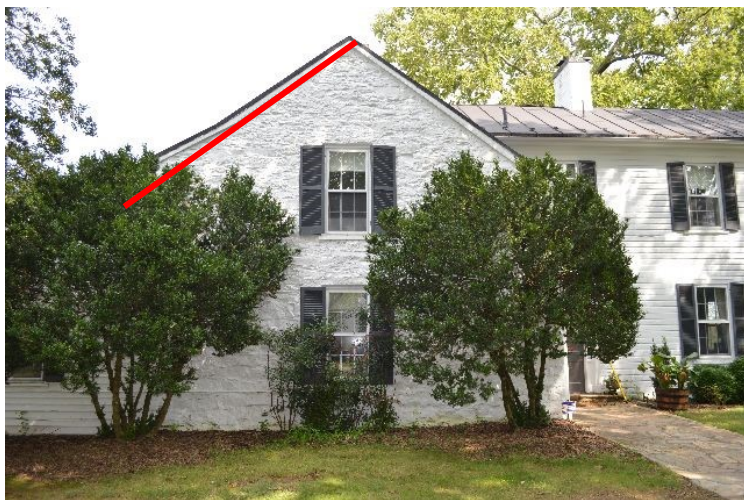
The original structure consisted of a south facing, two-bay, one-and-one-half story, side-gable roofed dwelling, with an interior brick chimney, arranged to serve as a double residence (Figures 2 and 3). The 19-inch-thick stone walls feature irregular coursing and large, flat stones at the corners. Measuring approximately 24 feet wide and 35 feet long, the façade was nominally symmetrical, with the chimney located roughly on center and with exterior doorways near each front corner. The doorways provided separate access to one of two equal-sized heated rooms on the first floor, with heated rooms above that were presumably reached by two sets of stairs that no longer survive. Single windows are centered on the end walls on both floors; it is likely that windows were roughly centered in the north wall of both first-floor rooms, which were enclosed by the earliest addition and now are not visible. The window in the east room (designated the dining room in 1973) likely was converted to form the existing doorway connecting with the pantry; another doorway in the north wall in the west room (library) connects with the maids room, and probably is an insertion, with the earlier window blocked off and concealed behind the current wall finish.

Figure 2. Little Oatlands Duplex 1, west elevation (2018); original pitch of roof indicated in red.

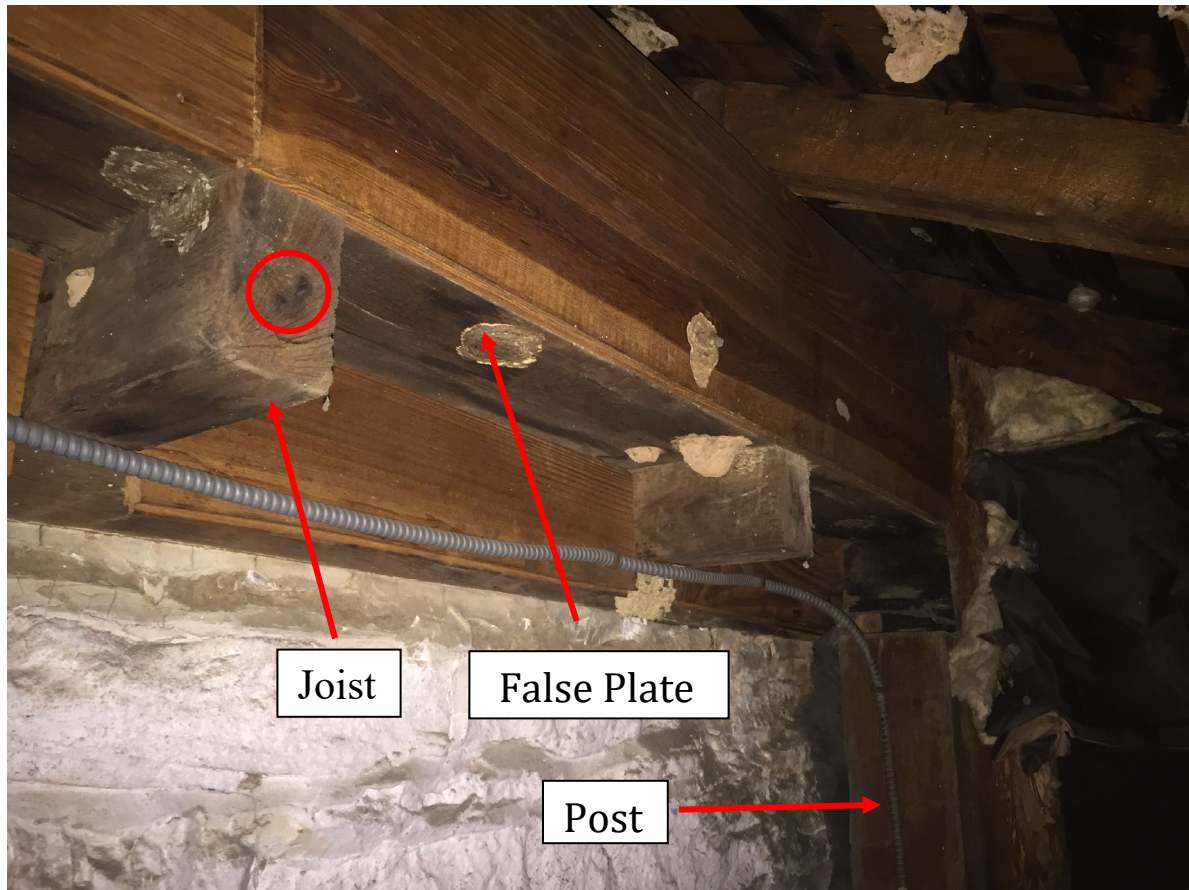
Physical evidence revealed in the captured north eave of the roof support a pre-1819 date of construction. Ceiling joists and the false plate on the north wall are visible below the shed roof for the north frame addition. The joists are hewn and pitsawn, and nails found in the frame are hand wrought (Figure 4), as are flooring nails visible on the second level.

Figure 4. Remnants of trapped north eave of Duplex 1, within attic of addition (2018): joists (hewn and pitsawn) and false plate (pitsawn); rectangular holes for nails (circled in red) to attach fascia and soffit (removed); wrought nail with spade point observed *in situ* to attach rafter to false plate. Corner posts (hewn) to support frame of addition, rafters and skip sheathing boards (sashsawn), with cut nails.

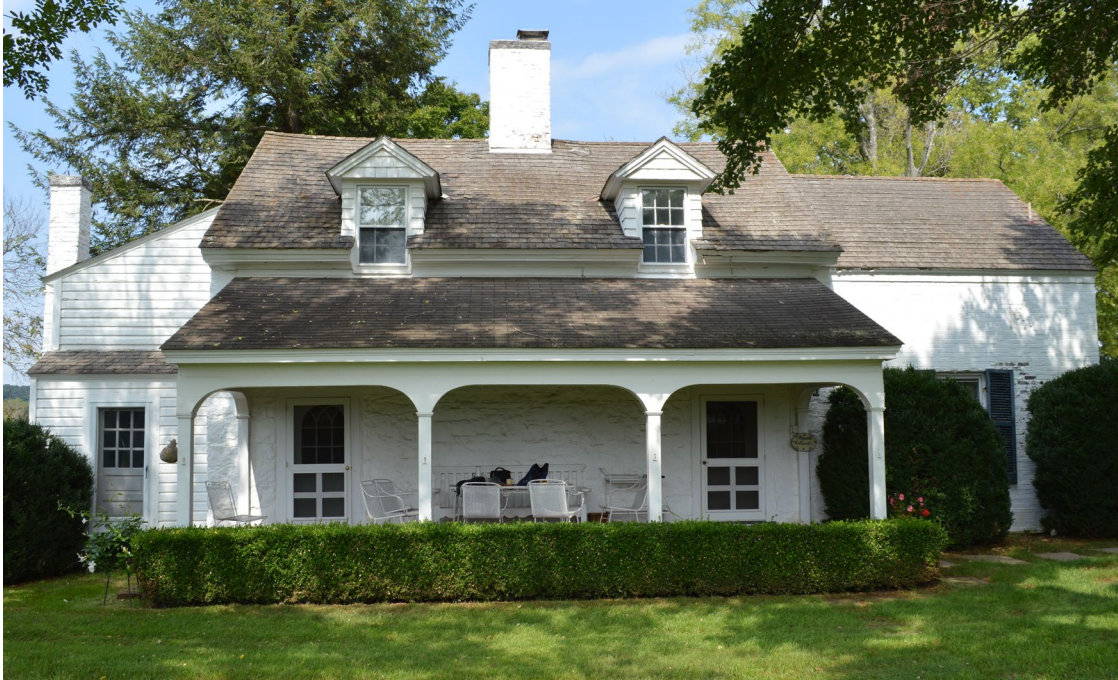
Figure 5. Little Oatlands Duplex 2, south façade (2018); dormers, porch, and wings added.

The most important change on the interior was to cut through the stone partition to allow direct access between the rooms on both levels. This necessitated removing and replacing the original stairs, although the current staircase and upstairs landing likely occupy the same position as the earlier versions, which probably were much steeper, open ladders. New wood floors with narrower boards were installed, as were modern utilities, with the additions containing a kitchen, dining room, and bathrooms. Closets and a storage alcove were placed on either the south or north side of the fireplace in each duplex room. In the 1930s or 1940s, the doors and windows were systematically reworked; the doors, sash, and the surrounding trim all were replaced.

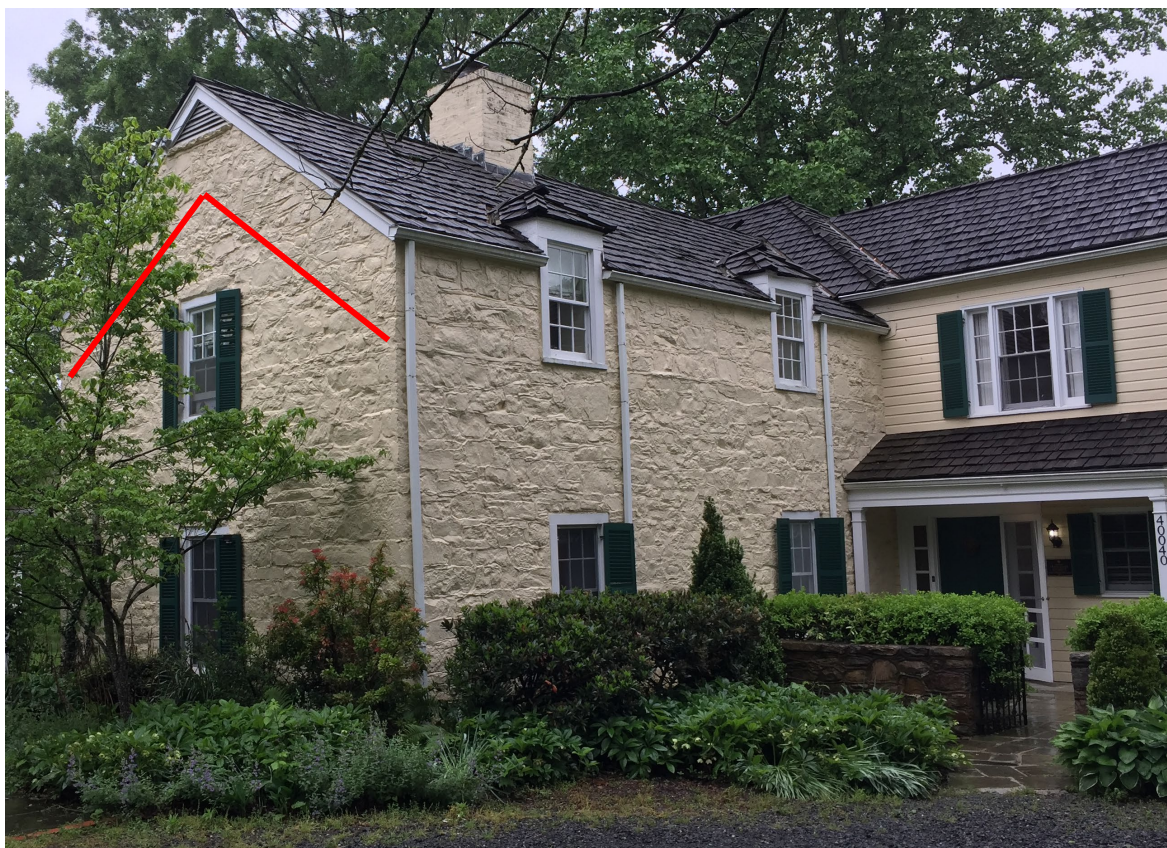
Figure 6. Hamlet Duplex, north and east elevations (on the left); incorporated as a wing to the former Emmet House, now the Inn at Oatlands Hamlet (2018). Raised from 1.5 to 2-stories, dormers added (former gable roofline in red).

On the interior, none of the original ceiling or wall surfaces, flooring, or fireplace materials are visible, and the doors and windows and the associated trim have been replaced. Therefore, the only interpretive opportunities relate to the overall plan, with a center chimney and two matching rooms accessed independently from the exterior. The similarities in plan with the duplexes at Little Oatlands, and with other known duplex slave quarters, suggests that stairs to reach the

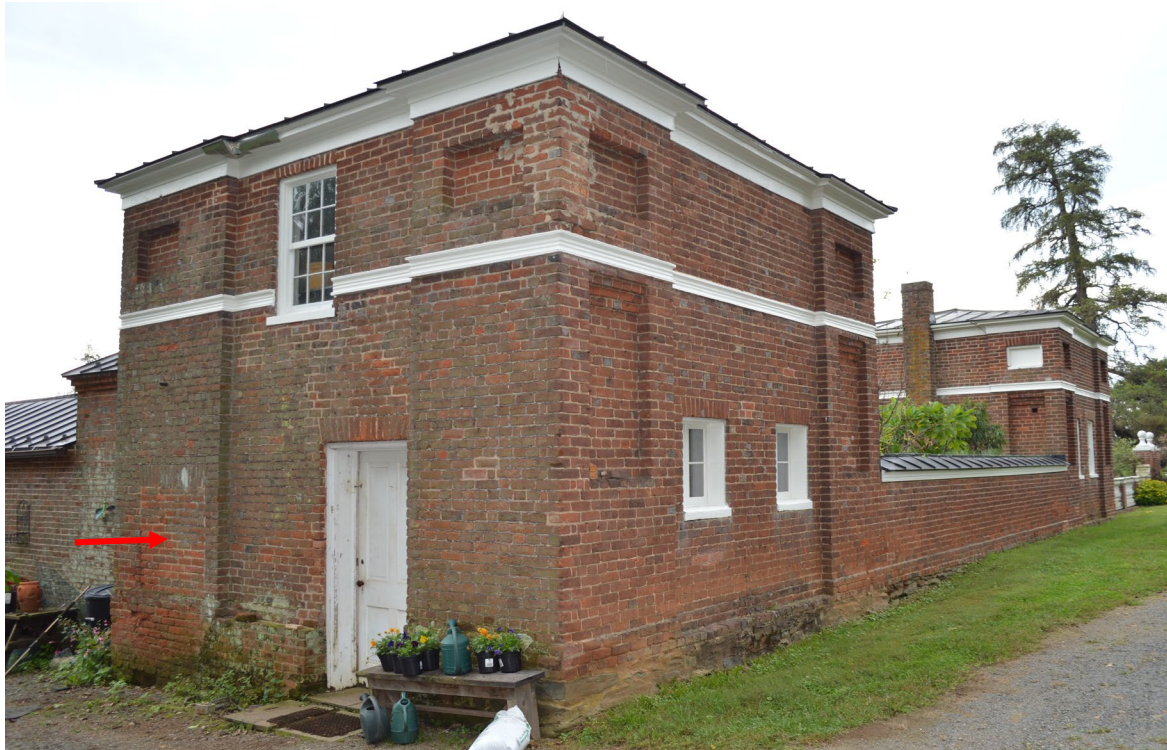
Figure 10. Pavilion north and west elevations (2018); two doorways in the north façade are original but have been altered (location of infilled doorway indicated by red arrow).

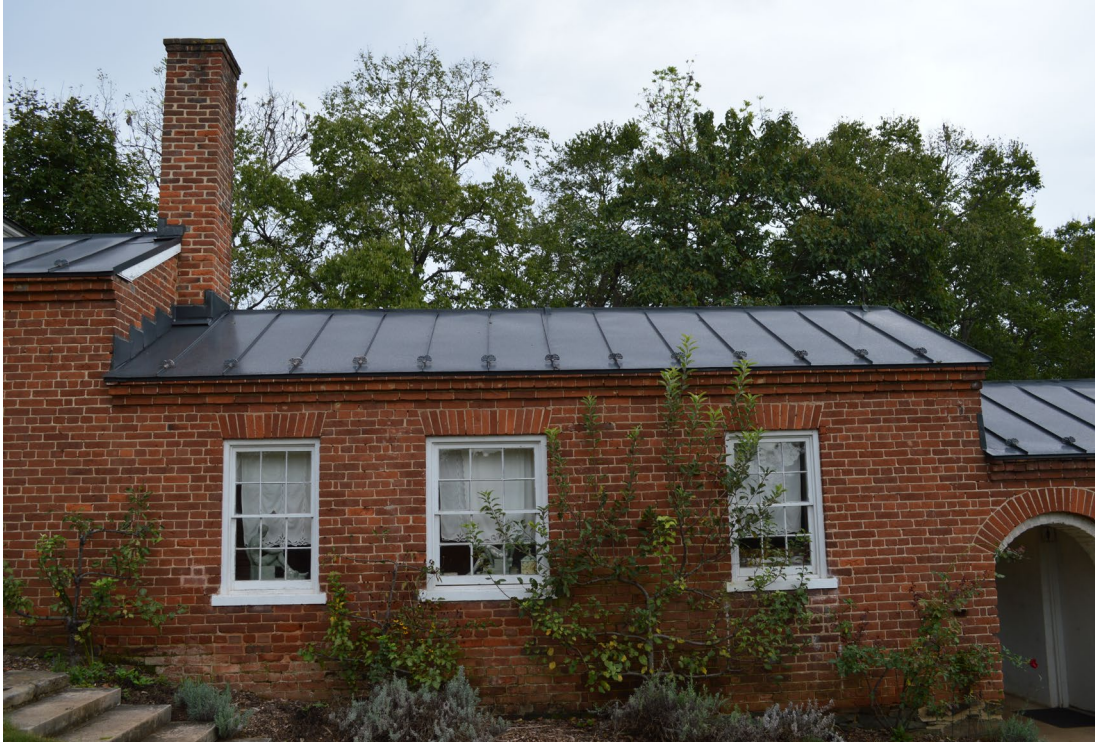
Addition 1 consists of three bays facing the garden, with a doorway originally located near the center of the south wall, flanked on either side by windows. A substantially larger room (garden library) occupies the west portion, with the west window and the exterior doorway now in the north wall. The fireplace against the west wall is an original feature, and is sized for domestic use. The east room had a window on the south, but was accessible only through an interior doorway in the frame partition. As elsewhere, the windows and doorways in Addition 1 have been extensively modified, with the south doorway turned into a window and two doorways added in the north wall providing direct exterior access to both rooms (Figure 11).

Figure 11. Addition 1, south elevation; center window originally was a doorway; two left bays front the heated space, which likely accommodated slaves.

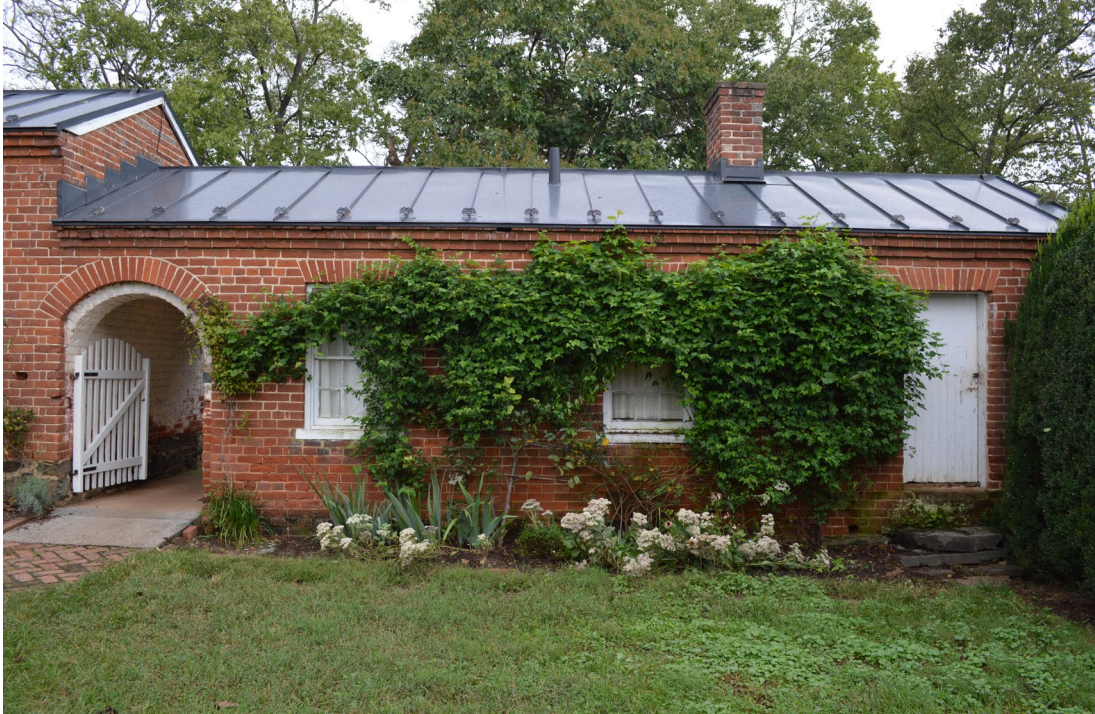
Addition 2 is separated from Addition 1 by the open, arched breezeway. The chimney location toward the east end of the structure is original, although the stack (as in Addition 1) has been rebuilt (Figure 12). The plan likely consisted of three rooms, with the middle space heated and slightly larger than the others. Extensive modifications were made to the structure over the years, with the most significant affecting what had been the two western rooms. Unlike the frame wall in Addition 1, the partitions separating the three rooms were masonry: the brick wall separating the middle and east rooms survives, the one to the west has been removed, as has the original end wall that formed the east side of the breezeway. The walls were removed at least by 1923, when the interior of the addition is depicted on the garden plan as consisting of the east room and two long, parallel spaces with doorways opening onto the breezeway. This unusual layout almost prefigures the current use of the space as gender-specific restrooms, which were outfitted in 1986.<sup>15</sup> As the result of this work, it is impossible to determine the original nature of the heat source, but presumably it was a fireplace similar to the one that survives in Addition 1. The exterior doorway in the south wall of the east room was created by converting the original window opening. The doorway in the partition between the two east rooms appears to be an original feature (now closed).

Figure 12. Addition 2, south elevation; east doorway converted from a window; two left bays fronted the heated space, likely to accommodate slaves.

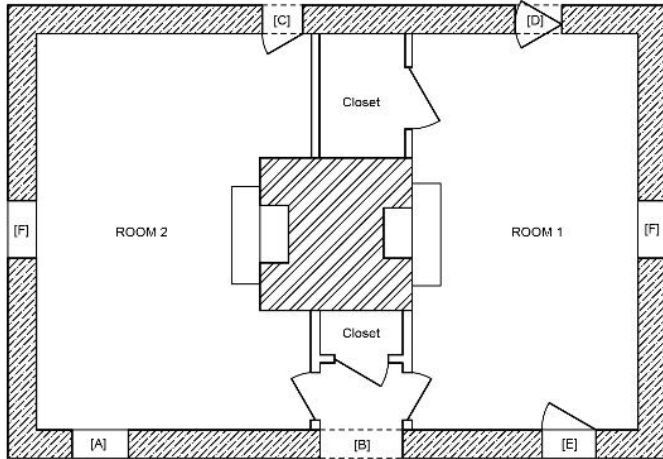
LITTLE OATLANDS I

- [A] Original doorway converted to window
- [B] Opening cut through exterior wall
- [C] Opening cut through exterior wall
- [D] Original window converted to doorway
- [E] Original doorway
- [F] Original window openings

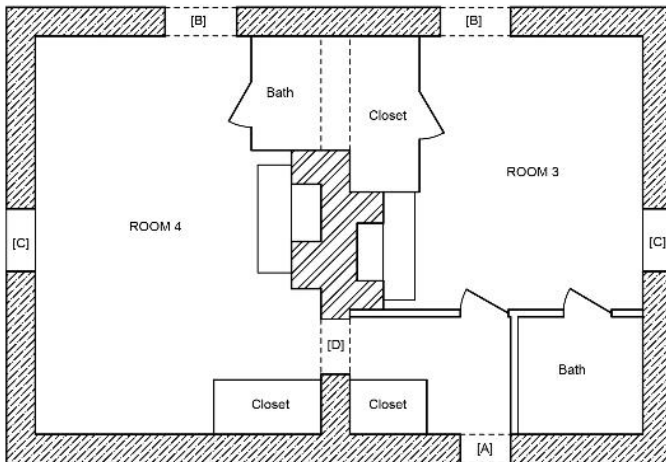
- [A] Opening cut through exterior wall
- [B] Window cut through exterior wall
- [C] Original window openings
- [D] Doorway cut through partition

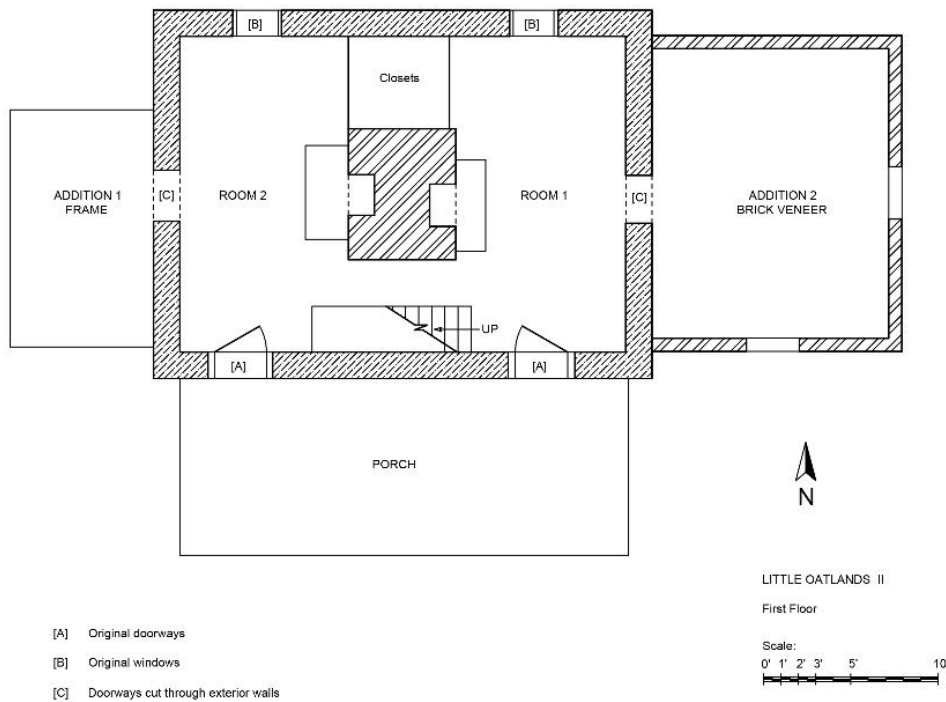
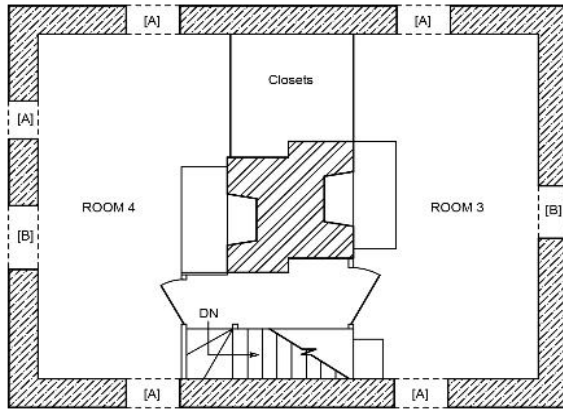
LITTLE OATLANDS II  
Second Floor

- [A] Window openings inserted in walls
- [B] Doorways inserted in walls to connect with additions

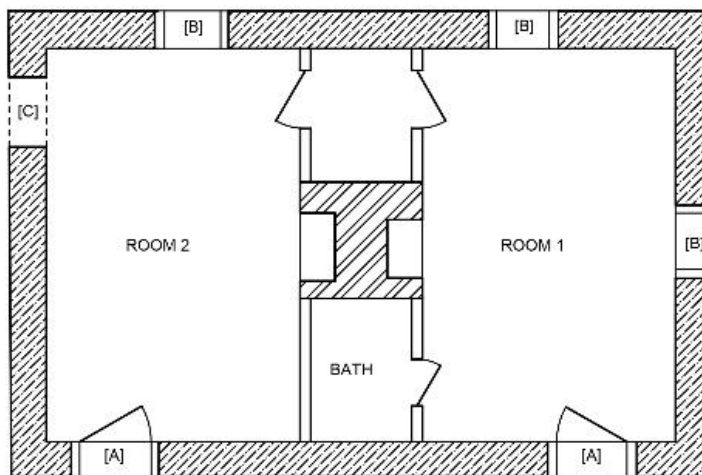
- [A] Original doorway
- [B] Original window opening
- [C] Doorway cut through exterior wall

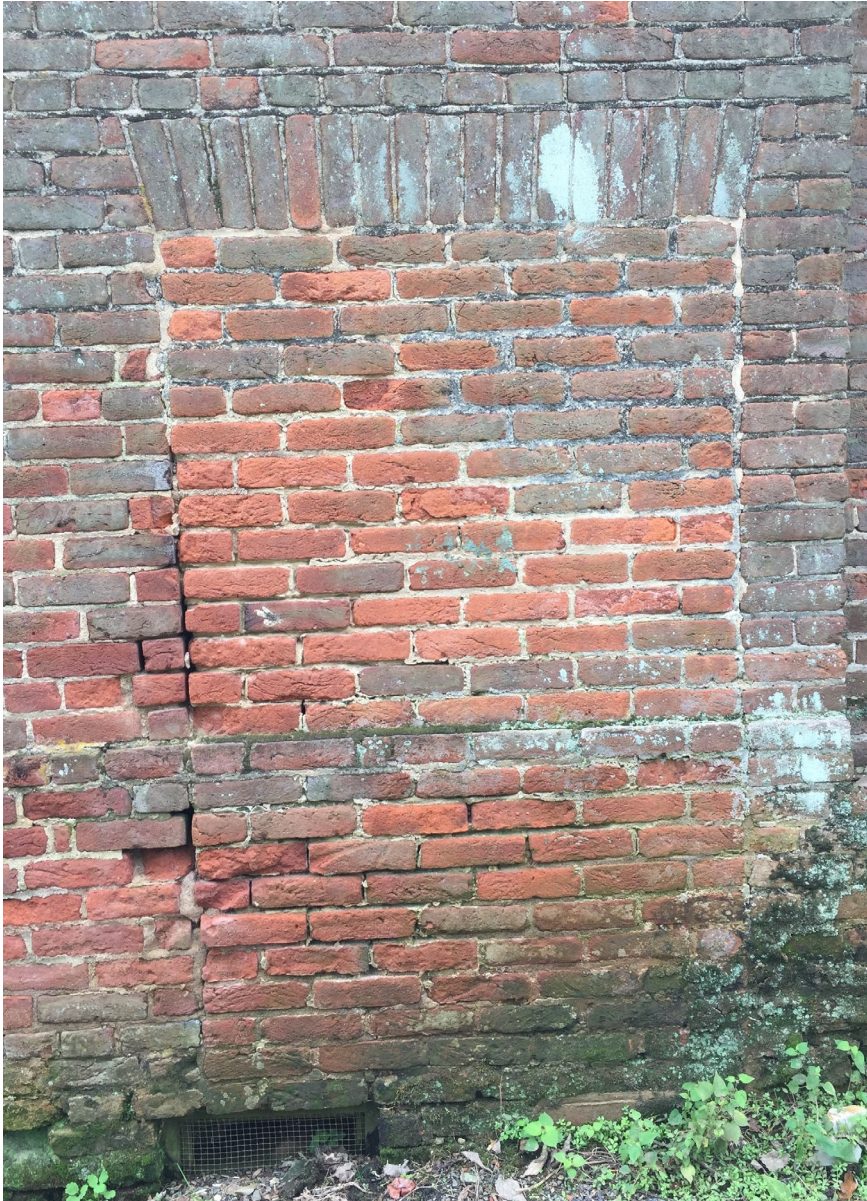
formerly led down into a substantial cellar or basement. Its original bottom limit (estimated sill) occurs three courses from the current ground surface. Later this doorway was enclosed with brick, totaling 24 courses beneath the jack arch. This doorway measures 3.9.0 wide as compared to the western door's 3.4.2 width.

Figure 1. Pavilion north elevation, east doorway (2018); former entrance to cellar storage area, infilled.

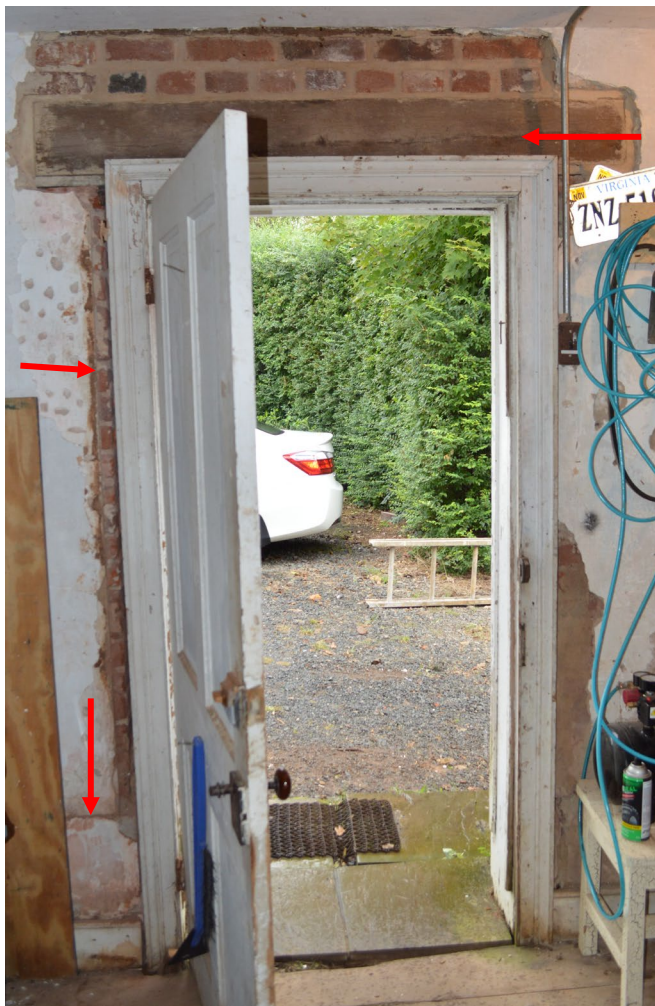
*North wall, western doorway:* The western doorway has been significantly altered, evidence for which is more readily observed on the interior. The current header is a ca. 1903 insertion at a lower elevation than the original, which survives near the current plaster ceiling (lower edge is visible). Two brick courses, set with Portland mortar, are exposed between the new and old headers. The current door framing is narrower than the original opening, with brick rubble and wood shims used to fill the gap on the west side between the frame and the original edge of the opening. Slots are set in the masonry to receive the original doorpost. O&A staff recognized this change, which together with a horizontal plaster ghost for the original baseboard, indicated that the building's original floor level was about 9 inches higher than the floor in 1999. The bottom of original wall plaster was at a distance of 6 feet, 6 inches beneath the current ceiling. The modern wall plaster, installed after the door's alteration, rises 11 inches above the current baseboard and crosses over the original brick edge and the rubble infill to meet the current doorframe. This higher elevation for the original floor would have accommodated a larger, more convenient storage space below, accessed by the eastern doorway on the north wall. The header for the eastern doorway is visible on the interior, with hatch marks to receive a plaster base coat.

Figure 2. Room 101, northwest doorway (2018); replacement header, original door opening, and pre-ca. 1903 height of baseboard, all with red arrows.

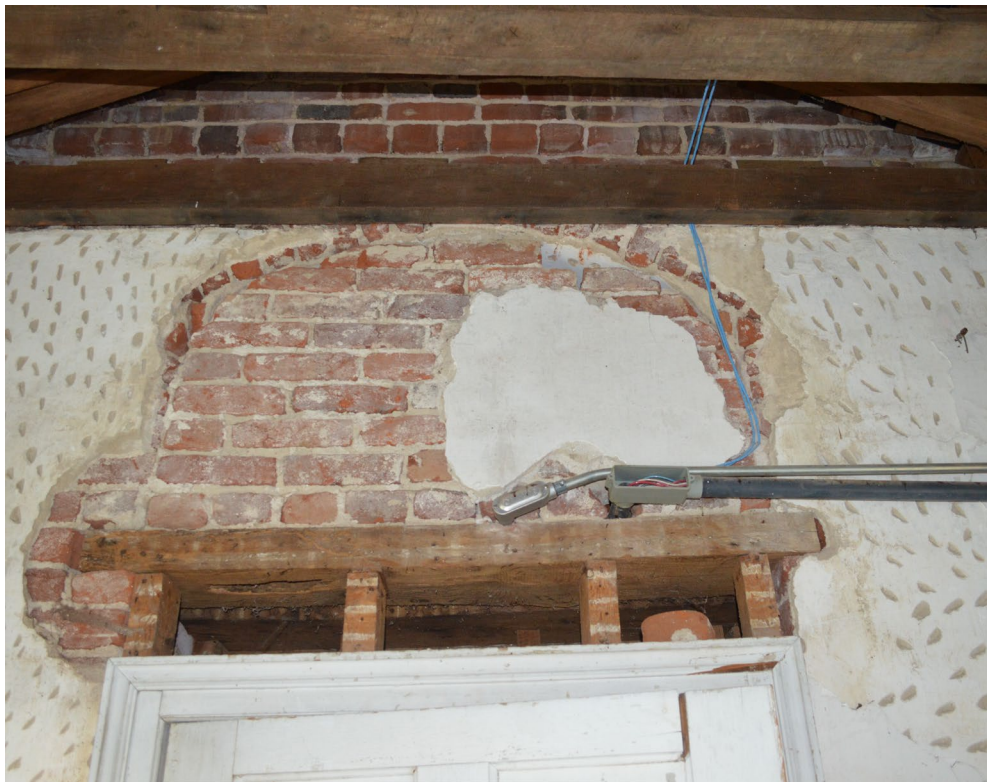
*East wall doorway (archway):* An arched opening in the east wall of Room 101 connected Rooms 101 and 102, which was infilled, framed, and hung with a door as part of the major renovations that were carried out ca. 1903. The unusual presence of the open archway suggests that the two spaces had linked functions that are currently undetermined. The bottom of the header for the later doorframe measures 7.7.0 from the current floor. The material in the doorframe is circularsawn and the trim has the same bead and profile as that for the other windows and the stairs. There is no immediate evidence of the archway's top portion (the arch) in the east wall of the upstairs room. The archway remained open and untreated into the modern era, as only the later type of plaster was applied to its surface. The arch measures 3.6.2 wide (N-S).

Figure 3. Room 102 with infilled former archway (2018); wood header and blocks to support brick archway infill; early plaster is just visible on the inner surface of the arch; ca. 1903 plaster with score marks to receive skim coat covers the walls and overlay the arch infill.

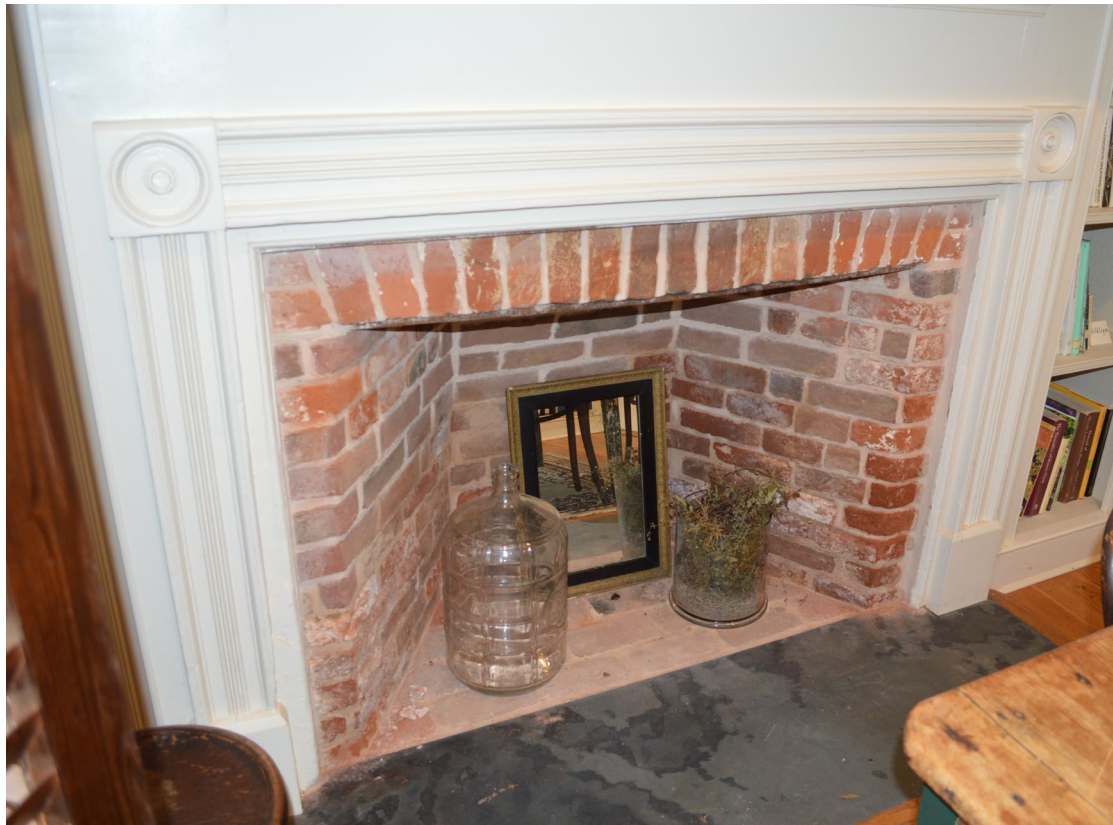
*Fireplace:* The fireplace opening at the west gable-end wall has a jack arch, a single flue, and measures: 4.1.0 (W), 2.10.2 (H), and 1.9.0 (D). At its rear, the fireplace is 1.10.0 wide. The replacement hearth (of slate) measures 1.7.0 wide (E-W) and 6.0.0 long (N-S). The interior floor and rear wall of the fireplace have been replaced. The front edges of the fireplace opening have angled or curved (rounded) bricks. On the south interior face is an eyehook for a crane. The eye is one inch in diameter, while the hook is 3/8ths inches thick, and is positioned 2.7.0 above the firebox floor. There is a machine-cut nail in the masonry just above the eyehook. The

Figure 4. Room 103 fireplace (2018); while heavily reworked the overall size of the fireplace opening is likely to reflect the original condition.

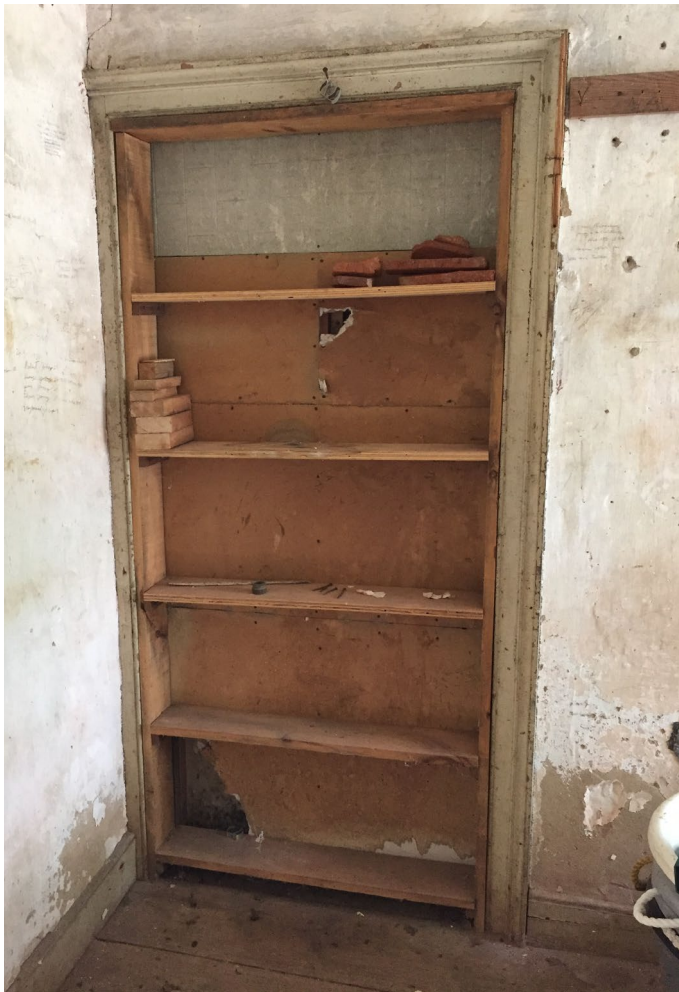
Figure 5. Room 107, blocked doorway connecting to Room 106 (2018); the opening and architrave are likely original.
