Slave Housing Data Base

Building Name: Ben Lomond Quarter
Evidence Type: Extant
Historical Site Name: Ben Lomond Plantation
City or Vicinity: Manassas
County: Prince William
State: Virginia

Investigators: Dennis Pogue
Institutions: Mount Vernon Ladies' Association
Project: NEH
Start: 7-19-07 **End:** 12-12/07

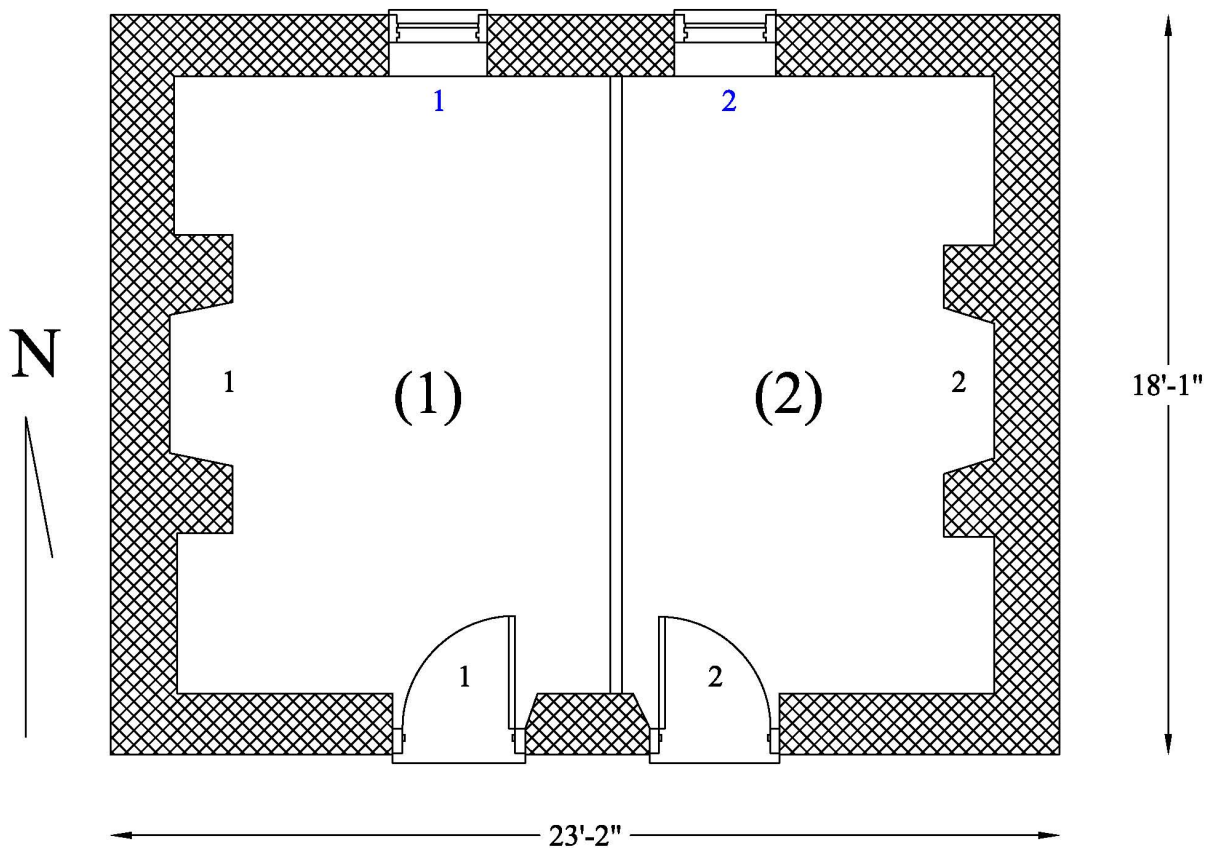
Period I Footprint:

Exterior Dimensions: 23' 2 1/2" by 18' 2"

Period 1 Number of Rooms: 3 (2 down, 1 up)

Dimensions: (1) 15' 2" by 10' 10"

(2) 15' 2" by 9' 3"
