# **Slave Housing Data Base**

Building Name: Mineral Springs – Building 2 Evidence Type: Extant Historical Site Name: Mineral Springs County: Brunswick State: Virginia

Investigators: Andrew Stempel; Katherine Husband Institutions: Center for Historic Preservation – University of Mary Washington Project Start: 9/22/07 Project End: 9/22/07

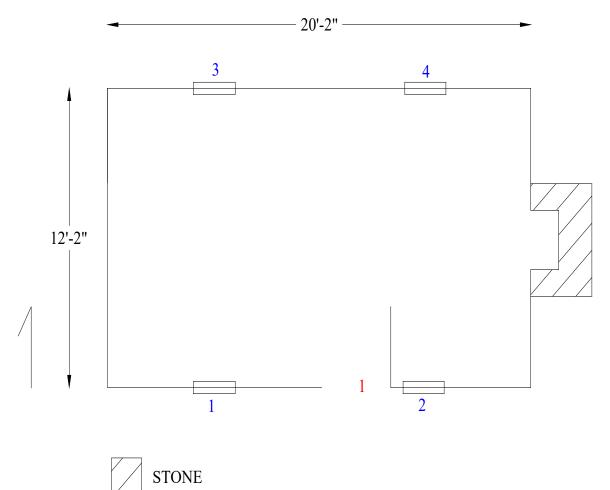
# Footprint:

Dimensions: 19 ft. 0 in. (E-W) x 11 ft. 3.5 in. (N-S; stud to stud)
