Slave Housing Data Base

Building Name: Sherwood Forest Kitchen/Laundry-Quarters

Historical Site Name: Sherwood Forest Plantation

Principal Construction Type: Masonry (brick), 1½ stories

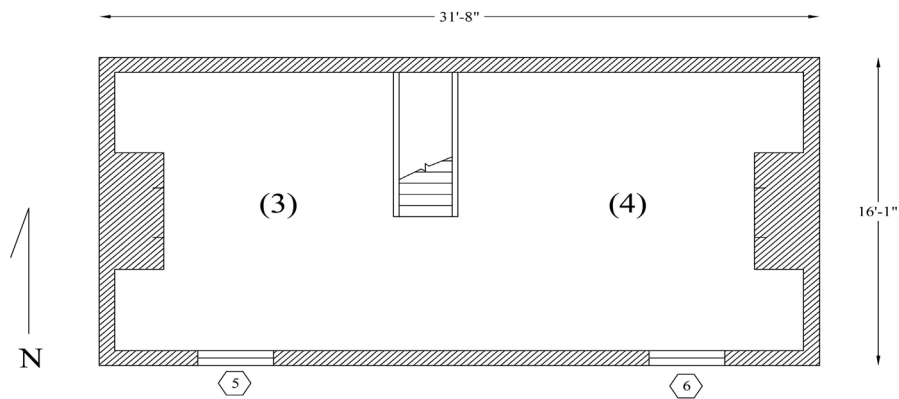
Second Floor: After partition removed (2014)

What appears to have been the original vertical-board partition for the upstairs space survived on the north side of the stairwell. The boards measured 8.5 to 11 in. wide, with a 0.25-in. bead, nailed to the rafter above. Nail holes on the center rafter pair suggest the partition continued across to the south wall, indicating the division of the upstairs space into two rooms, each with a fireplace. The partition was removed in 2014.
