BAYLY

Architectural Investigations // October 31, 2019 // Bayly Cabin Cambridge, Maryland

Dennis J. Pogue

Introduction

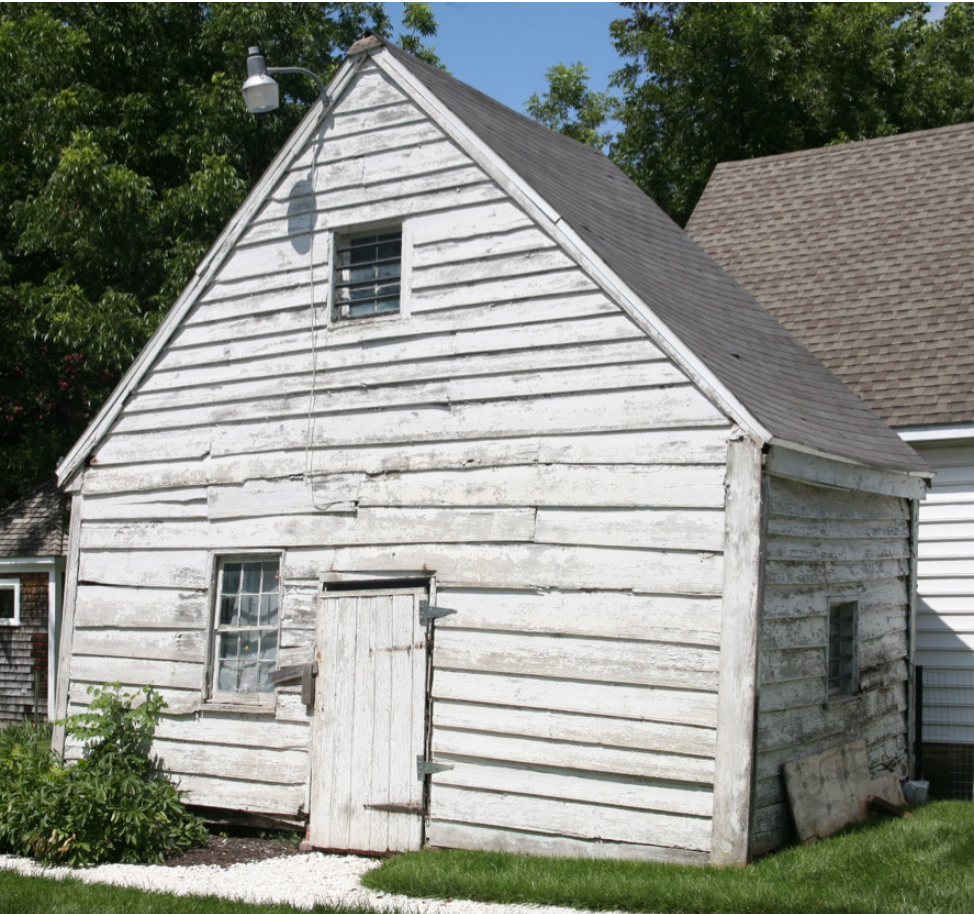
Figure 2. South-facing façade of the Bayly outbuilding (2018); doorway and windows are later insertions.

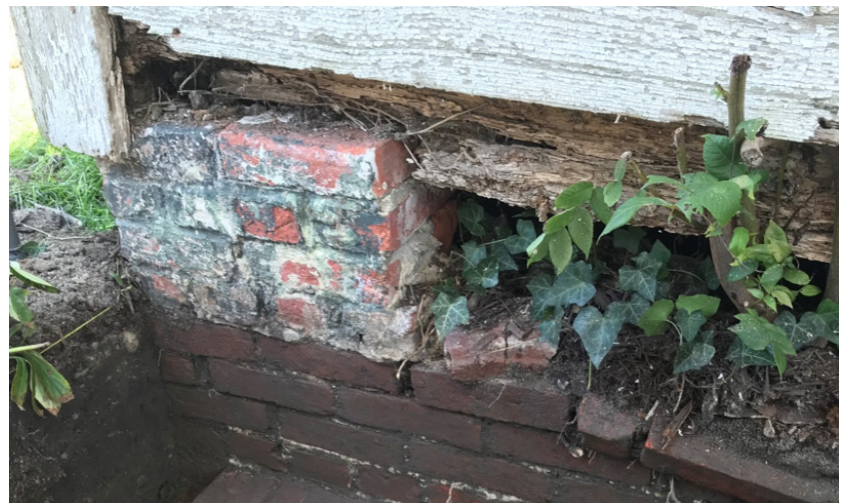
Figure 4. Southwest corner of the Bayly outbuilding, with the current pier resting on an earlier pier or partial foundation (2018).

The frame rests on brick piers on three sides, and on a continuous foundation along the fourth (north) wall. Archaeological evidence suggests that the foundation was a hybrid, with substantially larger piers at the corners (Figure 4). The current piers are relatively late repairs.¹³ The bricks in the foundation are of a type that date to the mid-19C; the bricks in the piers are a mixture of similar bricks and machine-made units of an even later period, laid with Portland cement mortar.

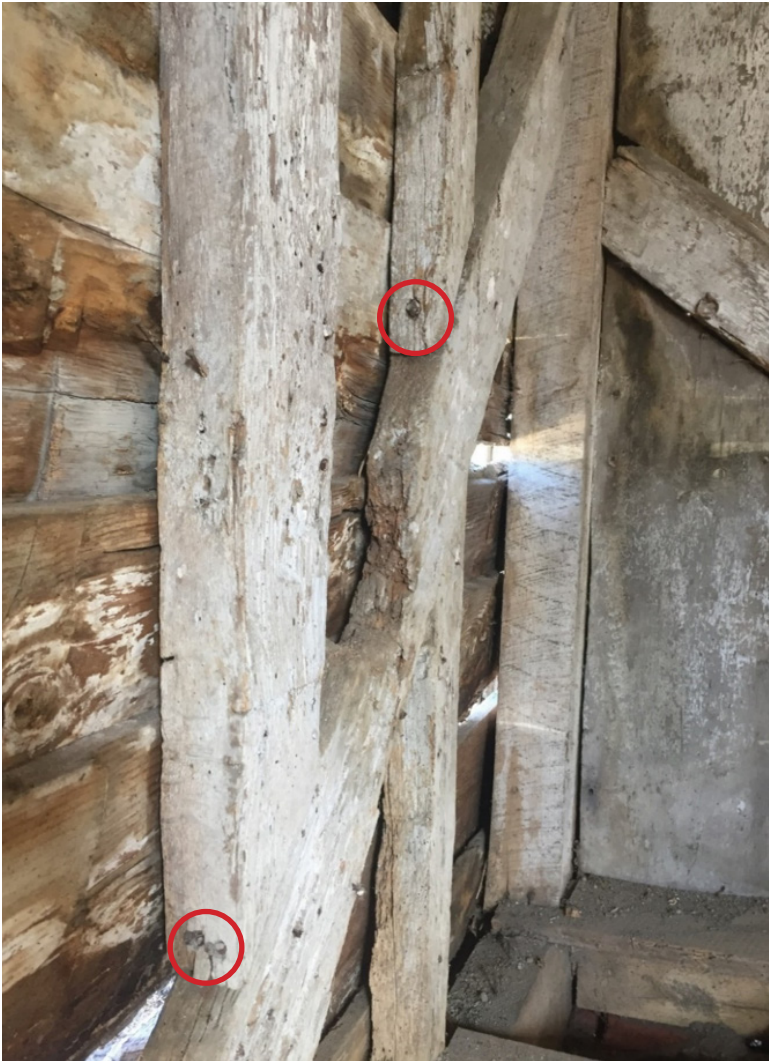
Figure 5. Northwest corner interior, showing the replacement corner post and sills (circular sawn), and two original down braces and two studs; studs are attached to the braces with wrought nails (2018).

windows centered on both walls. Along with three of the corner posts, the sills on all four sides have been replaced, as have the floor joists. A post and short joists anchored by a concrete pad were inserted at the southeast corner to compensate for the failed sill. The replacement floor joists are attached (toe-nailed) to the sills with wire nails. All of the floorboards on the lower level have been replaced with circular sawn units, but much of the flooring in the attic is original. Dimensional wood boards and blocks have been inserted throughout the building as needed to replace or shore up deteriorated members.

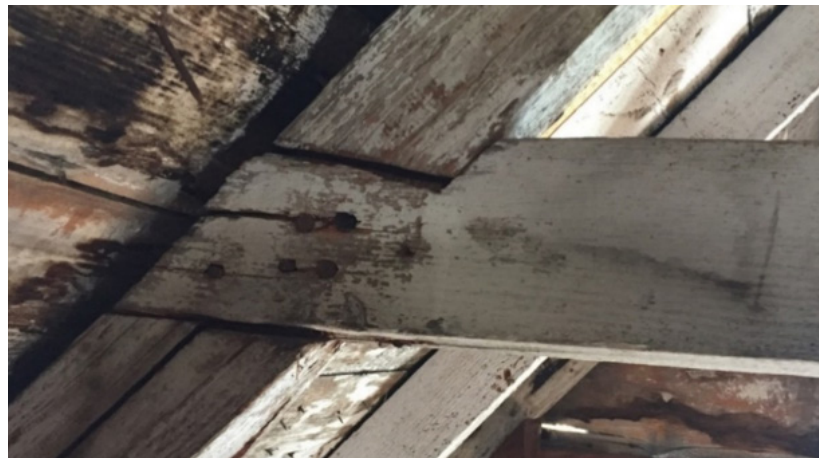
current site. It has been extensively altered due to major repairs necessitated by widespread water damage and structural failure. The frame originally consisted of six rafter pairs, which were joined at the peak with a saddle-notch and pegged. Each surviving pair has a substantial collar, joined to the rafters with a half-dovetail and fastened with cut nails. All of the rafters have been repaired or selectively replaced, and only one of the collars appears to be in its original position (Figure 6). The rafters are sashsawn or sashsawn and hewn; the collars are sashsawn. Open lap mortises found on several members indicate that at least some of the material was reused from another structure.

Figure 6. The roof frame has been substantially altered. One collar appears to be in its original location, attached to the rafters with a half-dovetail joint, and fastened with both cut and wire nails (2018).

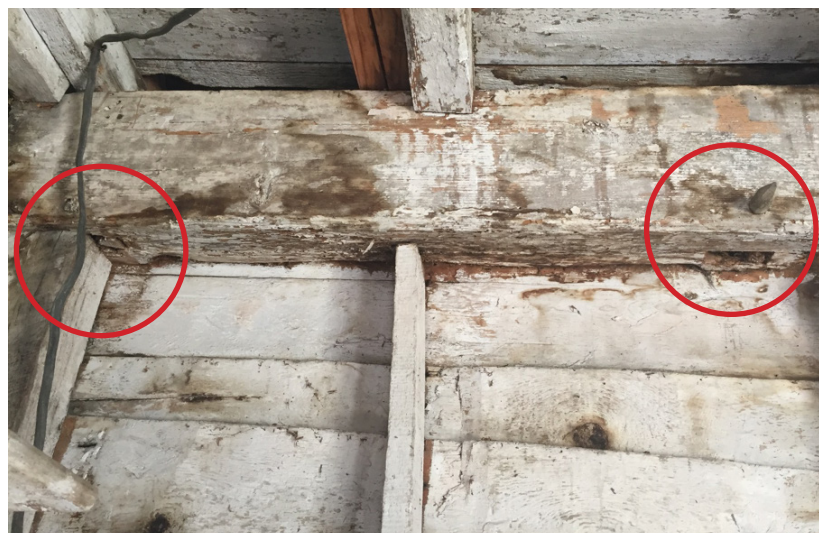
Figure 7. East wall frame detail, with original girt (chamfered corners) and two mortises in the bottom face, for the original corner post (left) and the door post (right); the narrow stud was inserted after the doorway was relocated (2018).

Two mortises in the end girt indicate the location of the original doorway at the north corner of the east wall (Figure 7). A substantial mortise, with two surviving pegs, indicates the position of the original corner post, which has been replaced by a smaller member. Another large mortise, with one surviving peg, is spaced roughly three feet from the corner post, which would be an adequate space to accommodate the doorway. In addition, the down braces (two each) connected to both the original (southwest) and replacement posts survive on all the walls, except at the northeast corner. A doorway in that location would have interfered with a matching brace, and thus its absence is likely an original condition. Another mortise in the girt is positioned roughly two feet south of the presumed doorpost, which related to a stud that was removed to accommodate the later barred window. A narrow stud has been inserted in the bay between the current window and the corner post, where the opening for the doorway had been located.

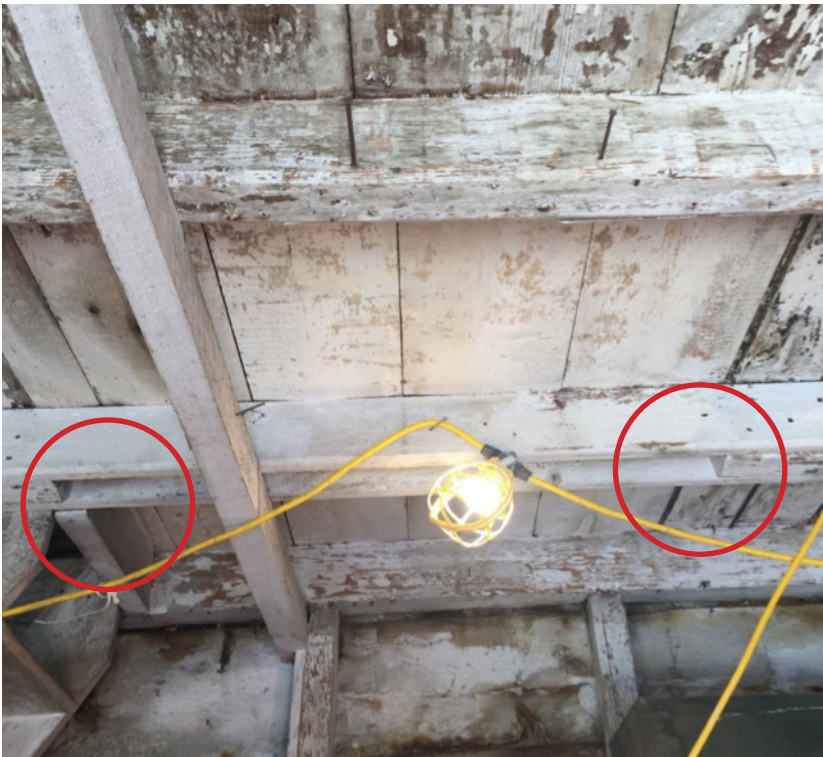
Figure 8. Detail of the frame along the north wall, east of the stairway, and the patch in the ceiling floor; the ends of the short joists are sistered with 1" planks (circled in red) (2018).

One of the most telling features of the building is the evidence for a gap in the ceiling frame, and for an associated opening in the floor (Figure 8). The first joist in from the north wall is discontinuous, with a gap of roughly 4'3" near the center. A patch in the ceiling floor corresponds to the east-west dimension of the gap, and spans from the north wall plate to the second joist. Planks to bridge the opening are fastened with cut nails to each side of the inner ends of the first joist. The chamfered lower corners of the planks match the joist. The boards for the patch covering the opening in the ceiling floor are distinct from the surviving original boards, and are attached with cut nails. Thus, the similarity in materials indicates that both spaces -- the gap in the joist and the opening in the floor -- were closed at the same time.

The most likely explanation for the opening in the ceiling is that it accommodated the brick chimney for a fireplace, a feature of the original construction that was abandoned at the time the building was repositioned. The almost exactly square opening (4'3" by 4'2½") seems unusually generous for a chimney in such a small building, but the joist spacing was a determining factor in the north-south dimension. Where a substantial opening of this type was incorporated into the frame of buildings, standard practice of the period called for inserting members (headers, trimmer boards) to finish the opening and provide support for the truncated joists as well as for the adjoining floorboards. There is no evidence (remnants of wood, nail holes, ghost marks) to indicate that supplemental framing had been installed.¹⁶ However, another method that was sometimes used in the specific instance of accommodating an interior chimney was to support the ends of the two short end joists by resting them directly on the face of the masonry base.¹⁷ An example of this strategy is visible at the 18C brick kitchen located at the Alms House site in Machipongo, in Northampton County, Virginia. At Machipongo, the ends of the joists for a 19C addition are cut at an angle to rest against the sloping sides of the shoulder of the chimney base (Figure 9). The ends of the short joists at the Bayly outbuilding are angled slightly in a similar manner. Therefore, the first joist, which has been sistered and now spans the length of the structure, consisted originally of two shorter individual members that rested against the chimney mass.

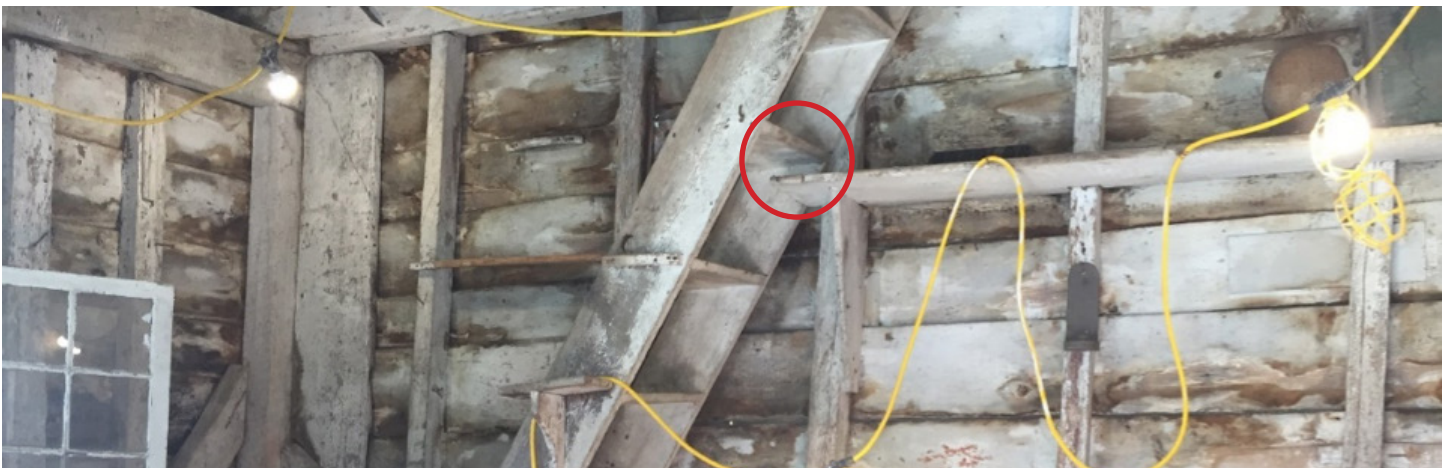
patched (Figure 10). The west end of the board has been cut just east of the ladder stair, leaving a rough, vertical surface. This indicates that the shelf had extended farther to the west along the north wall before it was shortened to allow for the current stairway. Therefore, access to the attic could not have been in this location until after the shelf board was altered. The beveled opposite end of the north shelf indicates that it was attached to another shelf that ran along the east wall. As that unit would have conflicted with the original doorway, installing the shelf and relocating the doorway to the south wall likely occurred at roughly the same time. A third shelf may have also run along the west wall. The barred windows were installed after the shelves were removed from the east and (likely) the west walls.

Figure 10. Detail of the northwest section of the north wall, showing the relationship of the stairway and the shelf; the west end of the shelf has an uneven vertical cut, indicating that it was trimmed to allow sufficient space to install the ladder stair (2018).

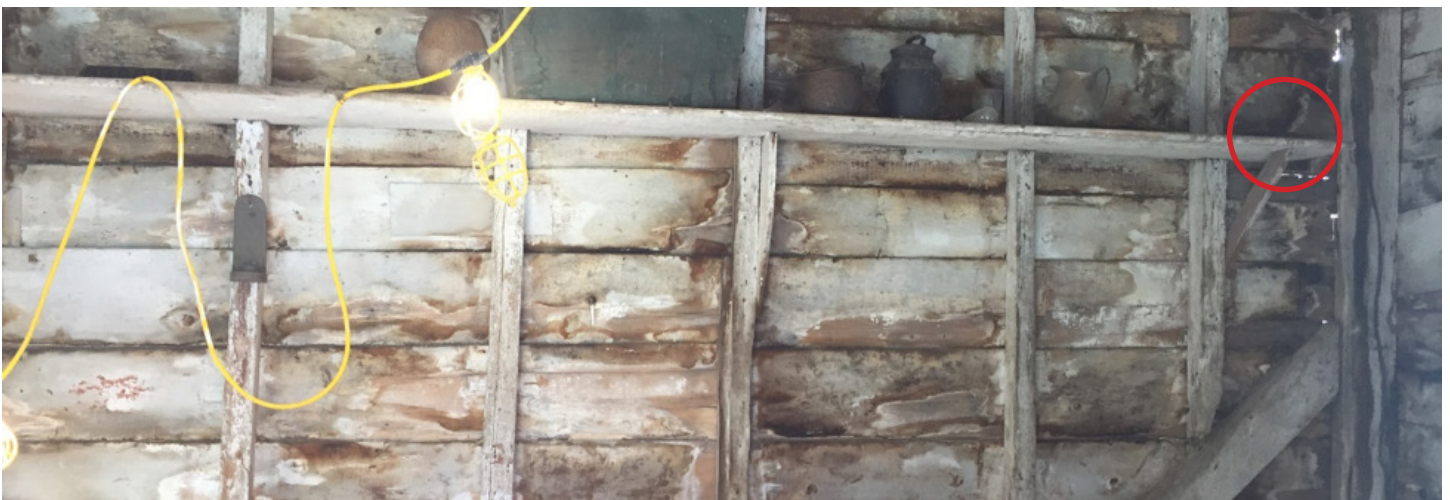
Figure 11. The north wall interior of the Bayly outbuilding, showing original plate, studs, and northeast corner brace, and replaced post, sill, and joists; the end of the shelf is beveled to overlap the shelf board that ran along the east wall; end of shelf and inserted bracket circled in red (2018).

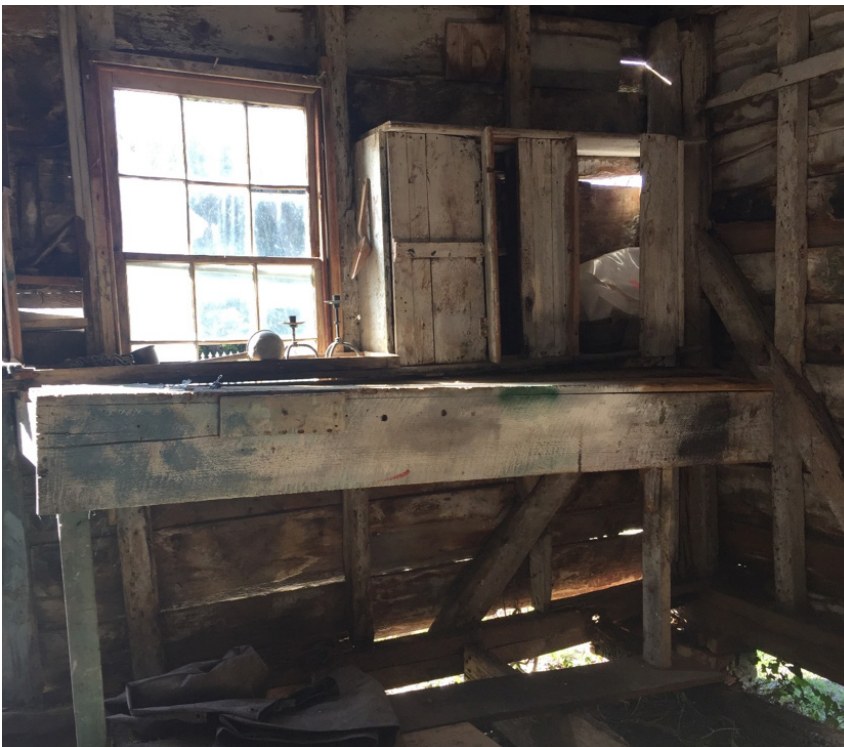
Figure 12. South wall interior, west of the doorway (P2), with cabinet and counter (P3), work bench and window (P4); southwest corner post and braces are original (2018).

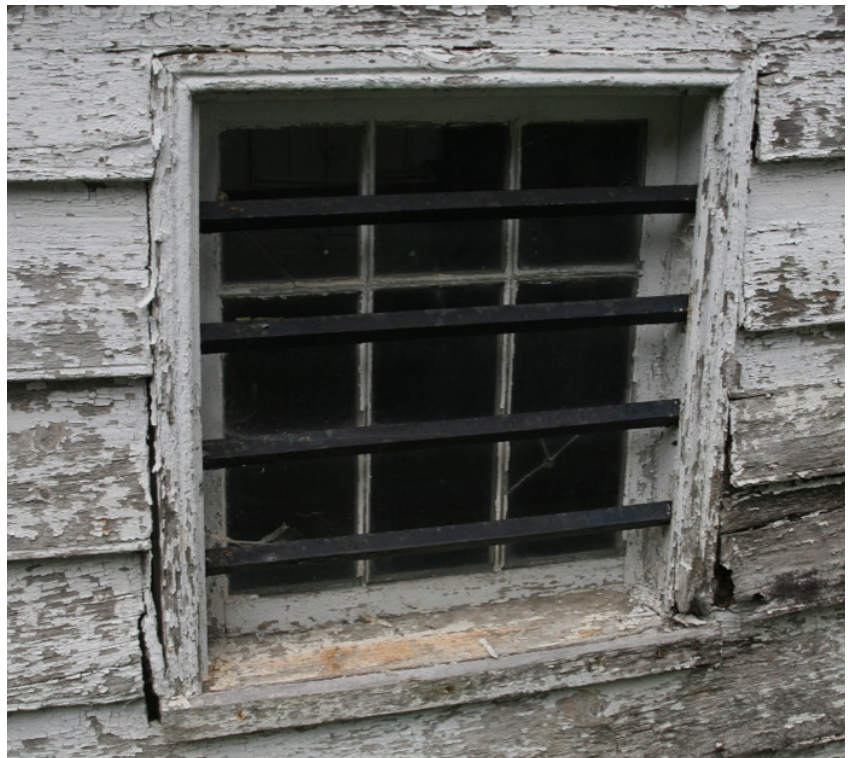
Figure 13. Window with hinged sash and iron bars, east elevation (2018).

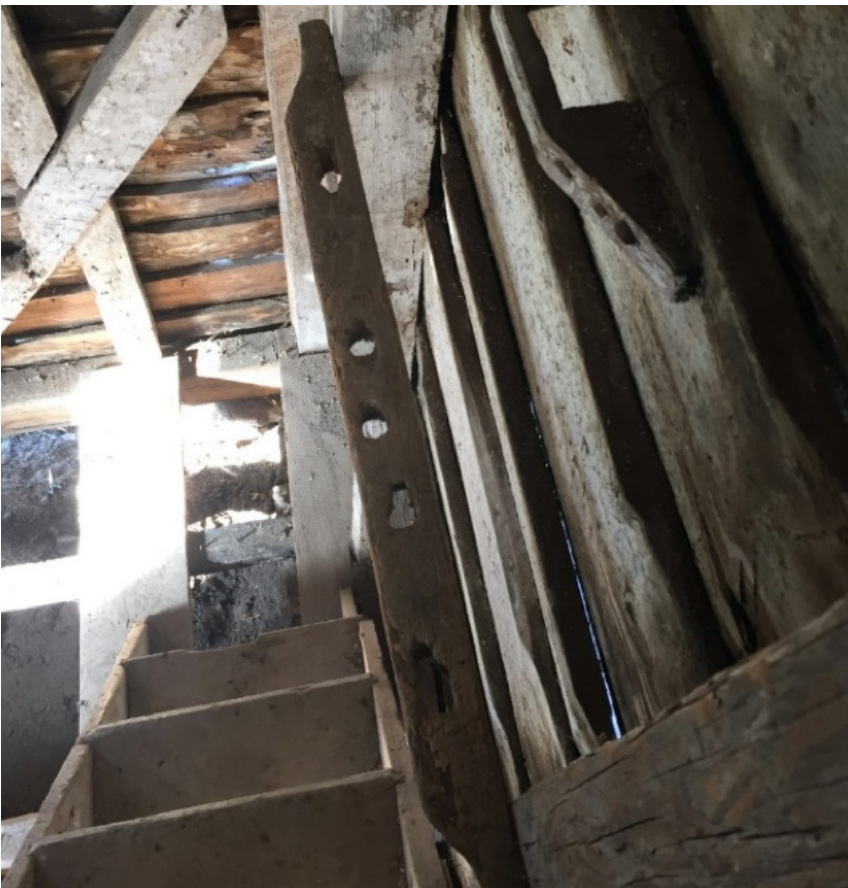
Figure 14. Detail northwest corner interior, with wood tool rack attached to two wall studs and a wood handle attached to the back of the weatherboard siding (2018).

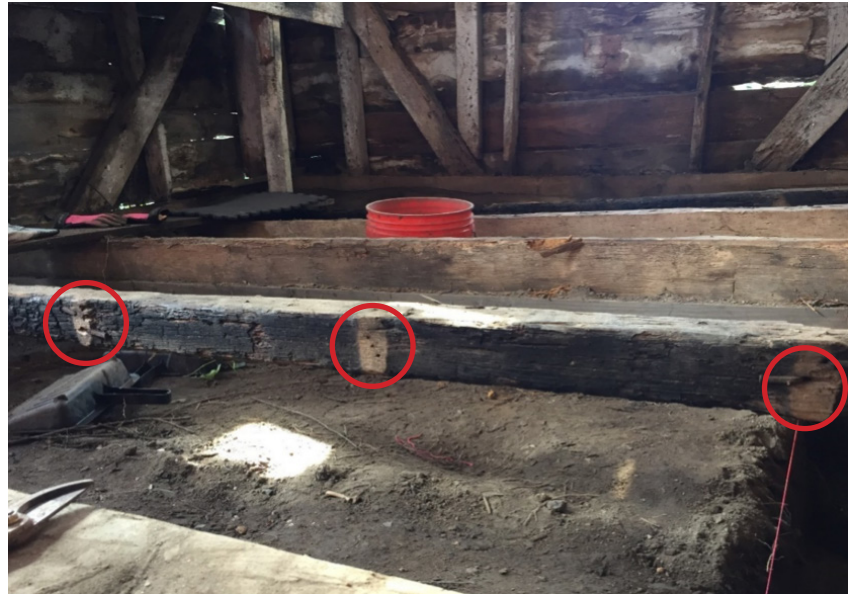
It appears that leaks in the roof caused significant water damage, especially at the west end of the building, which required considerable intervention. Portions of the roof frame and sheathing, the studs framing the gables, several square feet of the ceiling floor, and the west wall girt were all replaced. The west ends of three of the four ceiling joists were damaged as well, and each has been cut and sistered to reconnect to the west girt. All of the weatherboard siding on the gables, and large portions of it on the walls, have been replaced. On the east, the last floor joist is absent and the wall sill has completely failed. In addition to replacing the corner posts, a dimensional post was inserted in the east wall, and a concrete pad and supplemental joists were installed to shore up the southeast corner of the building.

Figure 15. Facing west, replacement floor joists; with two reused joists each with three charred faces, ghost marks for studs, and protruding cut nails (2018).
