Clermont Slave Quarter

After Action Report: Historic Fabric

Dennis J. Pogue and Ken R. Livingston
10-23-2017

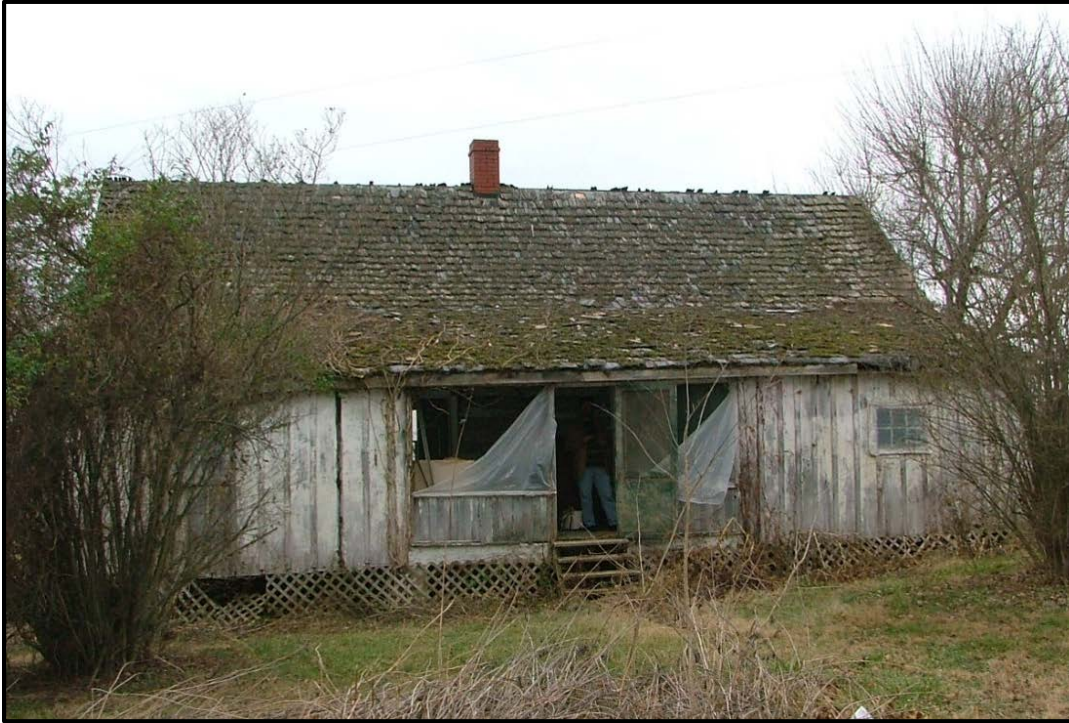
Figure 1. Clermont slave quarter, east façade (2010).

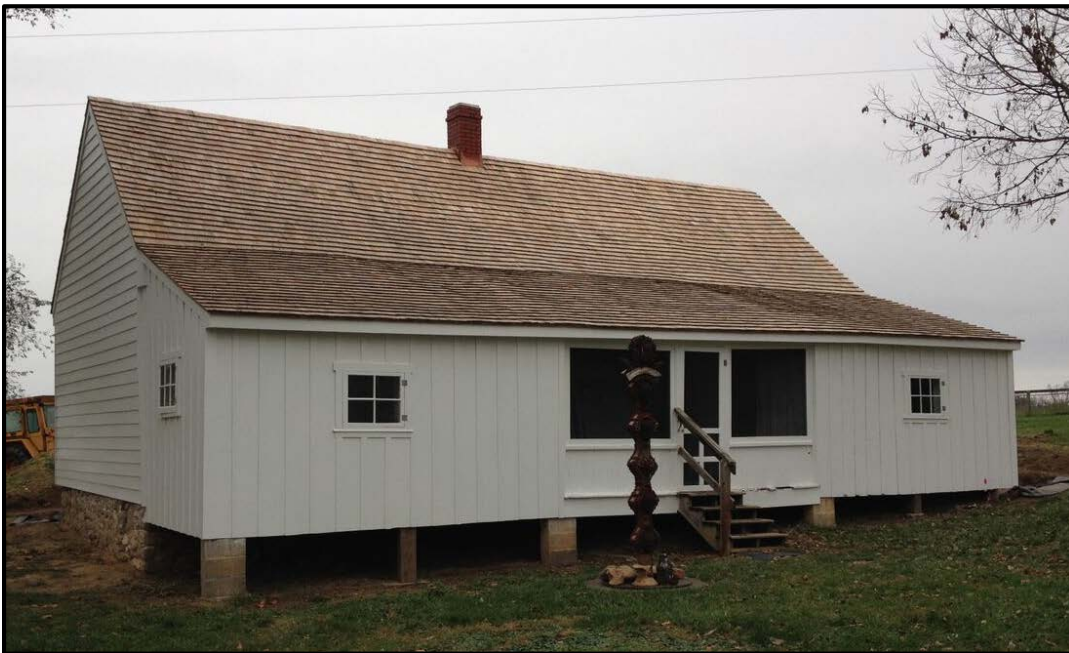
Figure 2. Clermont slave quarter, east façade after restoration (2015).

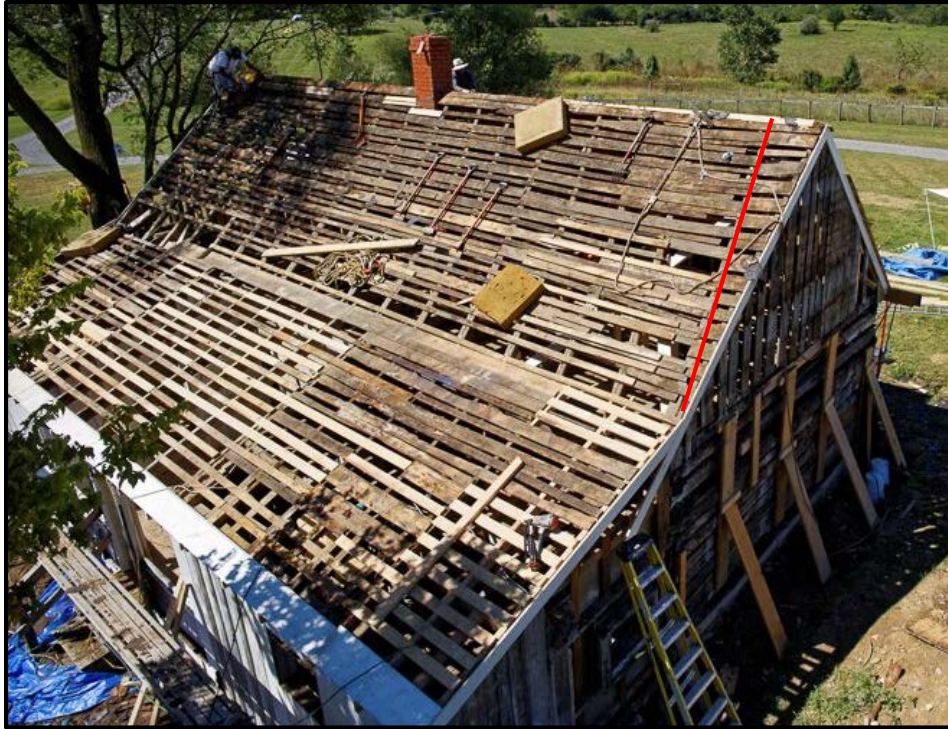
The current gable roof frame is a complex hodgepodge of materials, including both original elements of the first roof structure and the results of successive repairs. The frame of the original roof failed and deflected significantly from north to south at an as yet undetermined date. Based on a combination of physical and documentary evidence, however, this event is most likely to have occurred during the early 20th century. The deflected rafters were stabilized in their altered positions and incorporated into the repaired structure. The framing members for the gables had failed as well and were completely replaced (Figures 3 and 4).

Figure 3. The Clermont slave quarter east side roof frame after shingles and plywood deck was removed (2015); note the severe southward lean of the main roof rafters.

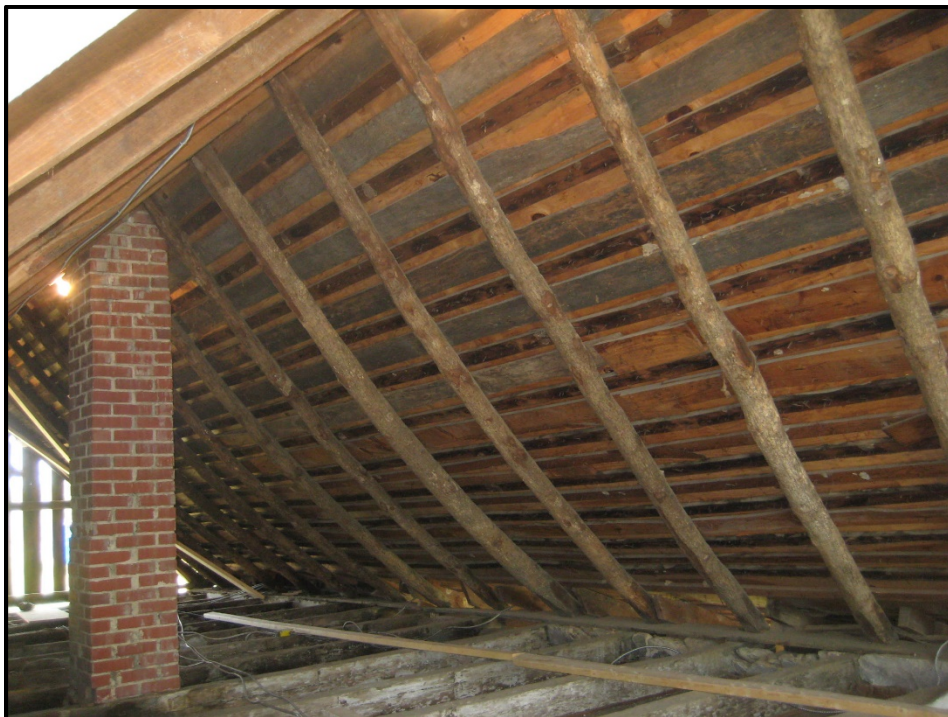
Figure 4. The original pole rafters on the east side of the slave quarter roof shifted between 2' and 2'6" to the south (2015); the existing brick chimney is a 20C replacement of the original.

The tops of the surviving rafters have shifted as much as 2'6", while the feet of the poles remain in place and attached to the false plate with wrought-headed iron spikes. When the frame was repaired and the new roof covering was installed, the members were stabilized and left in their deflected positions. The rafters currently on the west side of the roof are 20th century replacements, made of dimensional lumber, some of which are machine planed and others are circular sawn. Circular sawn oak boards of varying widths, spaced with a gap of @3" between the rows, are nailed to the tops of the rafters. Although the physical evidence presents a confusing picture, it is most likely that the current west rafters and skip sheathing boards date to the period when the roof was first stabilized.⁹ The mismatched rafter pairs are lapped and nailed at the peak, with the original pole rafters on the east angled to meet with those on the west (Figures 5 and 6).

It is not clear exactly when, or why the roof frame was damaged and shifted so drastically, but strong winds combined with a heavy load, such as snow and/or ice, seem the likeliest cause. The inadequate roof frame and poor maintenance of the building almost certainly were contributing factors. The character of the nailing boards that were inserted between the originals, and those that span the gap between the new and old end rafters, indicates that the event occurred in the 20th century. According to photographic evidence, the porch that runs the length of the east wall of the log building was installed beginning ca. 1938, and the roof frame must have shifted and was stabilized before the porch was added, as the rafters of the shed roof are securely fastened to the main roof according to its current position.

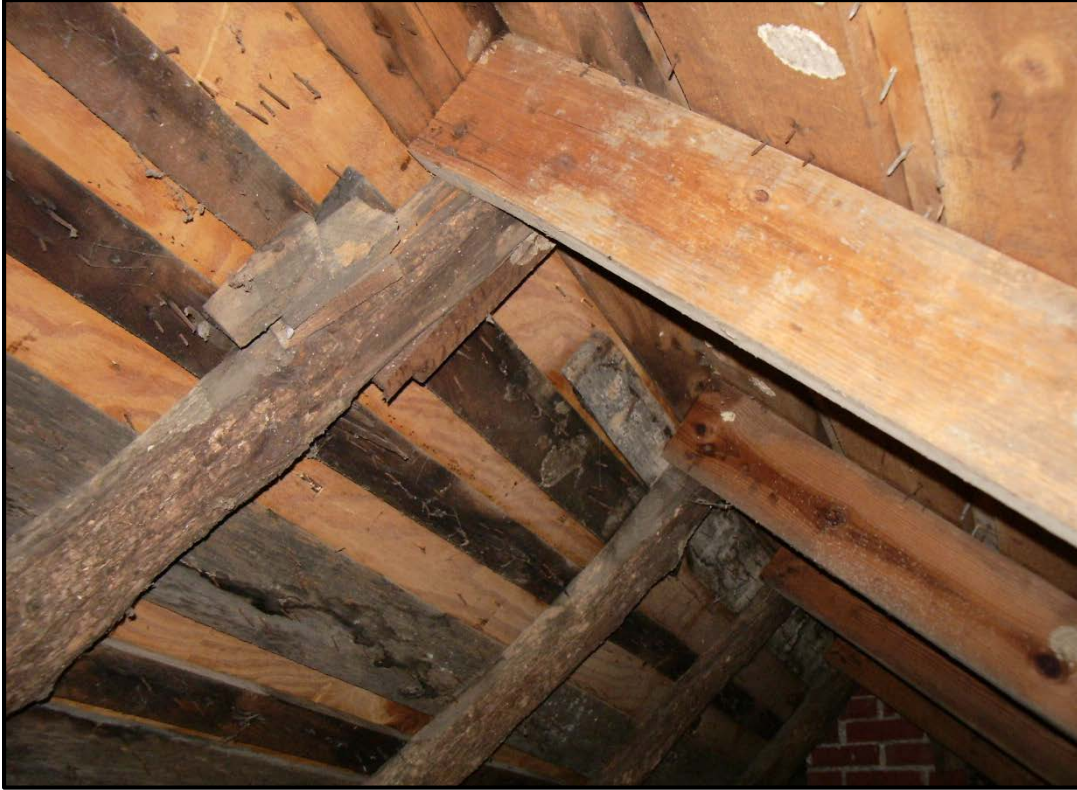
Figure 5. Original pole rafters butted and fastened to west side replacement rafters (2015).

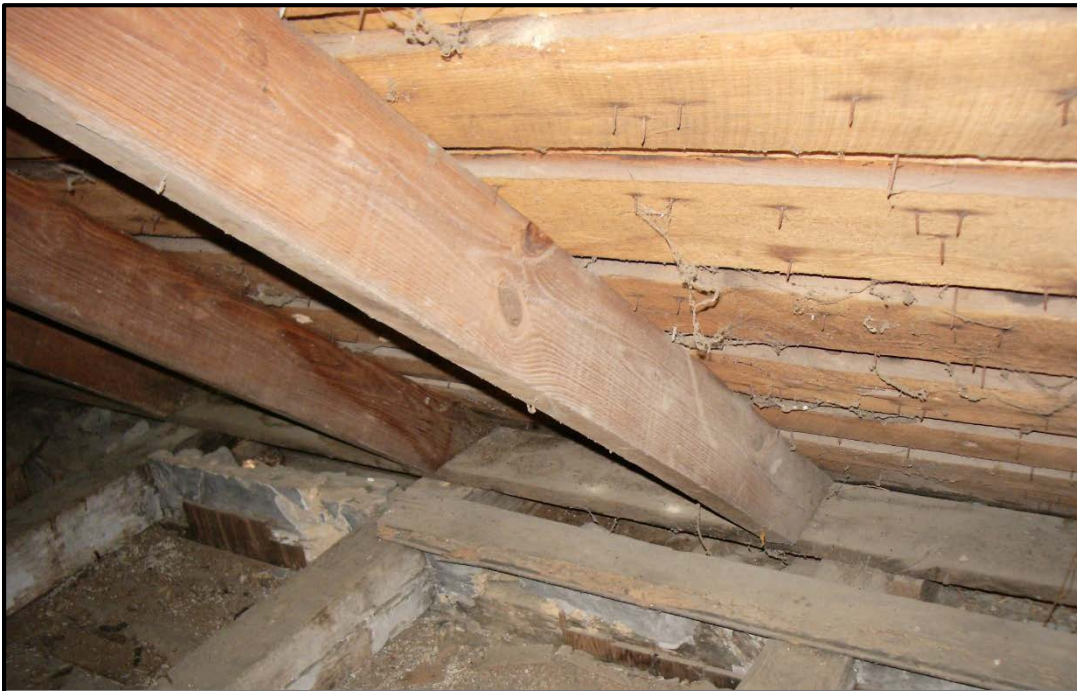
Figure 6. Replacement rafters, shingle lathe, and false plate on west side (2015).

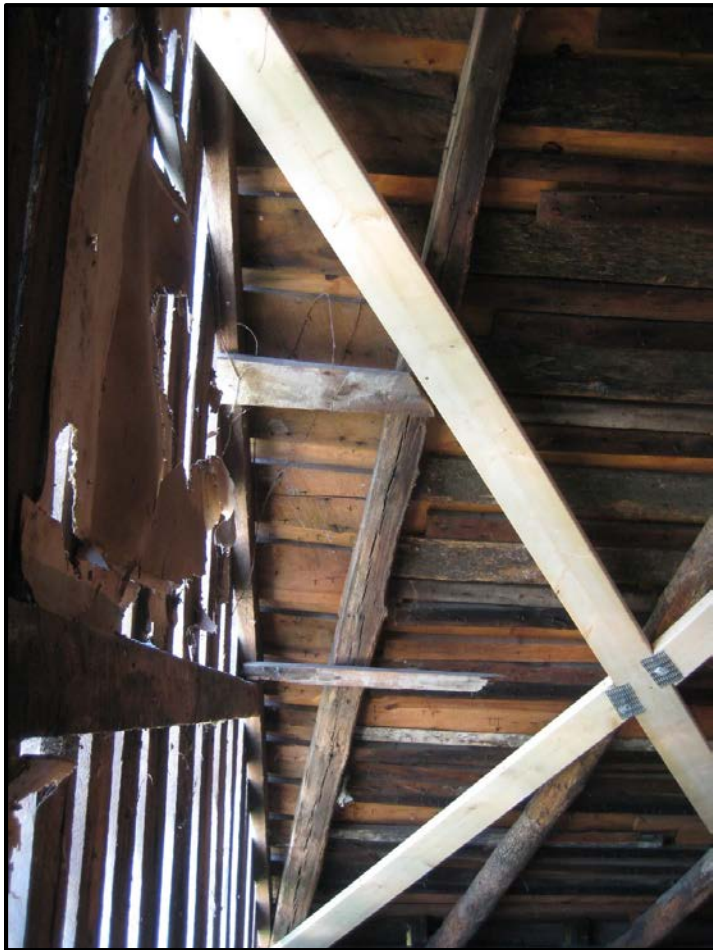
Both of the gables have been completely rebuilt and the end rafters were replaced. The original outer rafter on the north end survives on the east side of the roof, indicating that the outer rafters were squared on three sides to provide nailing surfaces for the studs, for the exterior siding, and for the skip sheathing boards (Figure 7). The top end of the remaining end rafter has shifted almost 2' to the south, and it now laps against a replacement member on the west to make up the first interior rafter pair. The last two rafter pairs on the south end of the building likely were lost when the frame shifted and they have been replaced with dimensional members. Although both gables were replaced, the physical evidence indicates that the entire north end of the structure had suffered much more deterioration than was the case at the south wall.

Figure 7. Slave quarter interior east side of roof (2015); original end rafter has shifted @2' to the south; boards of irregular width were installed to span the gap between the original end rafter and the 20C replacement.

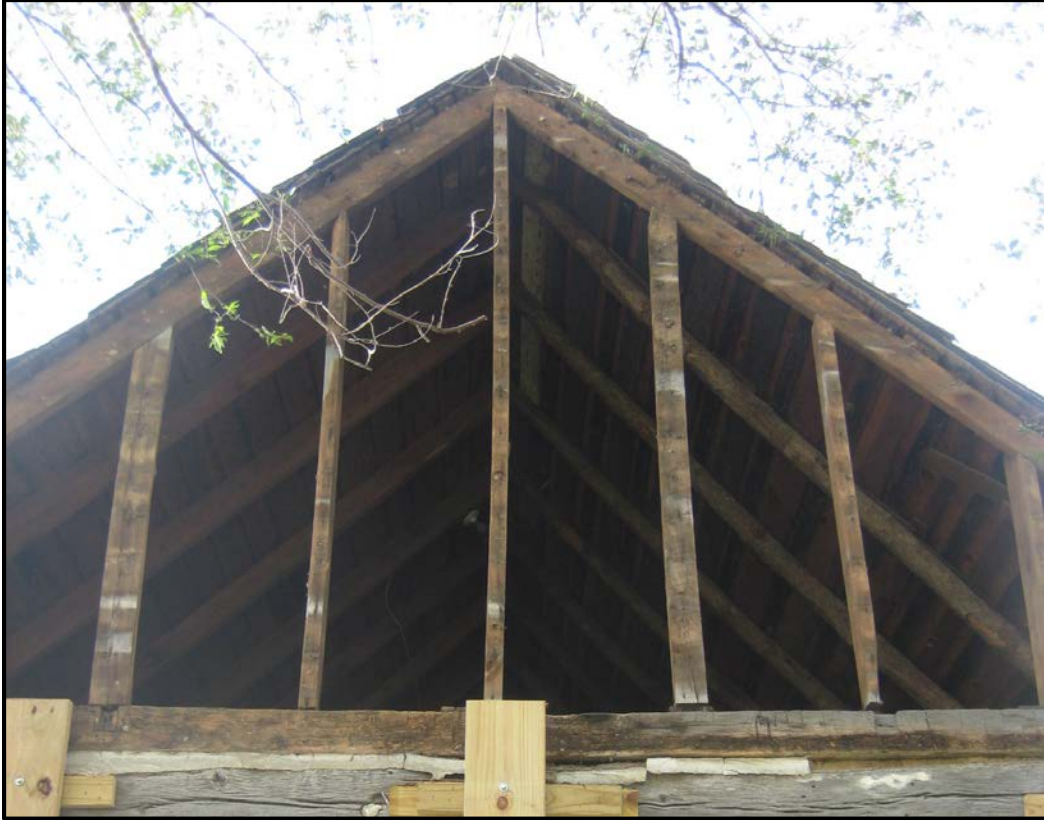
Nine studs were reinstalled on the south gable, toe-nailed to the top of the original joist and to the bottoms of the new end rafters. The mortises for the six original studs are visible cut into the top of the joist. All of the studs vary in dimension and are circular sawn, attached with wire nails. The middle stud is directly aligned with the peak of the roof and is cut at an angle to abut the bottom of the smaller east rafter. As on the north, the dimensions of the end rafters do not match: the west rafter is 6" by 2" in dimension, the one on the east is only 4¾" by 1½". The north end rafters measure 5½" by 1¾" on the west and 5½" by 2" on the east. All of the rafters exhibit marks resulting either from circular sawing or from planing by machine.

Figure 8. Slave quarter south gable with replacement end rafters and studs (2015).

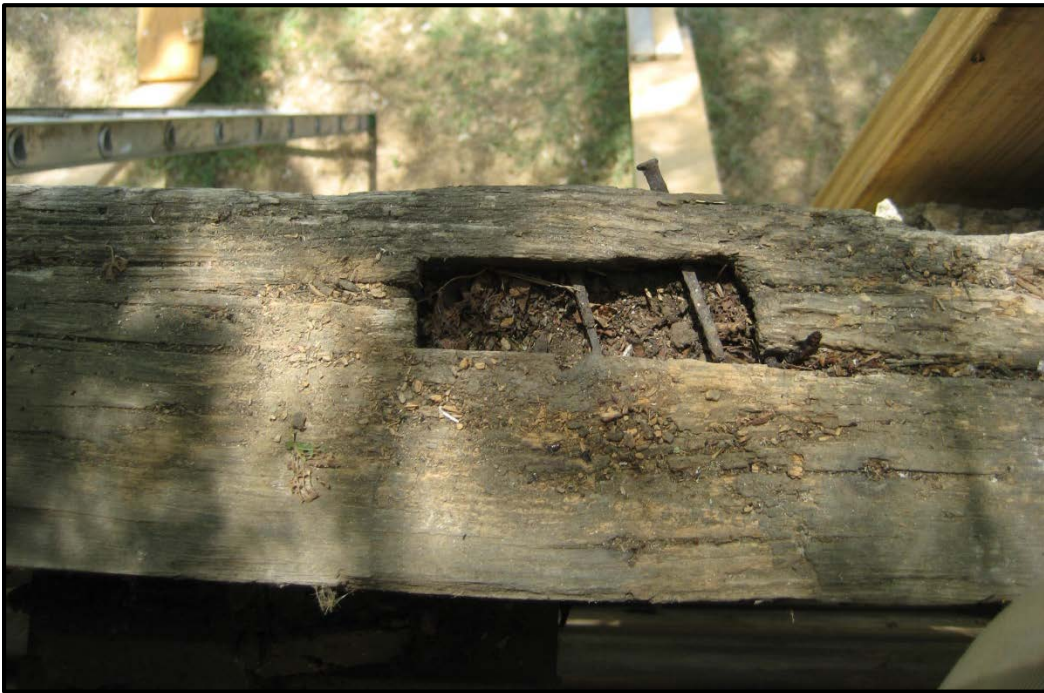
Figure 9. Slave quarter south gable, open stud mortise with cut nails (2015).

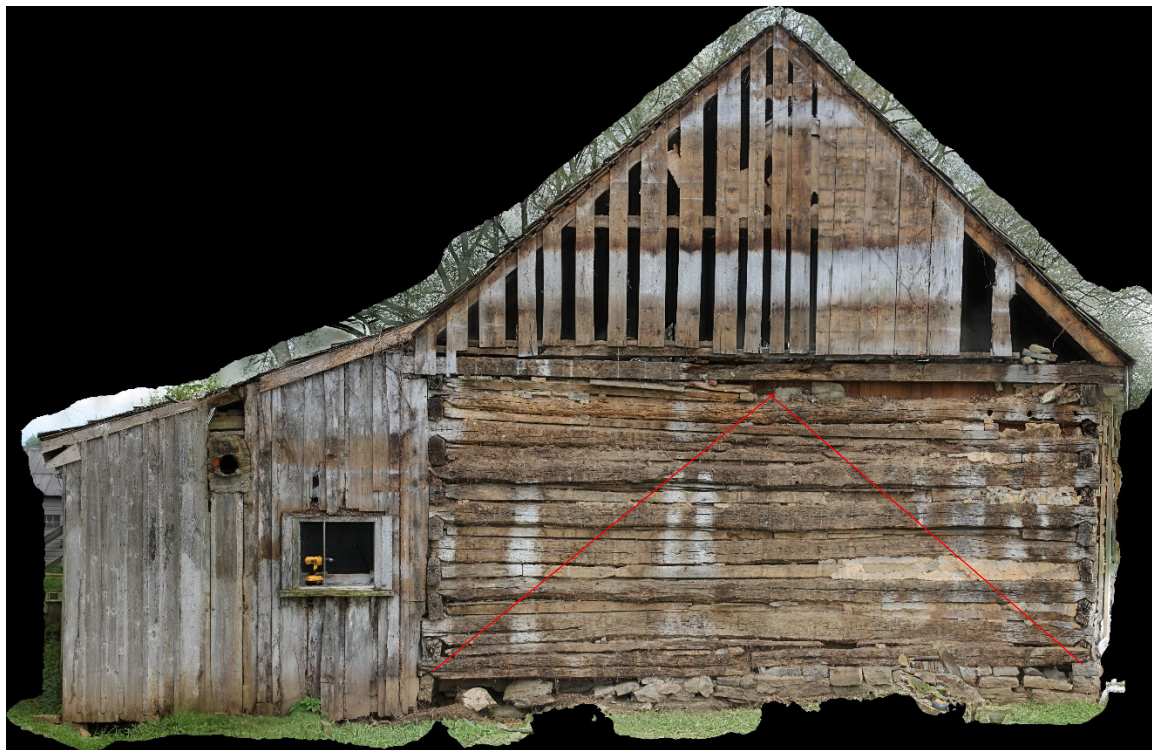
The markedly different methods of enclosing the gables raises the question of whether they are the result of more than one construction episode. The differences between the vertical boards at the north gable, and the associated methods of attachment, indicate at least two periods of construction, with the east boards seemingly changed out long after the original repairs that were made to the shifted roof. The slight differences between the rafter pairs is intriguing but does not necessarily indicate separate building episodes (Figure 10).

Figure 10. North gable after horizontal siding removed from both the gable and log wall, and after vertical siding removed from the log wall (2015). The ghost of wood brace in the form of an inverted V is visible on the log wall; the deteriorated mortises are visible at the c of the gable end girt.

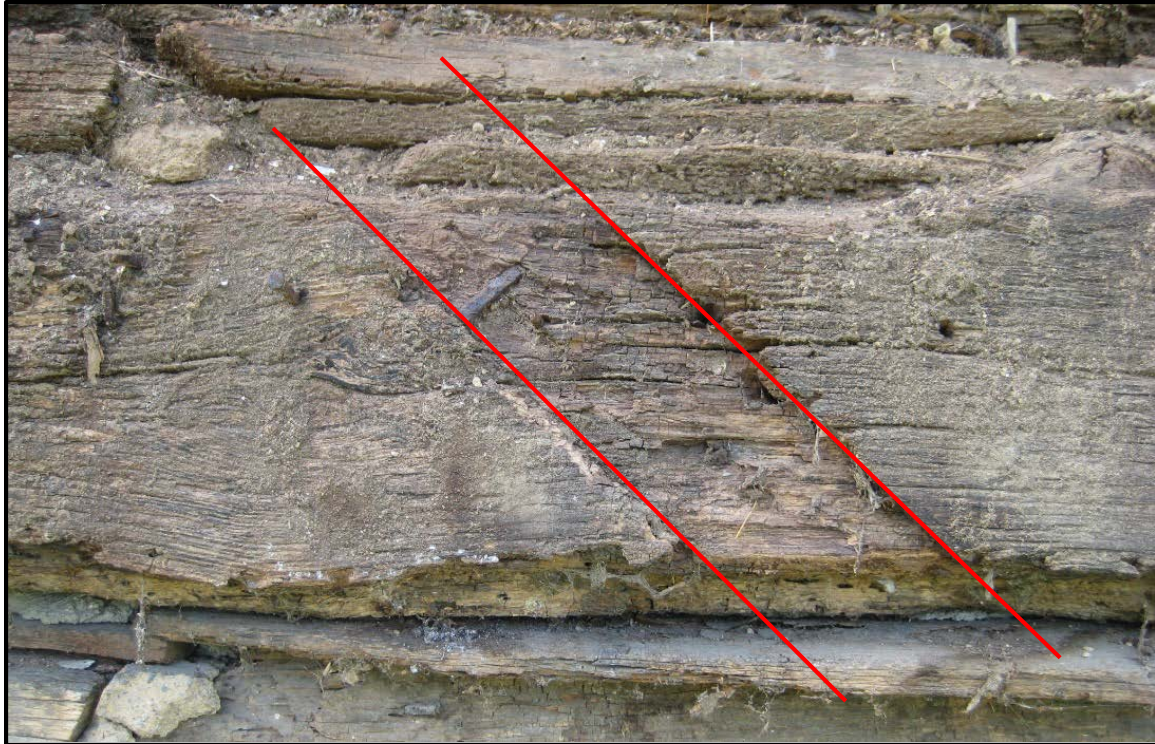
A curious pattern of nails and ghost marks found on the exterior of the north wall seems most likely to be related to an effort to provide support for the deteriorating logs and gable. The ghosts form an inverted V with the apex centered on the wall and terminating at the top of the original end joist. Cut nails follow the paths of the arms of the V. Given the poor condition of the joist, it may be that the two joined boards had been nailed in place to serve as a stabilizing brace (Figure 11).

Figure 11. North gable detail (2015); indentation to receive wood brace, with remnants of cut nails and nail holes; reused material uses as chinking above and below the log.

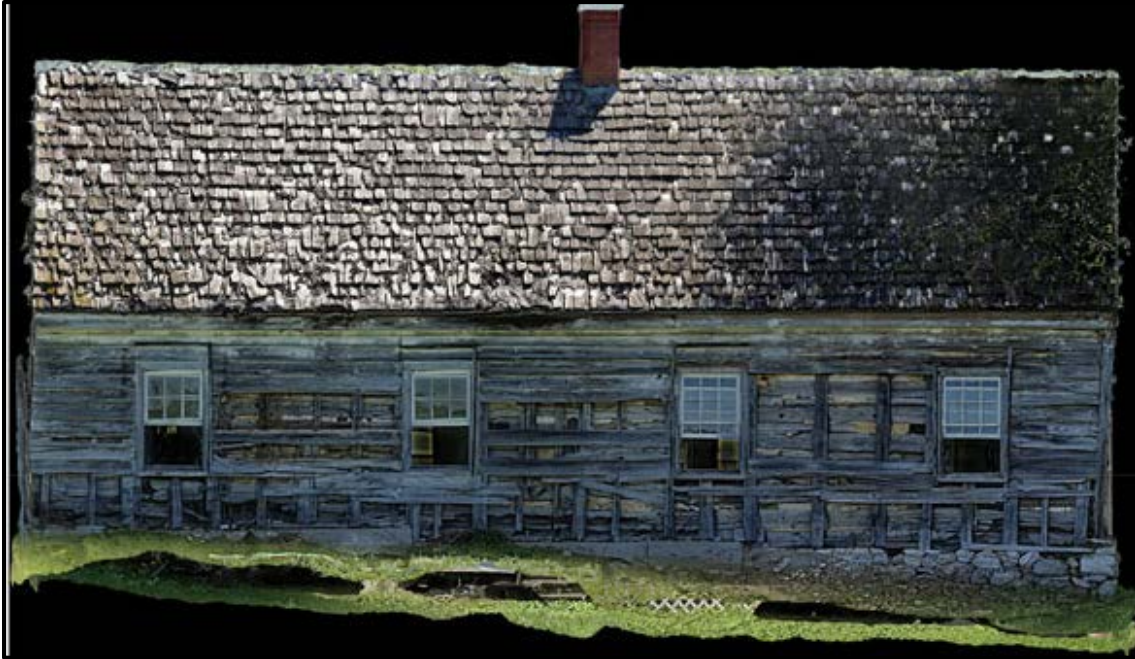
The original window openings were several inches narrower than currently, each of which would have accommodated two 4-light sashes. The logs forming the sides of two of the window openings were completely exposed as a consequence of repairing or replacing a number of adjacent logs. This revealed that both of the openings were enlarged @4" by cutting the ends of the logs to accommodate the wider, 6-over-6 replacement sashes. For the opening near the southwest corner of the west wall (room 504), the logs on the south side were cut the full 4"; the adjacent opening was enlarged by cutting @2" from the logs on either side of opening. Thus, the corner window was essentially shifted 4" to the south, while the second window retained its original alignment (Figure 12).

Figure 12. Slave quarter west wall (2015); all window openings have been widened 4”.

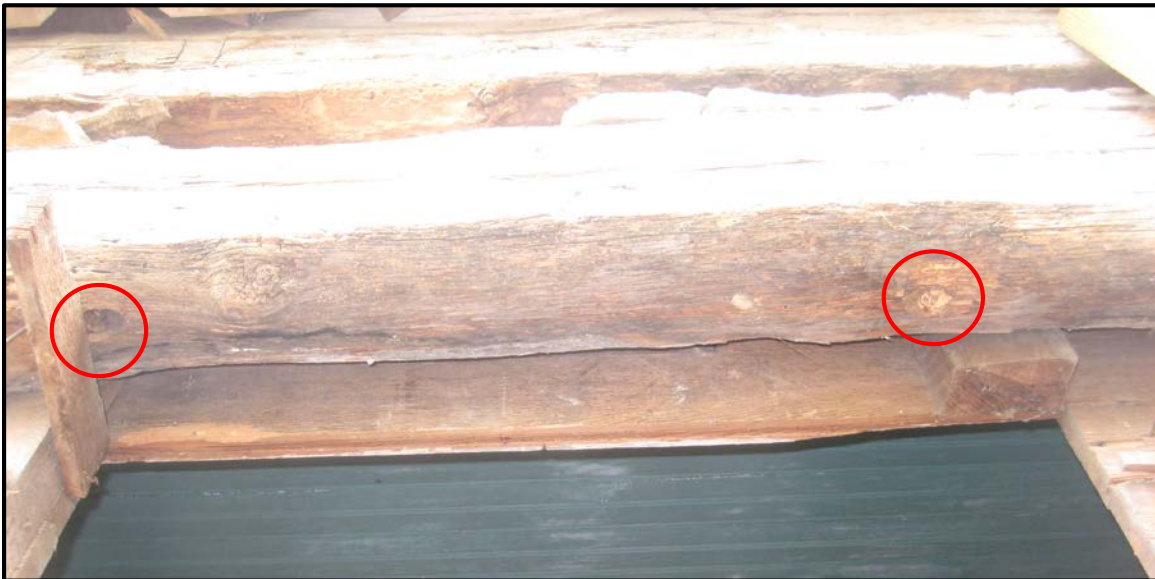
Figure 13. Slave quarter west wall, SW window (2015), cut-off pegs in top log of opening, cut stud and siding in room 504.

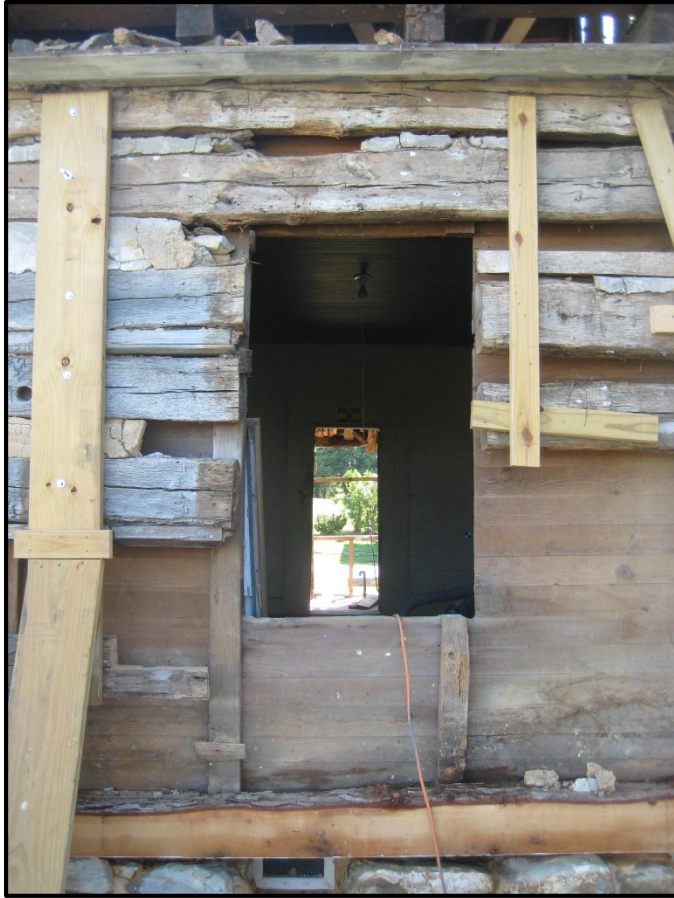
Figure 14. Slave quarter SW window opening (2015); stud and siding boards installed ca. 1917 in room 504 cut to widen opening.

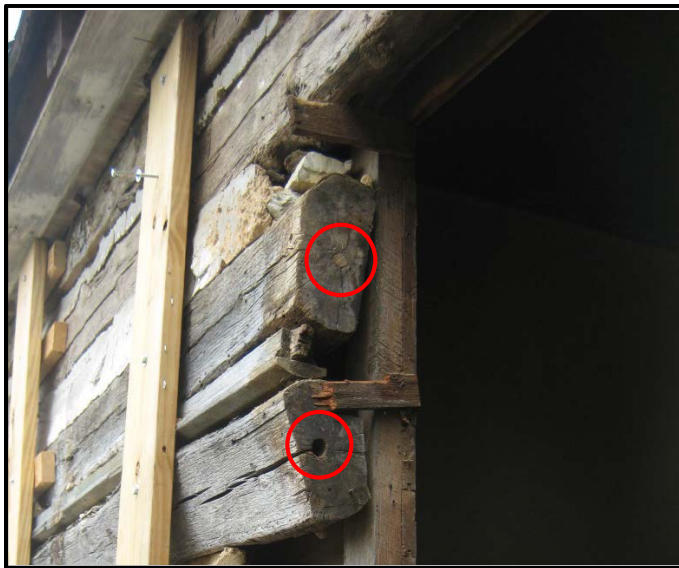
Figure 15. Slave quarter SW window opening (2015); holes for pegs in three side logs, one with sawed off remnant of peg.

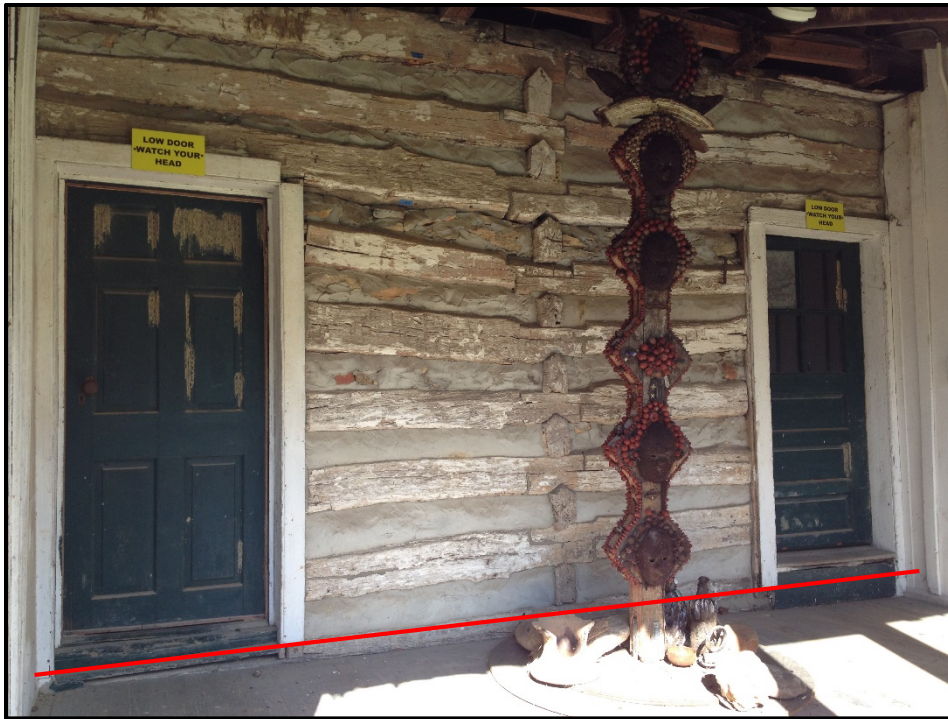
Figure 16. Slave quarter east façade (2015), two original exterior doorways; architraves for both doorways likely installed ca. 1861, cut evenly to suggest earlier floor level of porch (red line).

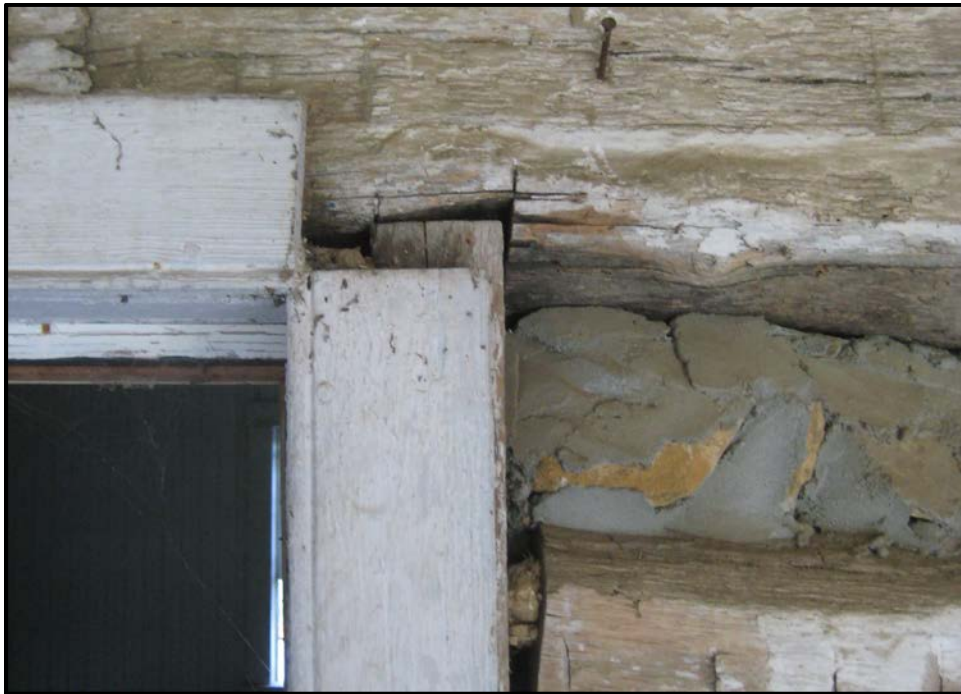
Figure 17. East façade detail (2015), notched jamb for original doorway.

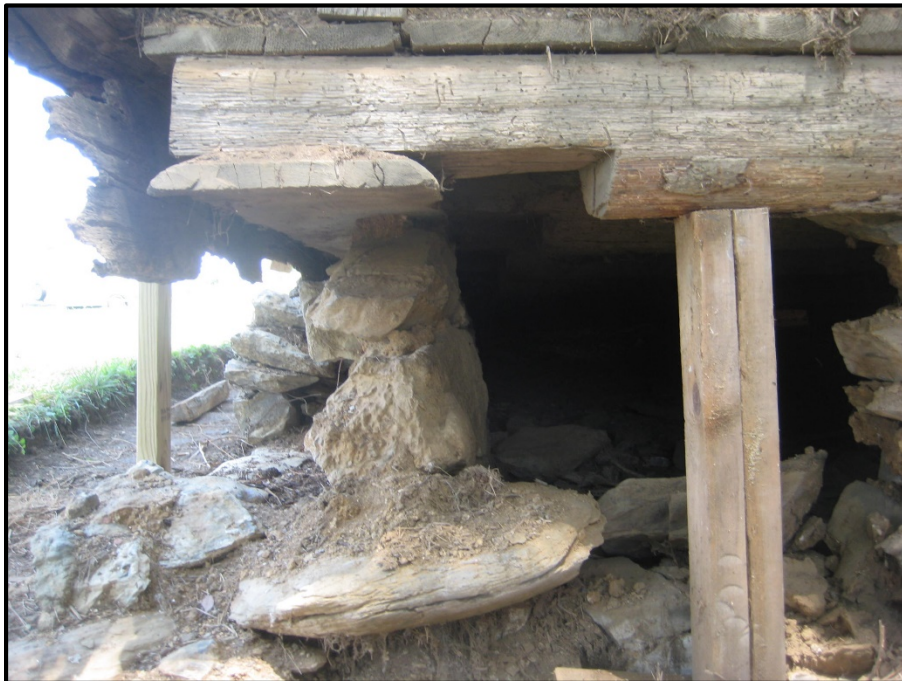
the sill in this location was undoubtedly due to lengthy exposure to water penetration largely resulting from faulty drainage, the slightly raised adjacent ground level, and the lower height of the foundation (Figure 18).

Figure 18. Slave quarter SW corner (2015); end joist notched to lap over flat sill resting on interior portion of foundation.

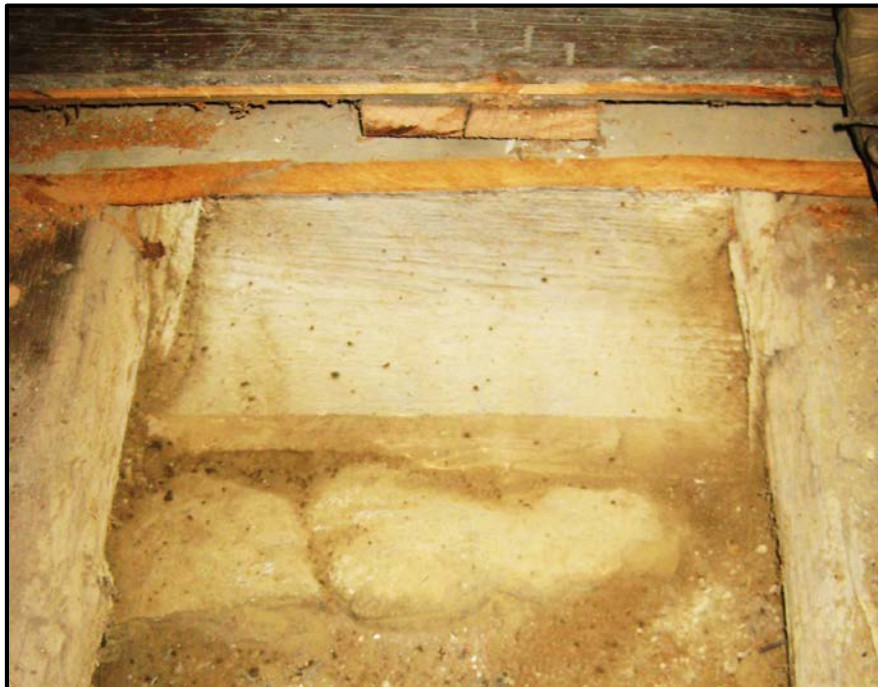
Figure 19. Slave quarter NW corner, interior (2015); joists notched over flat sill, two levels of flooring separated by nailers/spacers for second floor (room 507).

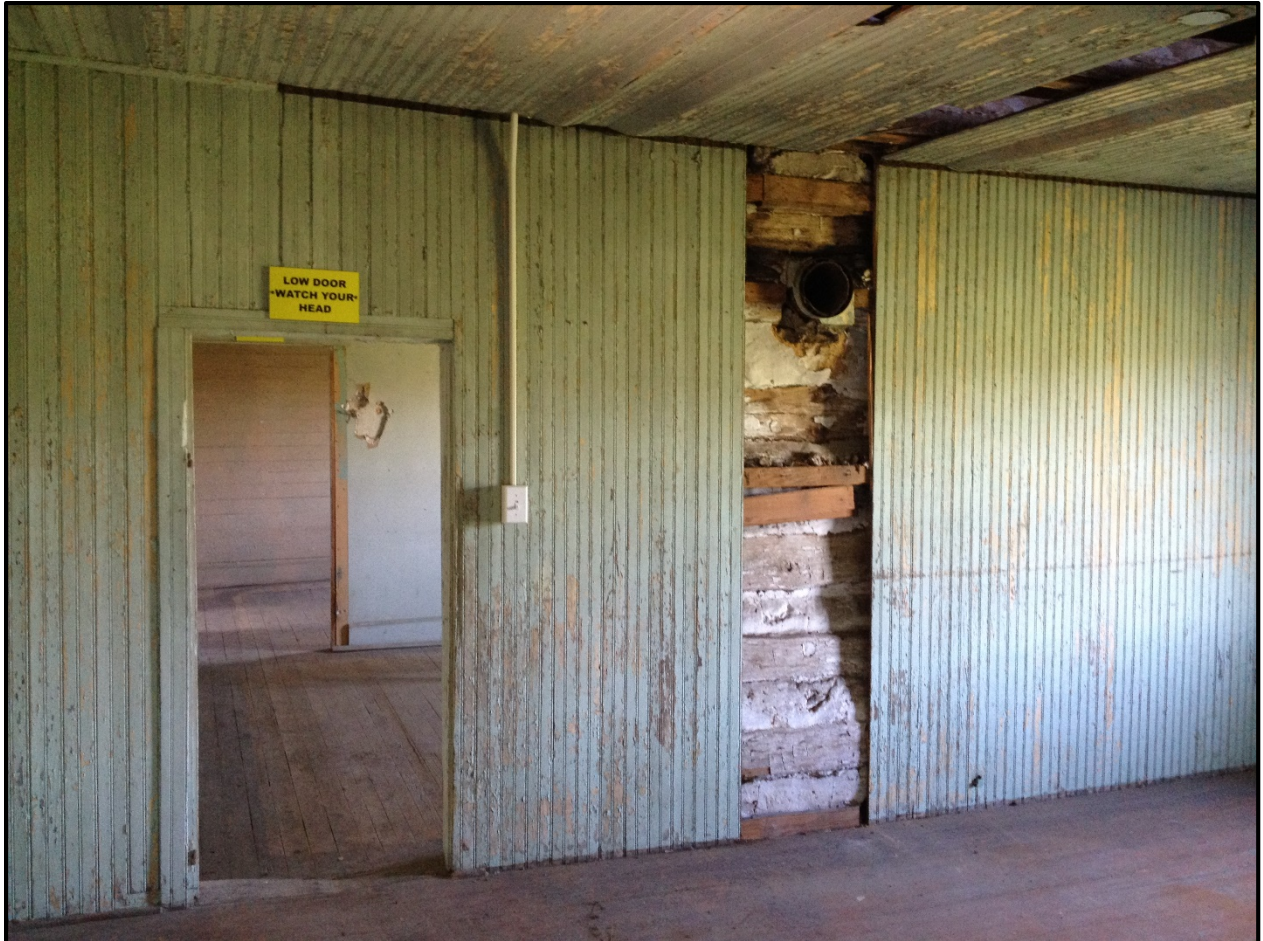
Figure 20. Slave quarter, interior view (2013); south wall room 506, vertical beaded planks applied to log walls and ceiling, hole and thimble for stove pipe visible in portion of exposed logs; plaster board applied to south wall of room 505; horizontal plank siding on south wall of room 504.

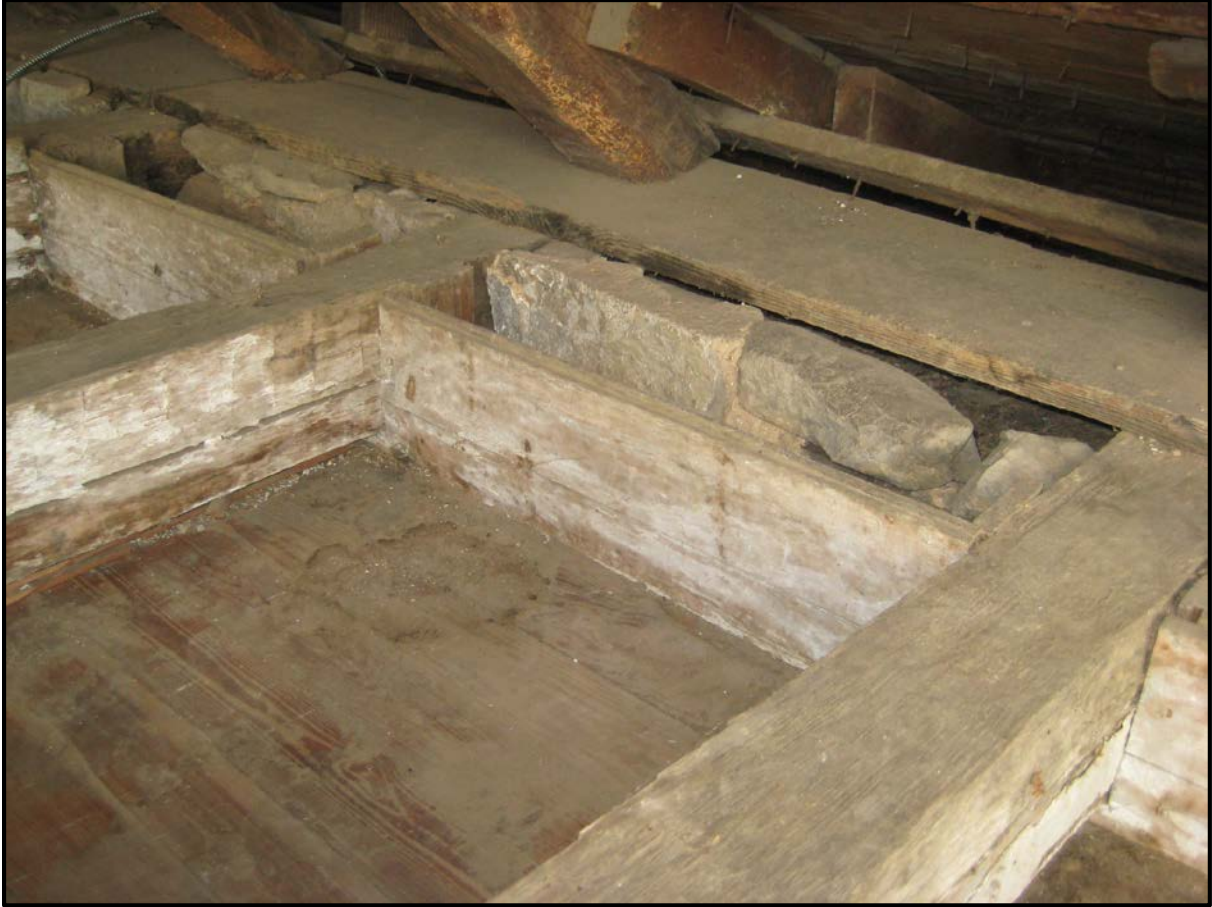
Figure 22. Slave quarter attic detail (2017); horizontal siding boards for room 504 extended to the underside of the original attic floorboards; the underside of the floorboards and the exposed joists, as well as the siding boards, were whitewashed.

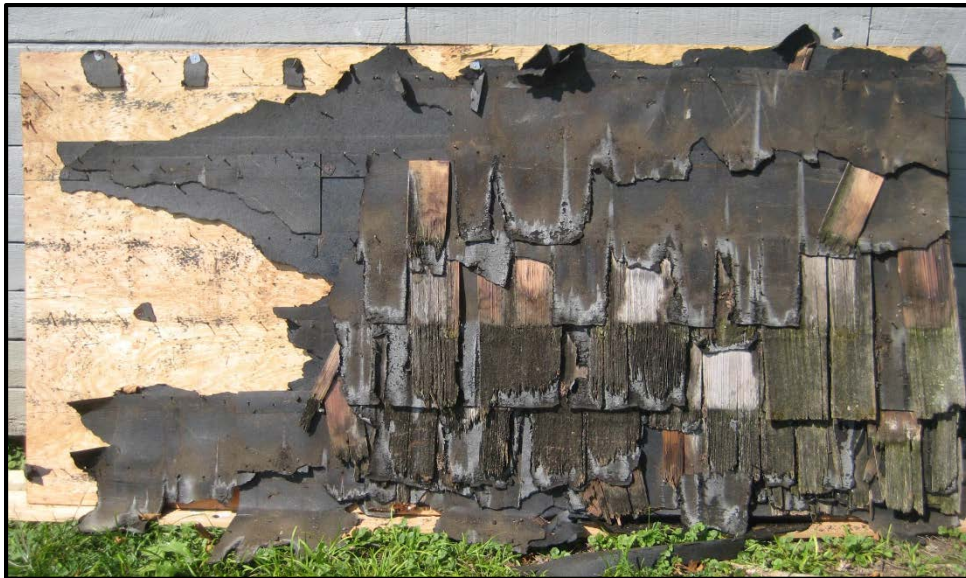
Figure 24. Remnant of 1970 cedar shingle roof, underlain by tarpaper and attached to plywood decking (2015).
