Slave Housing Data Base

Building Name: Presquile – Brick Duplex 2 (northern building)

Historical Site Name: Presquile Plantation

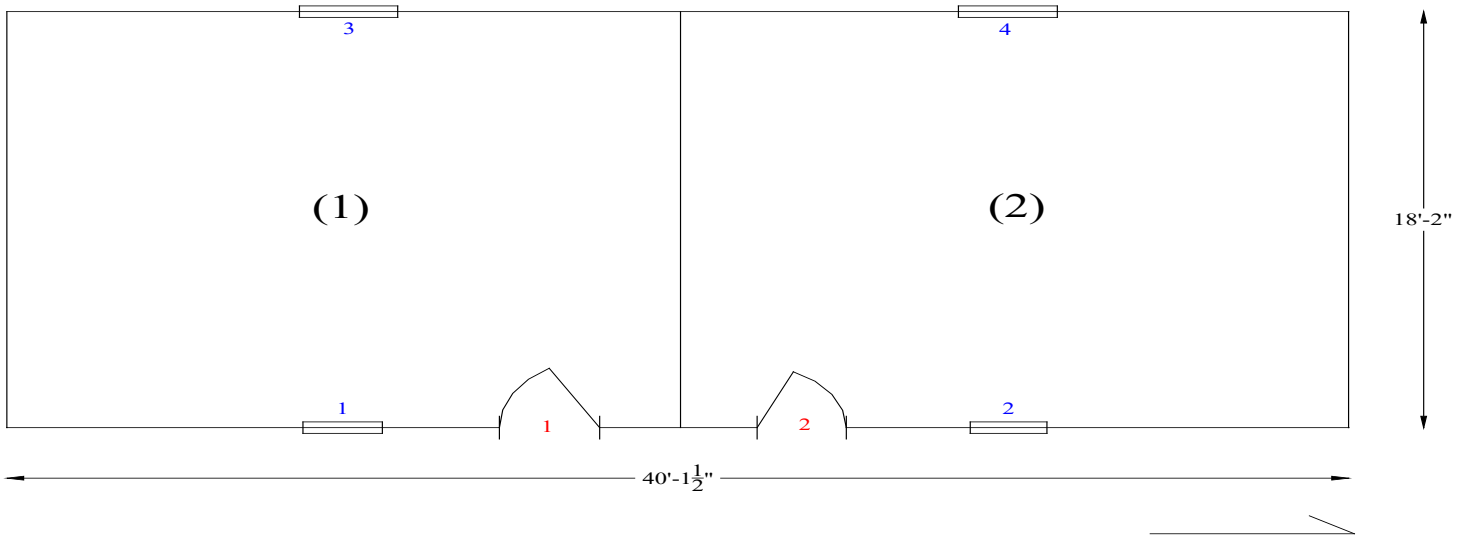
Phase I Footprint:

Number of Rooms: 2 (original; modern front addition not recorded)

Dimensions: (1) South room (Rm. 1): 16.9.0 (E-W) x 18.11.2 (N-S); 8.7.2 (H)

(2) North room (Rm. 2): 17.2.0 (E-W) x 19.1.2 (N-S); 8.5.0 (H)
