Slave Housing Data Base

Building Name: Pharsalia/Brick kitchen-laundry-quarter

Historical Site Name: Pharsalia

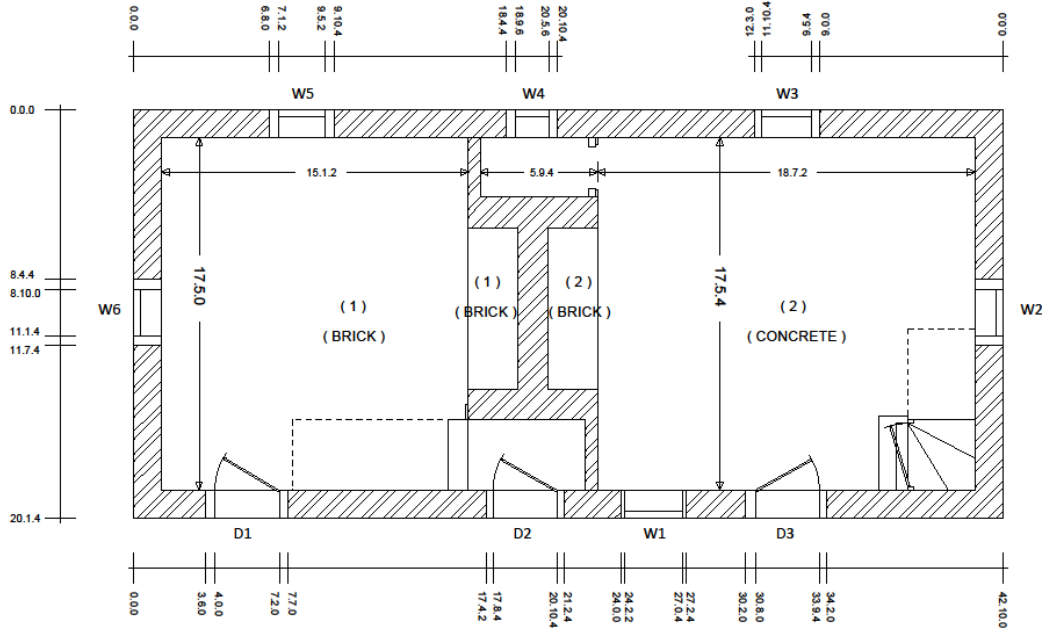
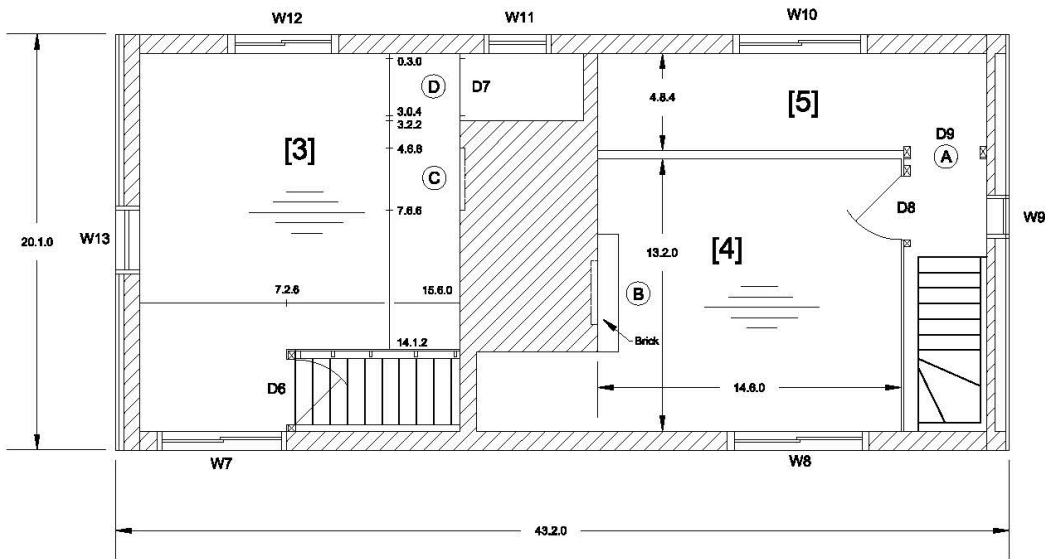
PHARSALIA, NELSON CO.
 BRICK KITCHEN - QUARTER 1 ST FLOOR
 DJP/DWS 10-10-17

The irregularity of the fenestration relates to the layout of the plan, which consists of two main rooms on each level, with those on the east substantially larger than the ones on the west. The larger first-floor room (#2) has a substantial fireplace that is outfitted with gudgeons and a cooking crane, along with an internal trammel bar, and given the

On the second floor, both rooms are heated by standard domestic-sized fireplaces; a closet between the fireplace and the north wall is accessible only from Room 3; east of the fireplace mass the space is divided into a room (#4) separated by wood partitions from the stairway running against the east exterior wall, and from a narrow (@5'-wide) corridor/closet running against the north exterior wall. A doorway is positioned in each of the partitions at the head of the stairs, both of which were outfitted with wood box locks. The studded walls above the brick knee walls and the ceiling in both main upstairs rooms are covered with butted boards; the boards and the brick knee walls are whitewashed in Room 4 and covered with a combination of whitewash and red paint in Room 3. The corridor/closet is also enclosed with horizontal planks, which were never whitewashed or painted; the knee wall bricks are whitewashed. The fireplaces in both rooms 3 and 4 have been infilled with brick; filled circular holes mark the former locations of stove pipes.

- Dimensions:** (1) West room downstairs: 17.5.0 (N-S) x 15.1.1 (E-W), 7.3.0 (H)
 (2) East room downstairs: 17.5.2 (N-S) x 18.7.1 (E-W), 7.3.0 (H)
 (3) West room upstairs: 18.2.0 (N-S) x 15.6.0 (E-W), 8.8.2 (H);
 (14.1.1 (N-S), between stairwell partition and north wall).
 (4) East room upstairs: 13.2.0 (N-S) x 14.6.0 (E-W), 8.8.1 (H)
 (5) Storage room (larder?) upstairs: 4.8.2 (N-S) x 18.10.3 (E-W);
 8.8.1 (H)
