Slave Housing Data Base

Building Name: Tuckahoe Plantation, Quarter B

Historical Site Name: Tuckahoe Plantation

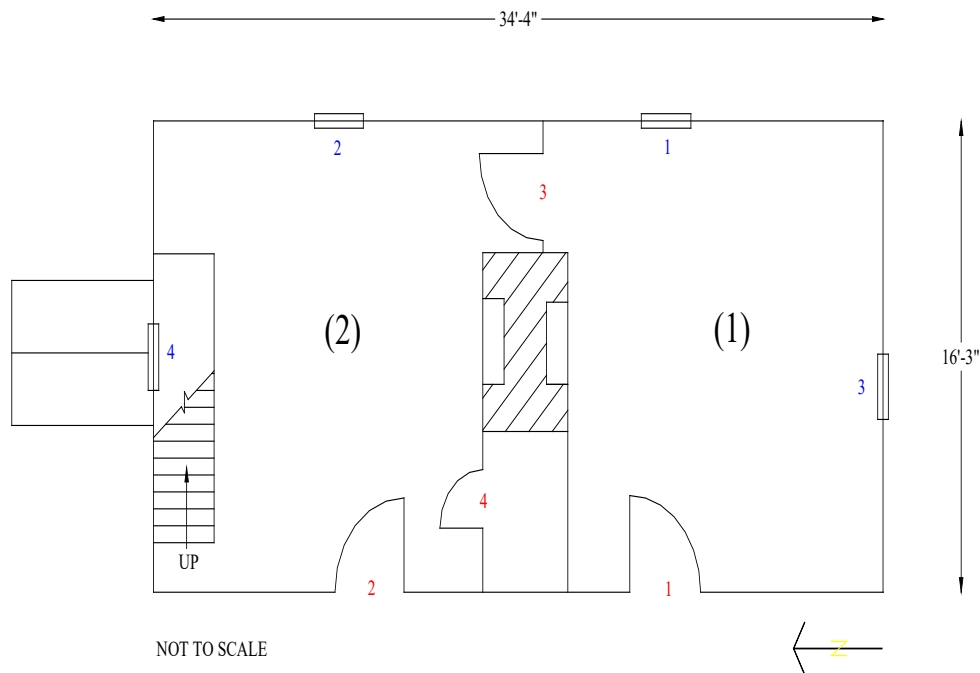
Principal Construction Type: Frame **One Story with Garret**
Footprint:

- Number of Rooms:** 4 (2 up, 2 down)
Dimensions: (1) 14'-2" (N-S); 15'-4" (N-S) x 15'-3"; height 10'-3"
(2) 14'-6" (N-S); 17'-4 1/2" (N-S) x 15'-4"; height 10'-2 1/2"
North garret (3) 15'-1/2" (N-S) x 11'-5"; height 5'-8" ~ collar

South garret (4) 15'-0" (N-S) old partition, 18'-0" x 11'-1 1/2" current partition
