## **Slave Housing Data Base**

**Building Name:** Pruden Farm Quarter

**Historical Site Name:** Pruden Farm

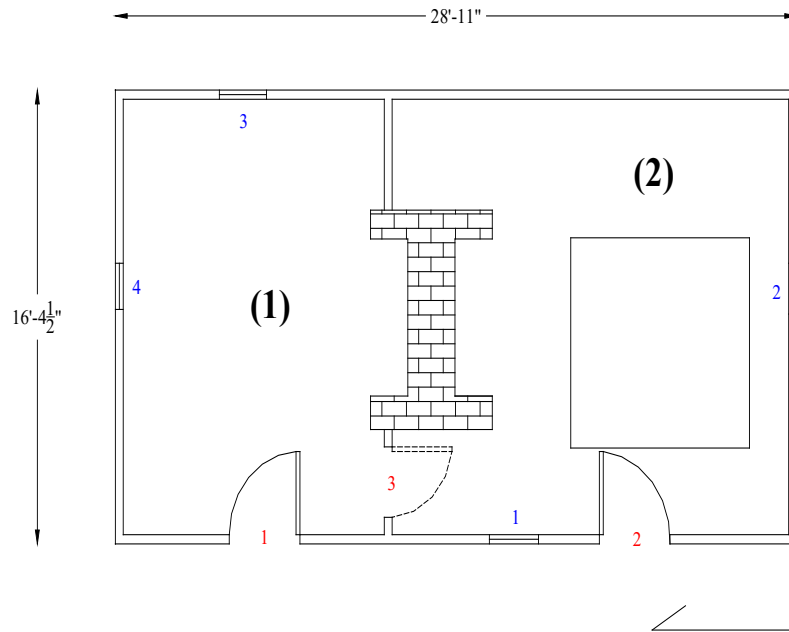
**Footprint:**

**Number of Rooms:** 2

**Dimensions:** (1) ~15'-5 1/2" (E-W) x 11'-1 1/2" (N-S)  
 (2) 15'-5 1/2" (E-W) x 16'-10" (N-S); 9'-3" (H) from top of brick cellar to bottom of ceiling joist
