Slave Housing Data Base

Building Name: Folly Farm (The Folly) Outbuilding/Quarter

Site ID: 001-0018

Historical Site Name: The Folly

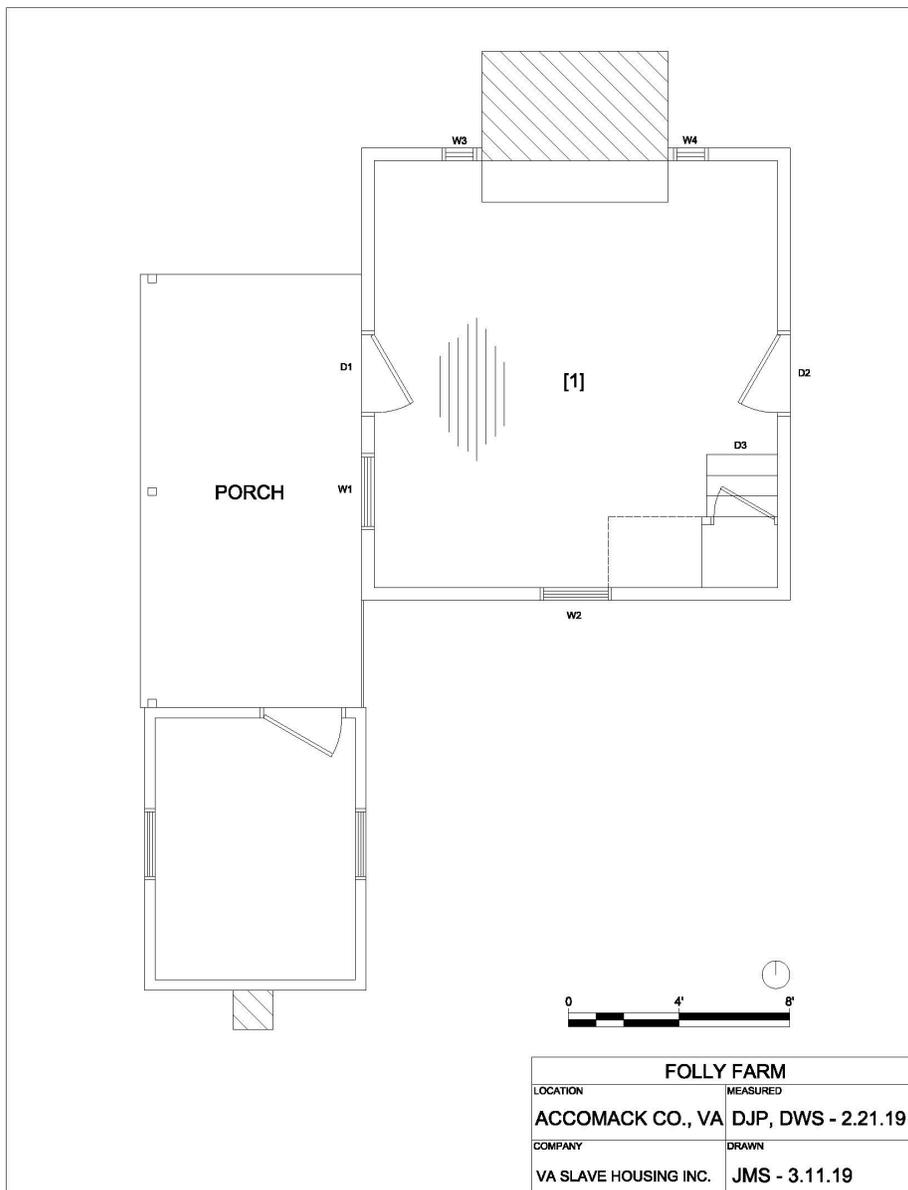
Footprint:

The outbuilding located along the entrance road leading to the Folly Farm domestic complex is a small (15'6" by 16'4"), one-story, frame structure, with a side-gabled roof, supported on brick piers. A substantial brick exterior end chimney (6'8") is centered on the north wall, serving a fireplace in the first-floor room. The chimney base has steep shoulders and the stack, capped with a corbelled, three-course cornice, is set back from the gable. Doorways are centered on the east and west walls, with a single-sash, six-pane window to the the south of the doorway on the west wall, and double-hung 6/6 sash windows centered on the south wall and in the south gable. Two small single-pane windows flank the chimney on the north wall. The walls are covered with lapped weatherboards, the oldest of which are sashsawn and are attached with mature cut nails.

Number of Rooms: 2 (1 down, 1 up)

Dimensions: (1) 15.3.2 (N-S) x 14.4.2 (E-W); Height: 7.7.1 to bottom of ceiling joists; 8.1.1 to bottom of floorboards above

(2) 15.3.3 (N-S) x 14.4.2 (E-W); Height: 5.4.2 to bottom of rafter collars
