# Architectural Analysis of Slave Dwellings at Oatlands Plantation, Loudoun County, Virginia

Douglas W. Sanford and Dennis J. Pogue

Virginia Slave Housing Project, Inc.

1/8/19 [Revised]

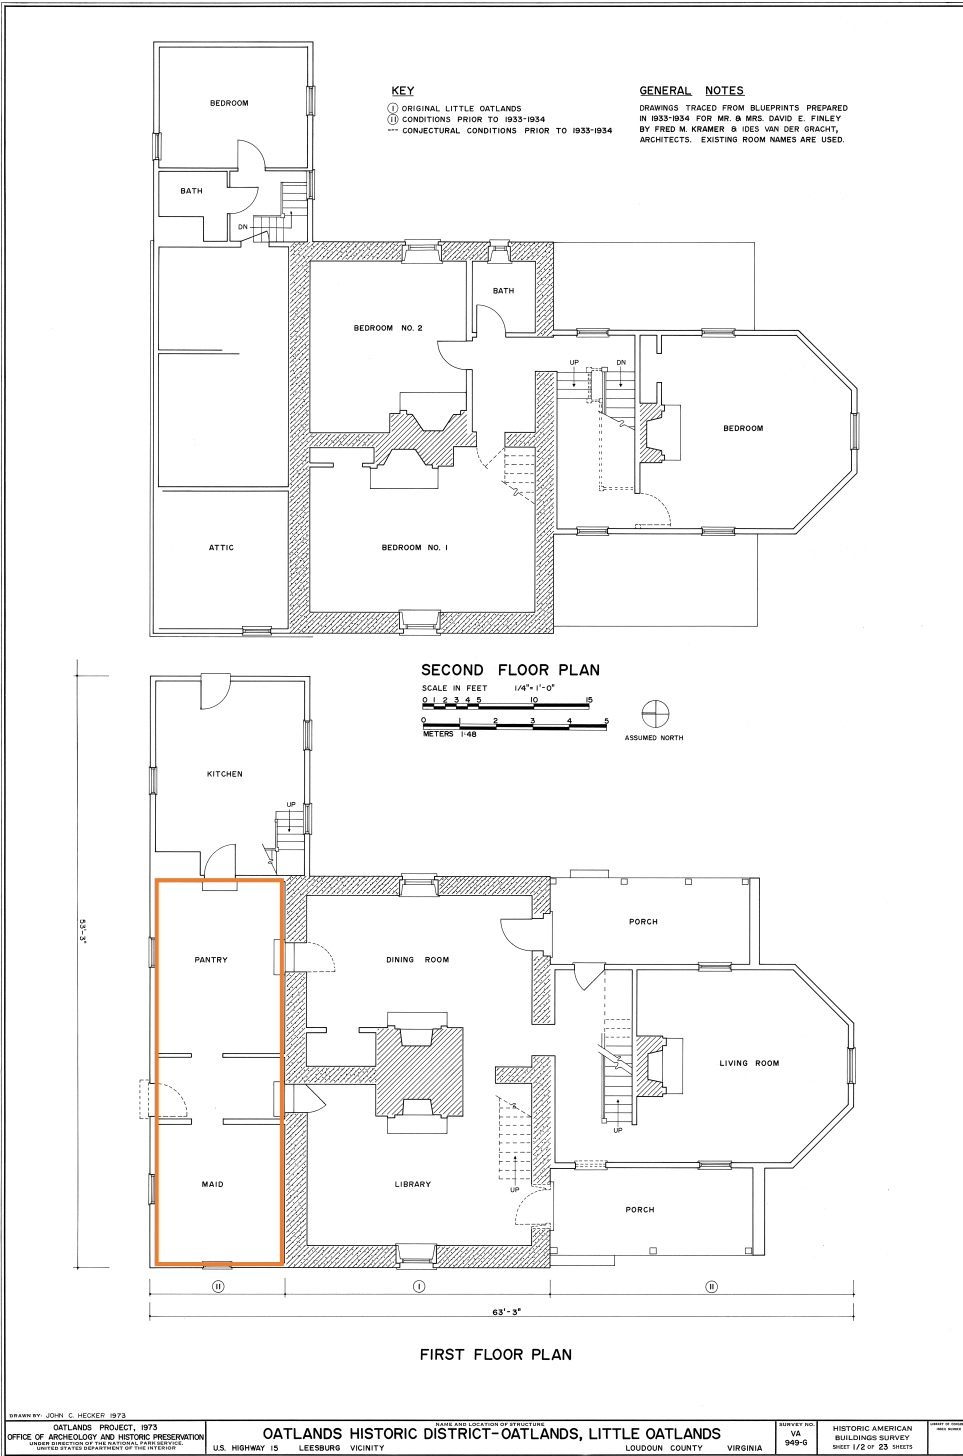
Figure 3. Little Oatlands Duplex 1, floor plans as drawn by HABS (1973); the first addition along the north elevation of the stone building is indicated in orange.

Physical evidence also suggests that the first episode of significant alterations occurred in the mid-19<sup>th</sup> century, possibly as early as preceding the Civil War. The first addition consisted of a one-story, one-pile, shed-roofed frame running the length of the rear (north) elevation (Figure 3). The roofline of the original building on this side was elevated to a shallower pitch by installing rafters for the new shed roof resting on the earlier frame; at a later date (ca. 1934), stones were inserted to raise the west gable end wall to accommodate the new angle of the roof.<sup>4</sup> The

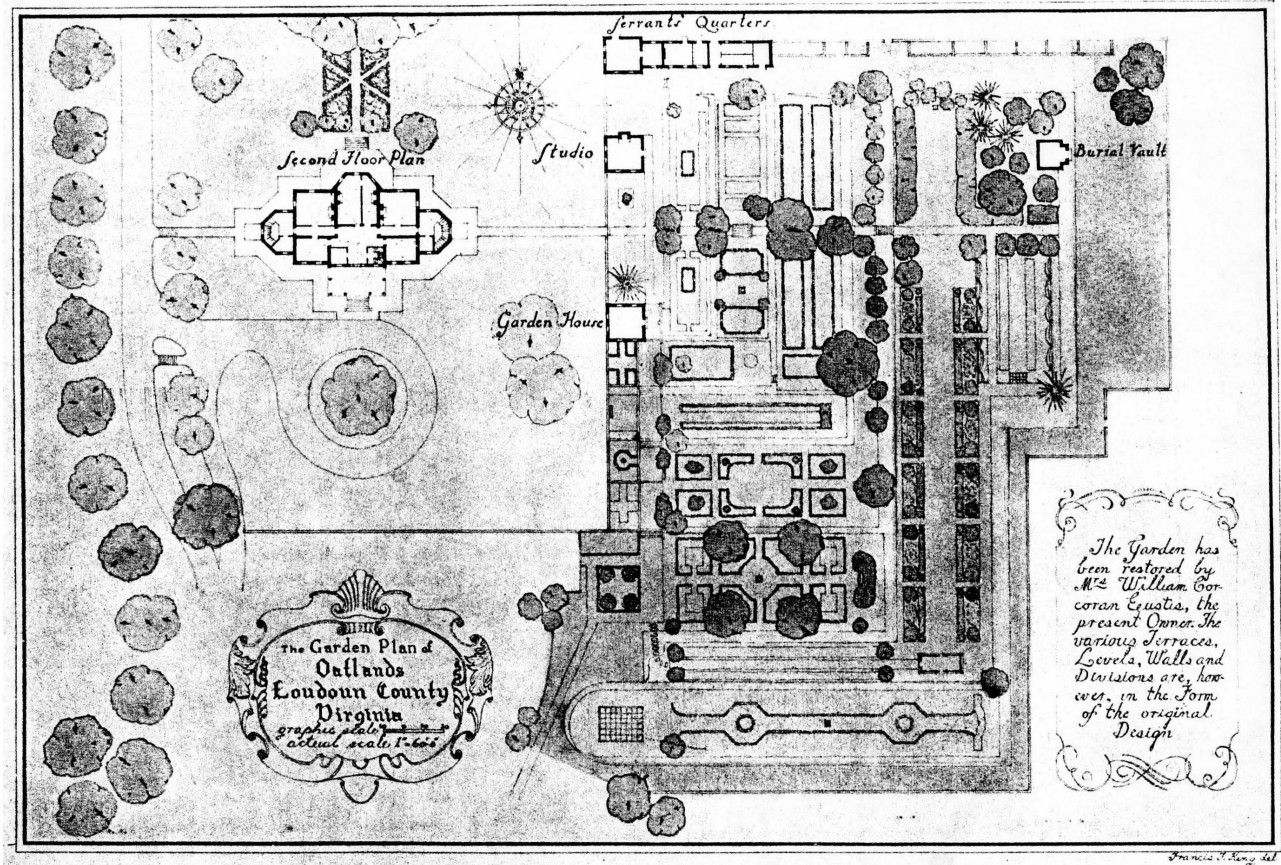
Figure 7. "Garden Plan of Oatlands," 1923. The Garden Dependencies are arranged in a line between the main house and the garden to the east: labelled as the Garden House (non-extant), Studio (smoke house/meat house), and Servant's Quarters (pavilion and "additions").

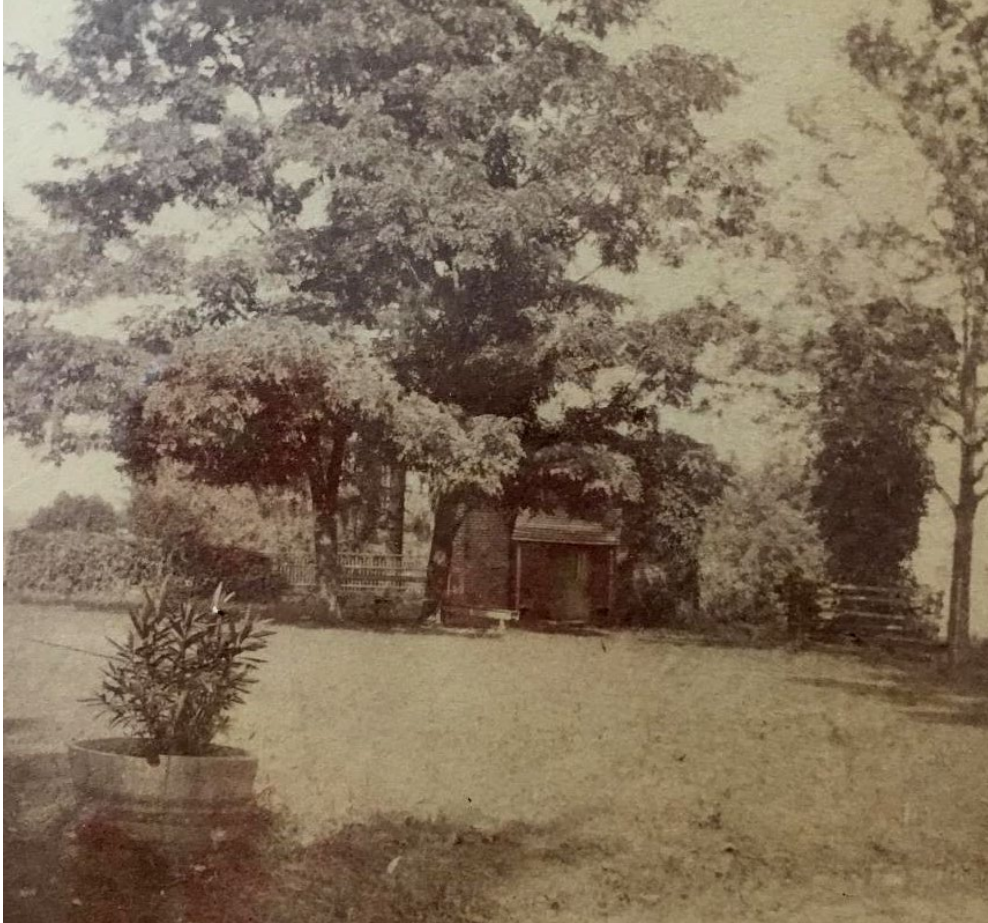
Figure 8. Undated photo of the structure (non-extant) identified as the Garden House on the 1923 plan, viewed from the west.

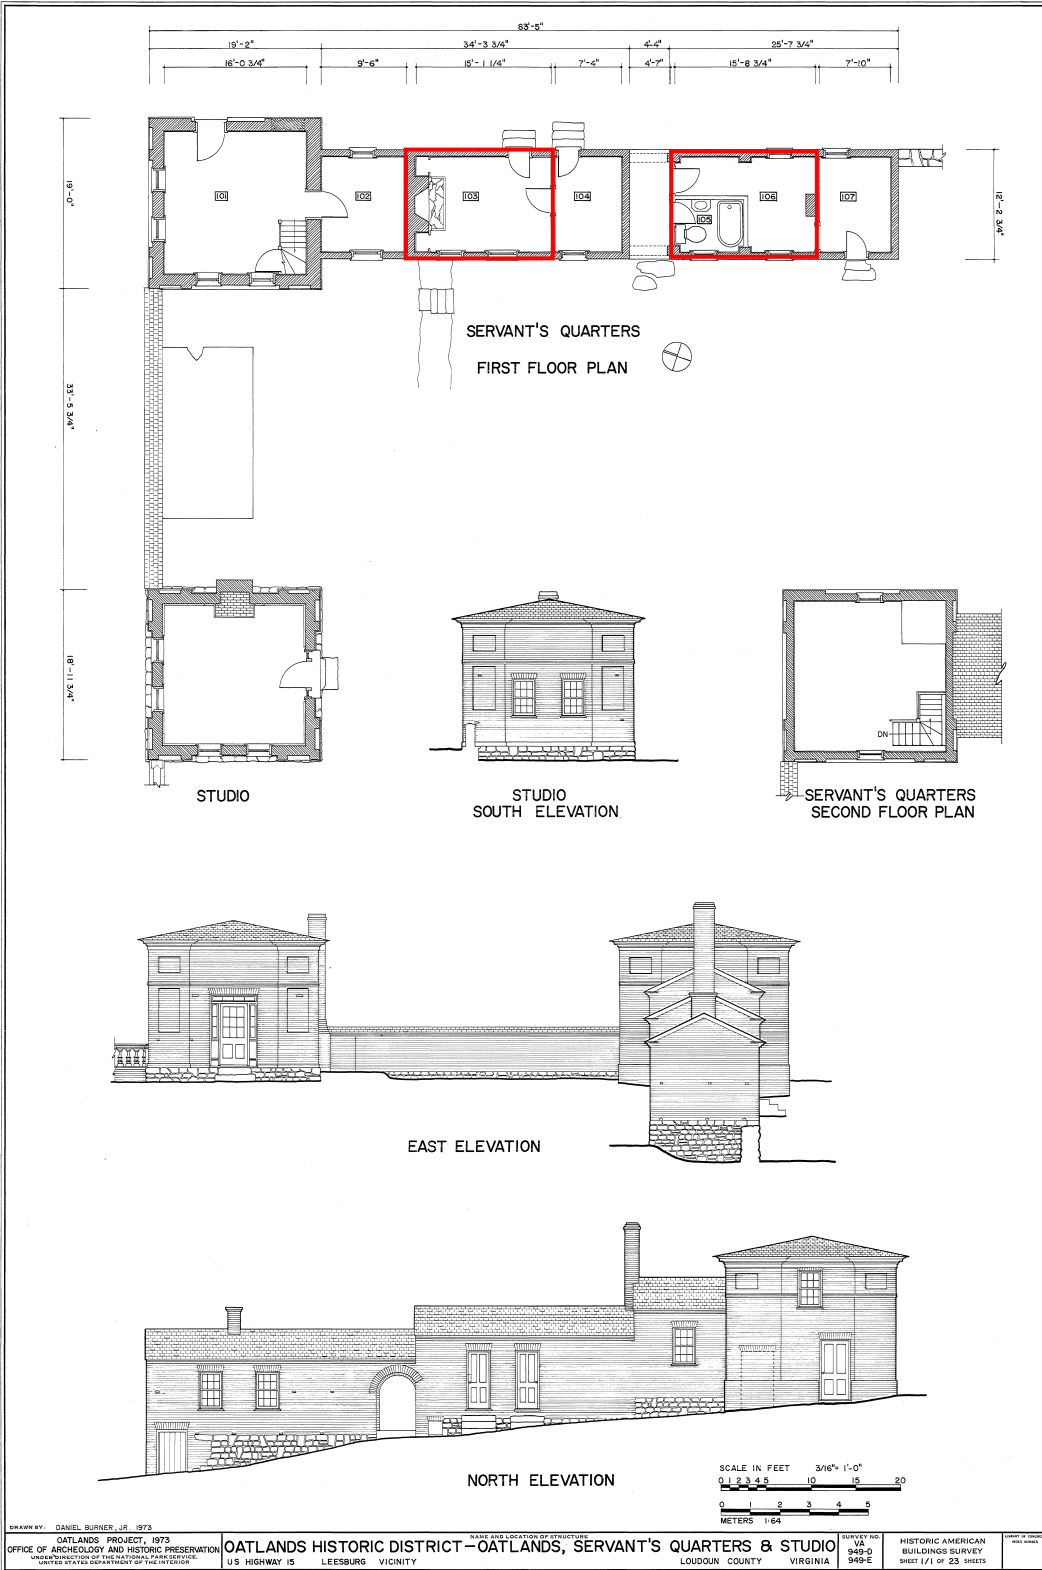
Figure 9. HABS (1973) documentation drawings of the “Oatlands Servant’s Quarters and Studio” (garden dependencies); likely spaces for housing slaves outlined in red.

Attribution of the uses of the Pavilion remains inferential, at best (Figure 9). The two doorways in the north wall are essentially original, although the doorway on the west was altered and the header was elevated to go along with raising the wood floor ca. 1903. The second doorway, which is infilled with bricks, is substantially wider and was set lower in the wall. Together with the finding that the interior floor level had been up to one foot higher when originally constructed, this suggests that the doorway provided access to a storage cellar below the Pavilion floor. Access between the Pavilion and the room to the east (Room 102) was provided by an arched opening that was not fitted with a door until ca. 1903. A doorway in the south wall of this room provided direct access between the Pavilion and the garden; that opening has been converted into a window. Whatever the function of the first-floor rooms, they were planned to act in concert, and were physically separated from the storage function assigned to the cellar. The current stairway positioned in the southeast corner of the Pavilion was added ca. 1903 to
