BAYLY

Architectural Investigations // October 31, 2019 // Bayly Cabin Cambridge, Maryland

Dennis J. Pogue

Introduction

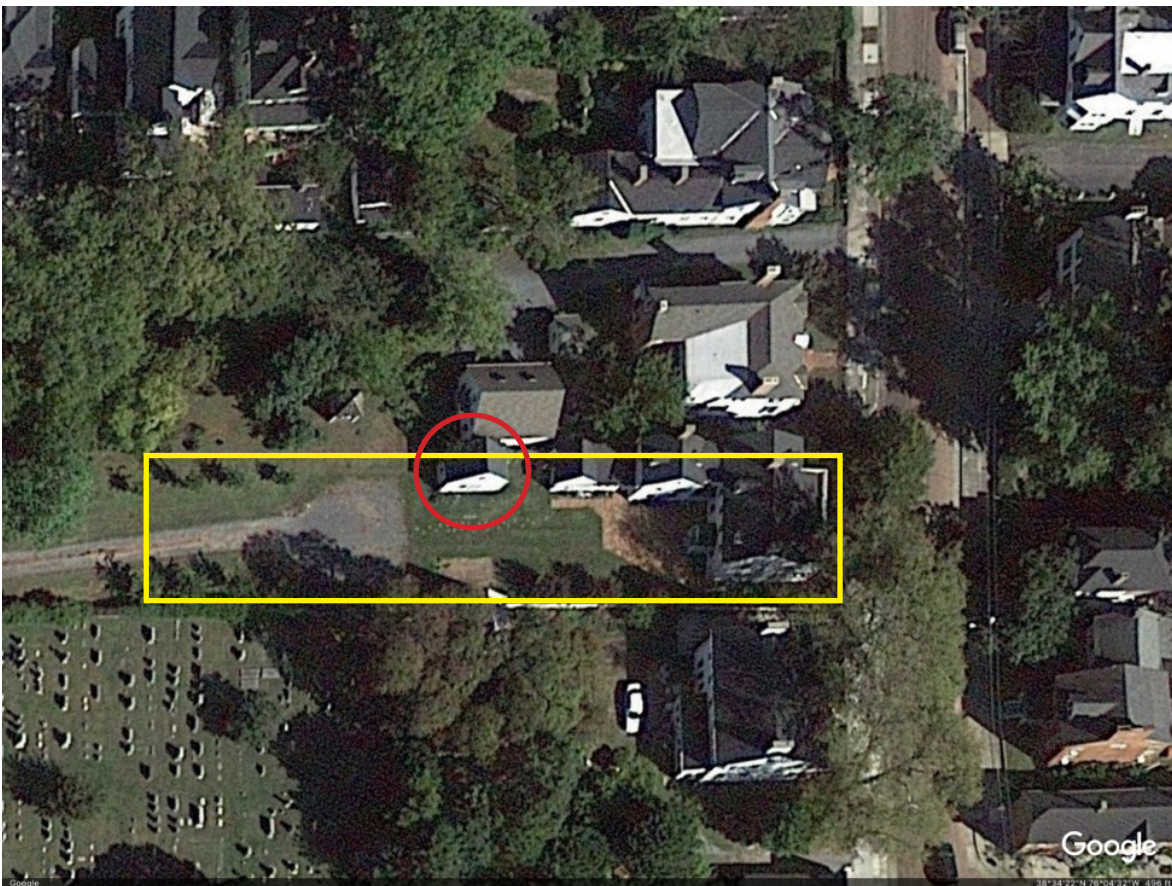
Figure 1. The “Caile-Bayly” property, 207 High Street, Cambridge, Maryland; the cabin is circled in red (grid north is at the top of the image; Google Maps, accessed December 2018).

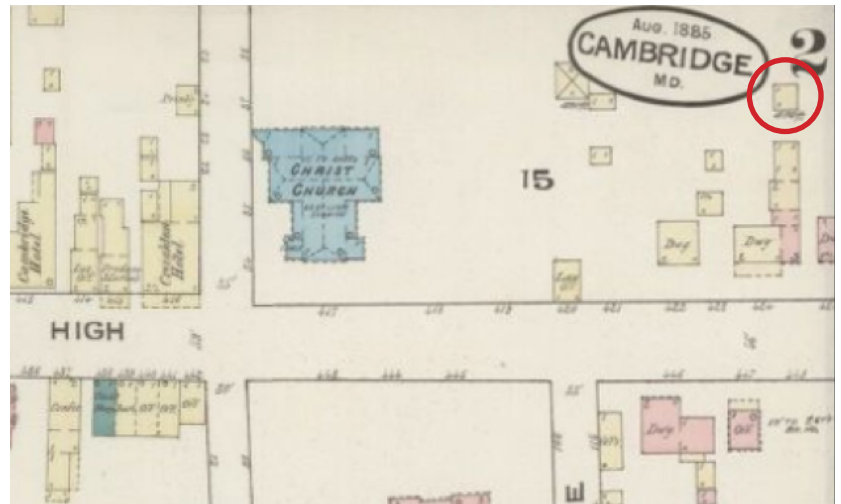
Figure 3. Detail of 1885 Sanborn map, with the Bayly outbuilding circled in red; numerous small, 1-story structures located along High Street and Court Lane are labelled as offices.

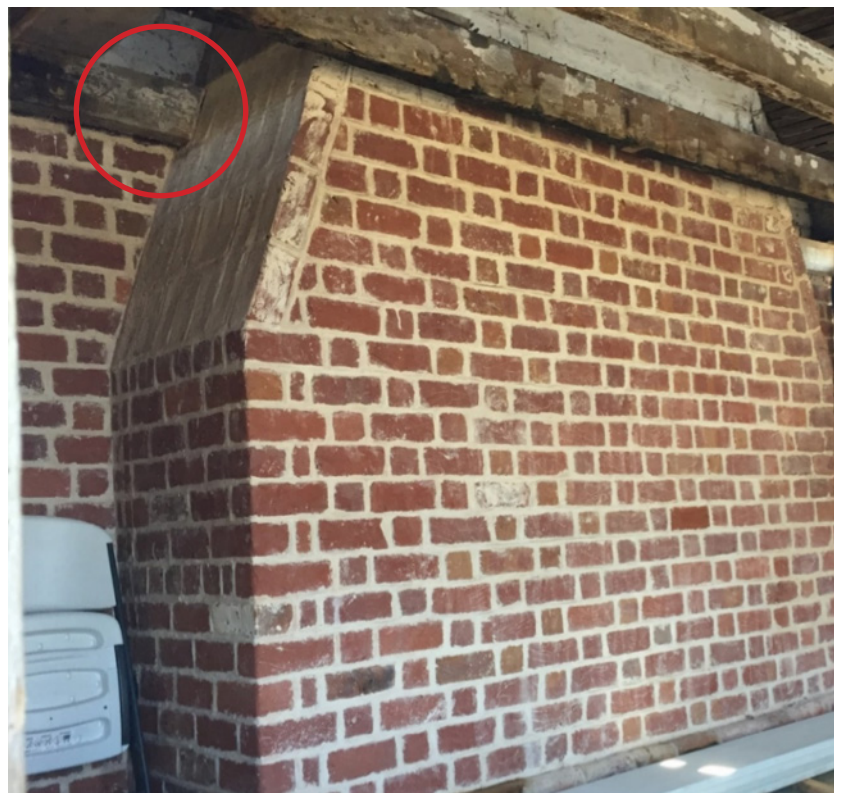
Figure 9. The exterior of the chimney base of the Machipongo kitchen, incorporated within a 19C addition; in this instance, the end joists of the addition were cut on an angle to rest against the sloping shoulder of the earlier chimney base (2019).

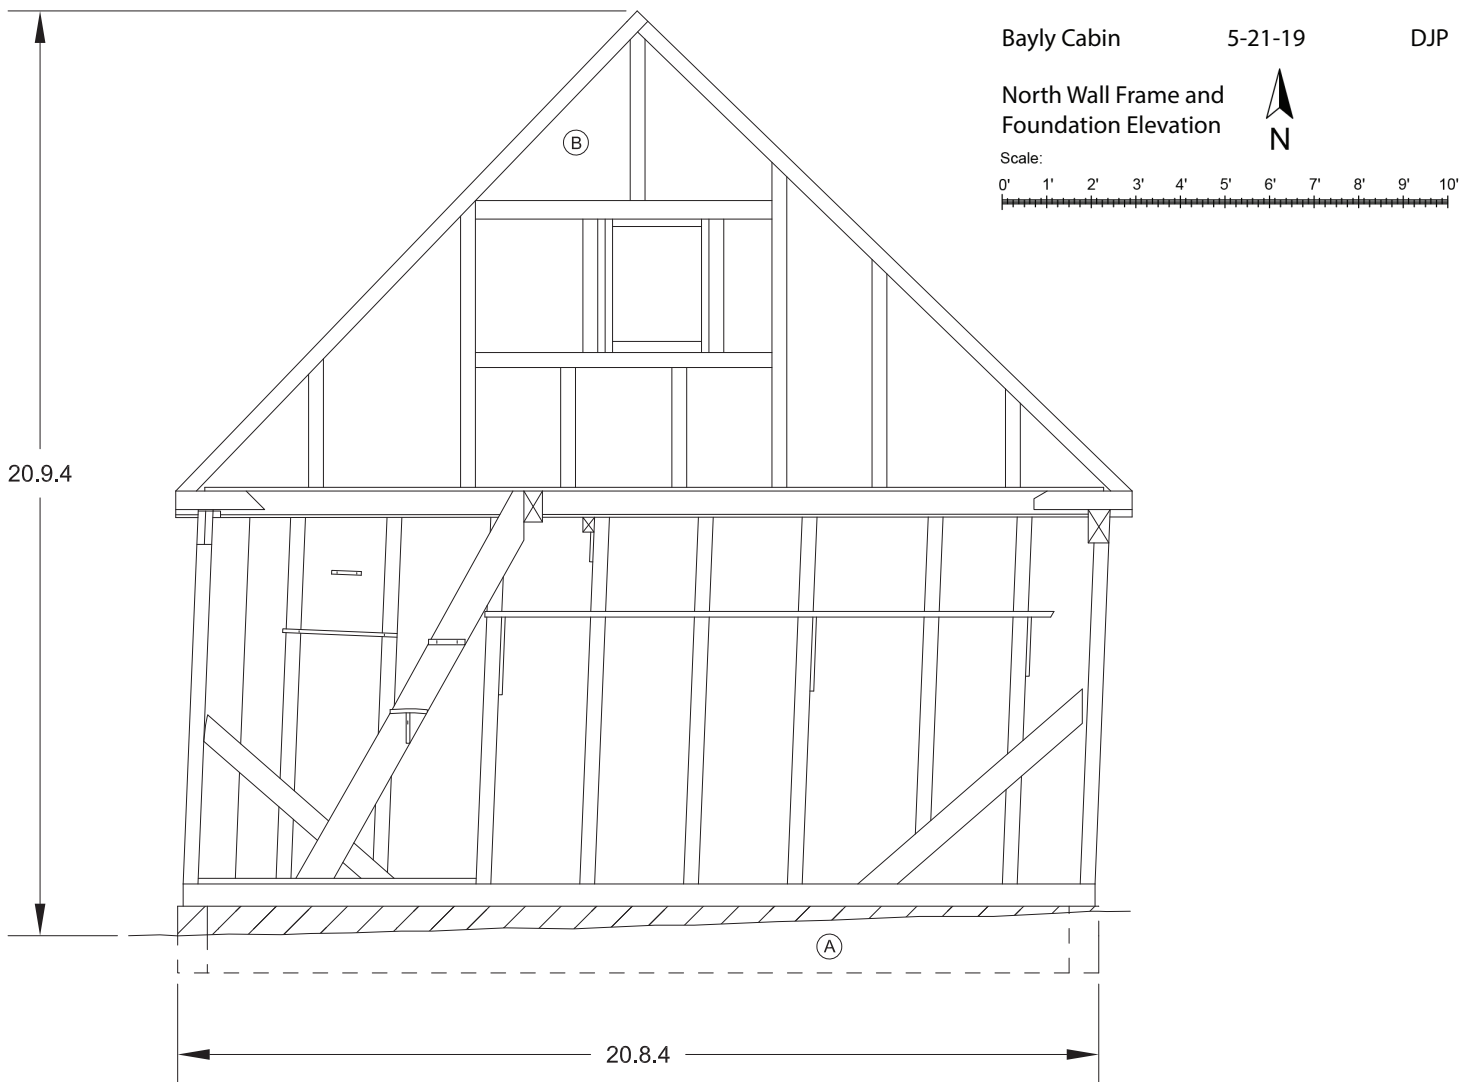
No 7: North Wall Frame and Foundation Elevation

- (A) Continuous brick foundation
- (B) Gable frame all replaced
