Clermont Slave Quarter

After Action Report: Historic Fabric

Dennis J. Pogue and Ken R. Livingston
10-23-2017

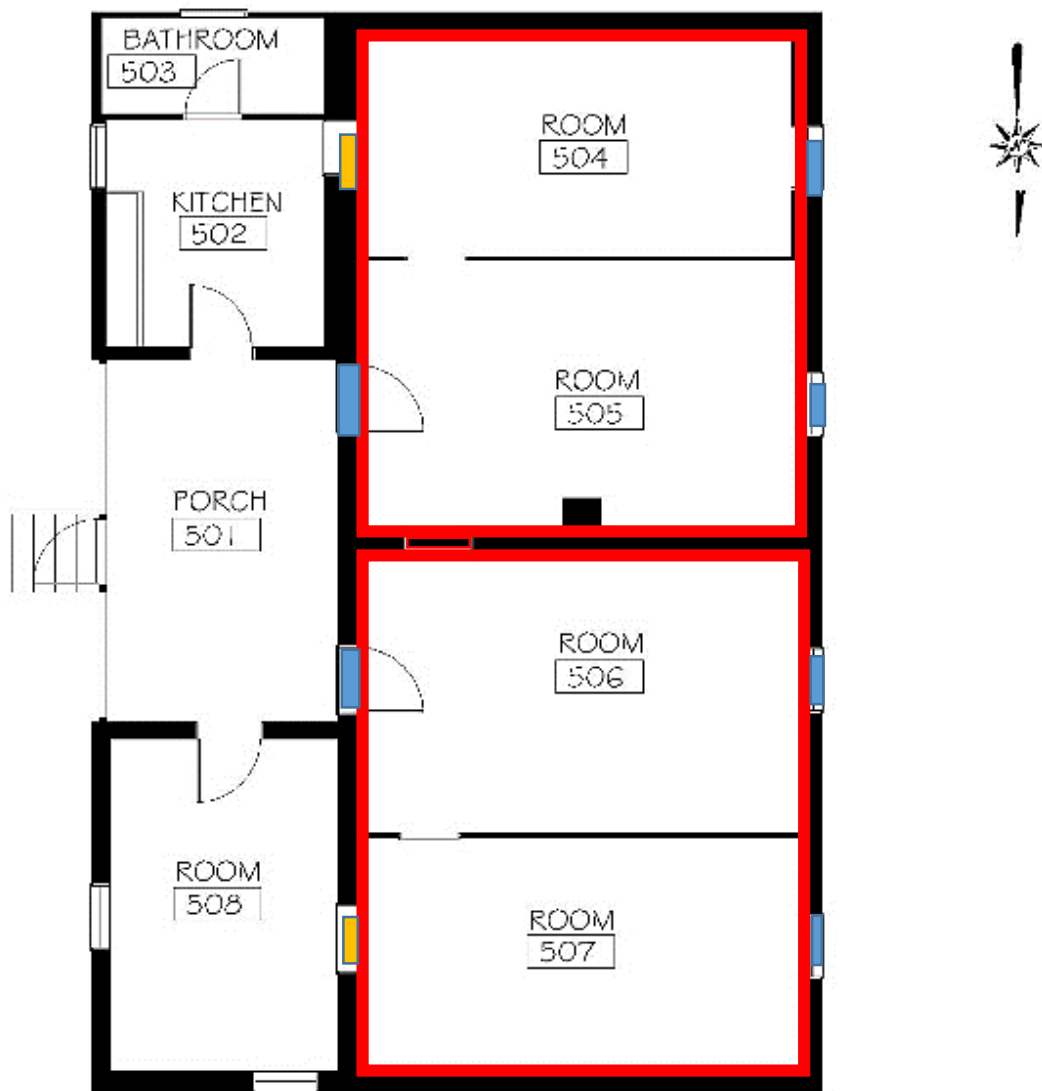
the east façade provided access to the rooms, possibly with two symmetrically arranged flanking windows; four regularly spaced windows were positioned in the rear wall (Figure 21).

Figure 21. Slave quarter plan ca. 1823; two main rooms, two exterior doorways, two windows likely on the east and four windows on the west.

The recent investigations revealed the original locations of the four rear windows. The openings were roughly 4” narrower, which was sufficient to hold four-over-four-pane window sashes. Pegs were used to attach the window jambs to the wall logs on either side, and to the top log in each of the openings. In the 20th century the openings were widened to accommodate the current six-over-six sashes.

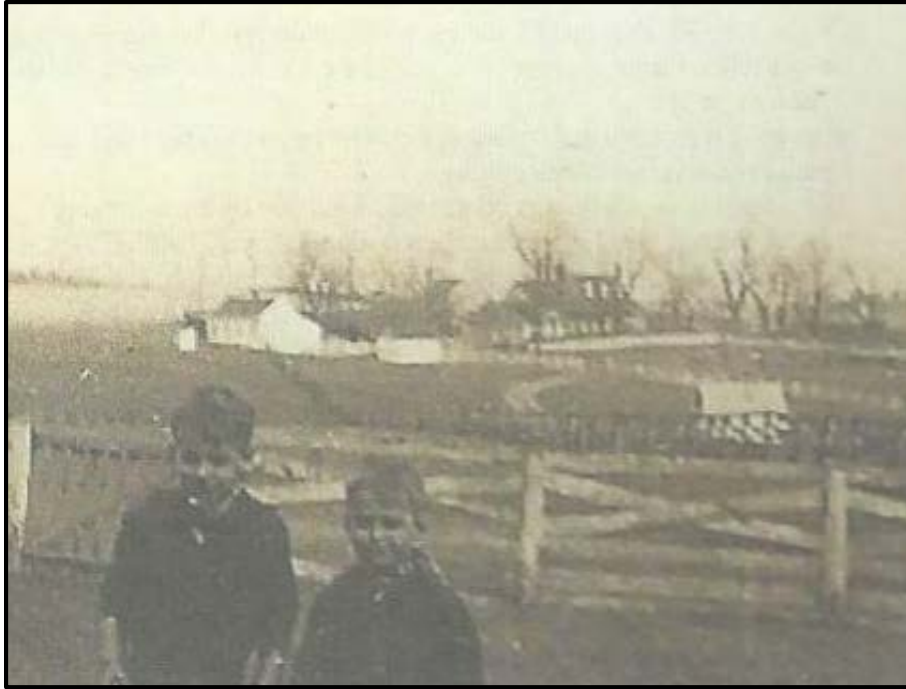
The porch that runs the full length of the east elevation likely was completed at this time. A series of photographs provided by members of the Royston family depict the former slave quarter during the period between 1939 and 1948, when Gilbert Royston served as the Clermont farm manager. All three photographs show the quarter as painted white, with the porch clearly depicted on the east elevation; one of the three images is dated to December 25, 1941 (Figure 23). The catalyst for erecting, or extending, the porch likely was the construction of a sewer line in ca. 1938 running from the new sewage treatment plant in the nearby town of Berryville across the Clermont farm. In exchange for allowing right of way to lay the line through the property, three connections were provided: for the main house, the tenant house, and the former slave quarter.¹⁸

The southeast porch room accommodated a toilet, which must have been installed after the sewer line ca. 1938 and before the picture taken by the Royston's in December 1941. Geneva Jackson reports that the toilet was in place during the time she lived in the building, beginning in 1950. The small frame structure shown to the west and slightly south of the building in the Royston family photographs was a privy (outhouse), which remained in use in some capacity even after the indoor toilet was installed. To accommodate the toilet room, the doorway leading from the porch to room 504 was narrowed significantly in size, to 23" wide.

Figure 23. Royston family photograph (1941); former slave quarter viewed from the south, with full-length east porch, painted white, and surviving privy.
