TECHNICAL NOTE

GLULAM CONNECTION DETAILS

Introduction

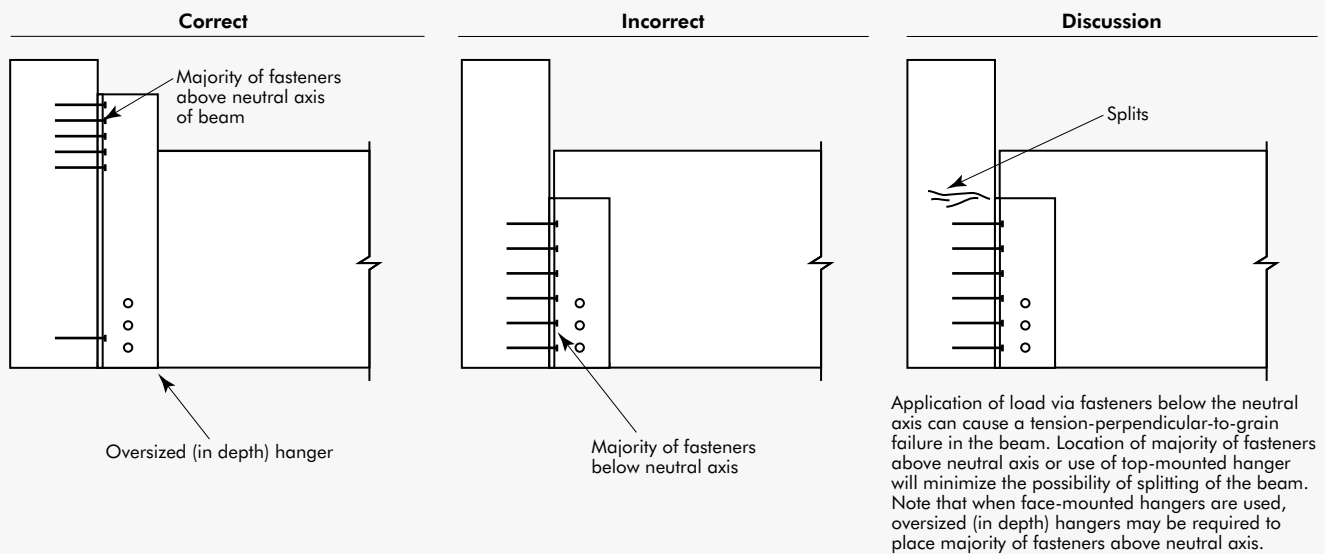
FIGURE 5

BEAM-TO-BEAM CONNECTION

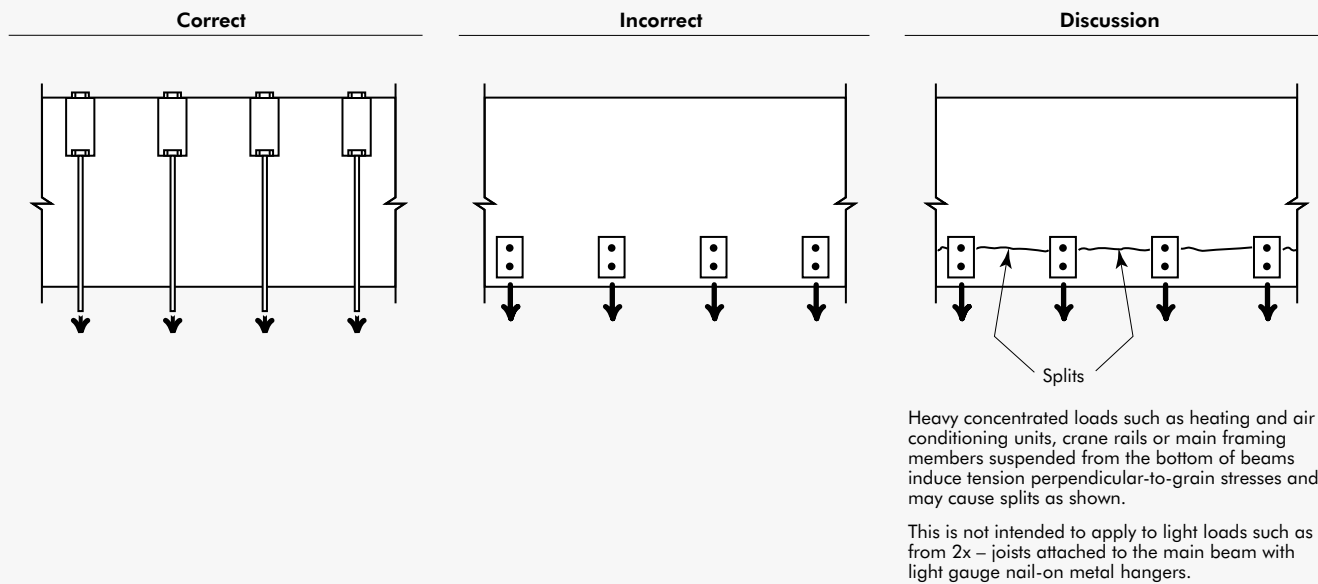
FIGURE 8

HEAVY CONCENTRATED LOADS SUSPENDED FROM BEAM

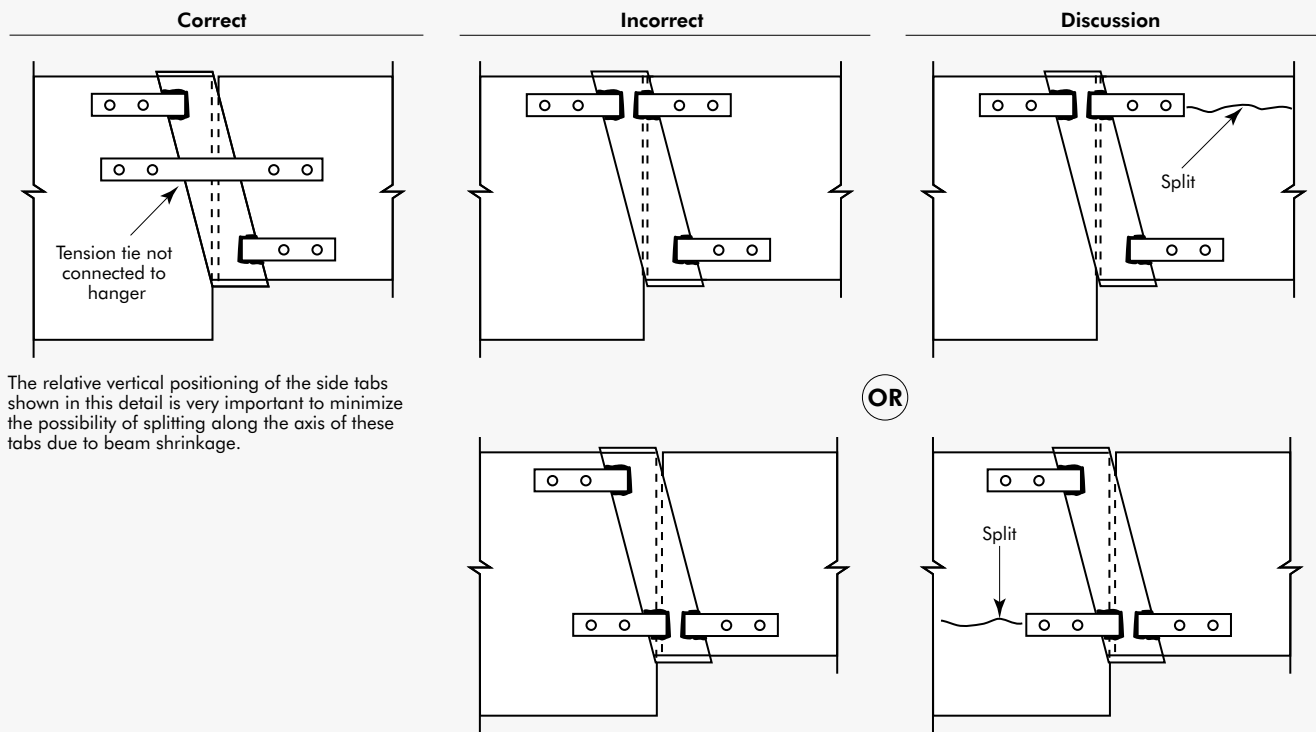
FIGURE 10

CANTILEVER BEAM CONNECTION – INDEPENDENT TENSION TIE

The relative vertical positioning of the side tabs shown in this detail is very important to minimize the possibility of splitting along the axis of these tabs due to beam shrinkage.

An integral tension-tie connection can cause tension perpendicular-to-grain stress to develop due to beam shrinkage. This can happen regardless of the location of the integral tension tie connector. If a tension connection is required, a separate connector may be used as shown in the figure to the left. This tie is not welded to the beam hanger.
