Slave Housing Data Base

Building Name: Banks Farm Kitchen and Slave Quarter

Historical Site Name: Within the Pamplin Historical Park property

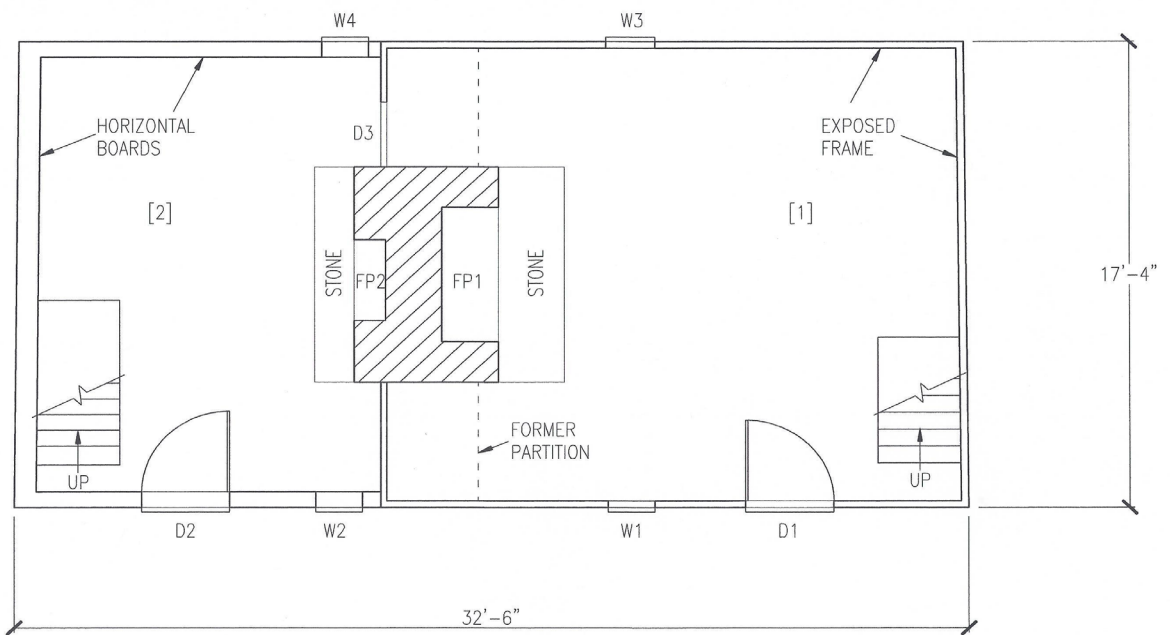
○ First Floor Plan
 Drawn by: Teresa Boegler

Footprint:

Scale: 3/2" = 1'-0"

The Banks Farm slave dwelling is a 1½-story frame structure, with a moderately pitched, wood-shingled side-gable roof, supported by stone piers and enclosed with horizontal wood weatherboards. The building is roughly 17'4" by 32'4", with a brick chimney positioned off-center, serving fireplaces in the two unequally sized ground floor rooms and two rooms in the garret. The east-facing façade is generally symmetrical, with a doorway located near each corner and two windows in between; two windows are regularly placed in the rear wall, and there is one four-pane window in the north gable. The structure is arranged as a duplex, with doorways opening into the two first floor rooms, which were separated by a partition, with ladder stairs in the front corners providing access to each of the garret rooms above. The expansive fireplace opening in the larger north room (stone below the lintel, brick above) supports the interpretation that this space served as the kitchen, serving the Banks farmhouse located a few hundred feet to the east; the other three rooms presumably served as dwelling space for the enslaved workers.
