Slave Housing Data Base

Building Name: Logan Farm
Evidence Type: Extant
City or Vicinity: Ivor
County: Isle of Wight
State: Virginia

Summary Description:

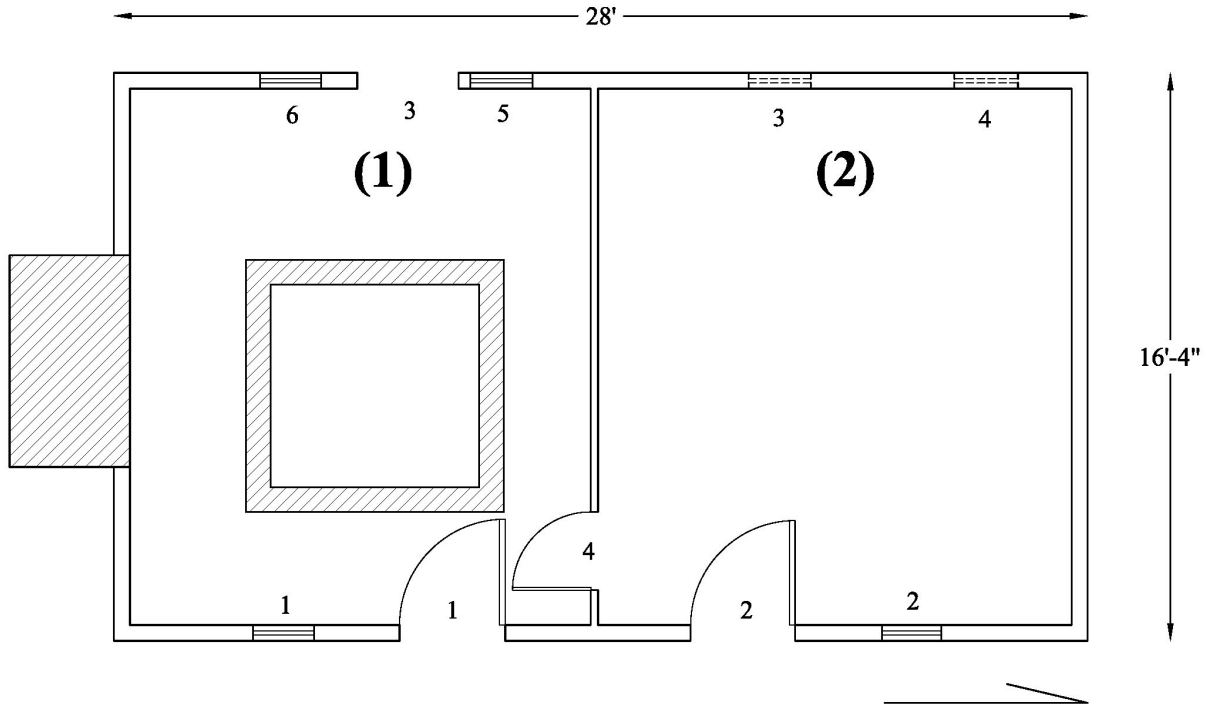
Footprint:

Number of Rooms: 3 (2 down, 1 up)

Dimensions:
 (1) South Rm.: 13'-3" (N-S) x 15'-5" (E-W); 7'-5 (H) to flooring
 (2) North Rm.: 13'-7 1/2" (N-S) x 15'-5" (E-W); 7'-6 1/2" (6" joist)
 (3) Garret:

The quarter at Logan Farm is a frame duplex structure, one story with an attic, covered by a side-gable shingle roof. It has horizontal siding (at least two generations of which survive) and rests on brick piers; it measures @28' by 16'4" in dimension. Each of the two first-floor rooms is accessed via a single doorway located in the east facade, with a third doorway (added) in the west wall of the south room. The fenestration has been substantially altered, possibly more than once, currently consisting of single sash windows in each room on the east facade, and two windows in each room on the west. Both spaces likely were heated originally by fireplaces served by exterior end brick chimneys, but if so the one to the north is completely absent, while the chimney serving the south room survives but largely has collapsed. Direct communication between the rooms is provided by a doorway set into the partition, which probably was added. A substantial brick-lined pit/cellar is positioned beneath the south room. The partition appears to be comprised of reused siding boards, and several of the structural members also likely were salvaged from an earlier structure. There is no stair to the attic, but empty mortises in two of the joists in the north room suggest its probable location. A section of flooring currently covers the joists above the south room, but it is unclear whether the space was floored originally. The core of the structure has been dendro-dated to circa 1838.
