Slave Housing Data Base

Building Name: Sherwood Forest Duplex
Evidence Type: Extant
Historical Site Name: Sherwood Forest Plantation
City or Vicinity: Fredericksburg
County: Stafford
State: Virginia

Investigators: Gary Stanton, Carter Hudgins, Doug Sanford, Arianna Drumond,
Kate Egner
Institution: Center for Historic Preservation, University of Mary Washington
Project Start: June 2007 **Project End:** 1/25/08

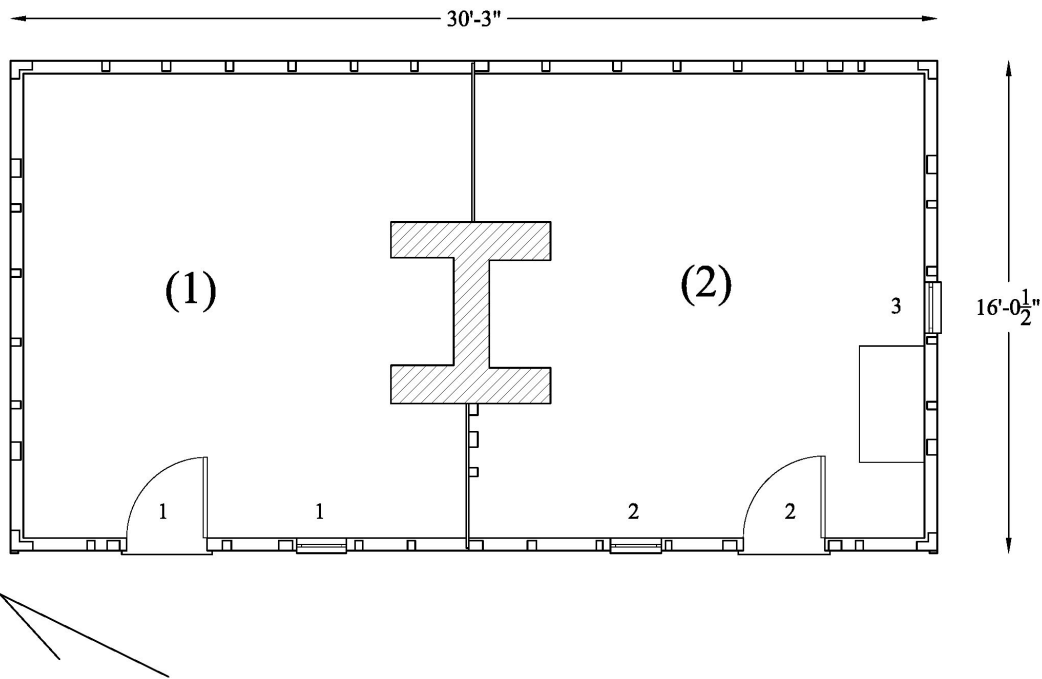
Period I Footprint:

Number of Rooms: 2 down, 2 up (Period I); 3 in modern rear addition

- Dimensions:** (1) North: 15 ft. 3 in. (E-W) x 14 ft. 3.5 in. (N-S); 7 ft. 11.5 in. (H)
(2) South: 15 ft. 4 in. (E-W) x 14 ft. 9.5 in. (N-S); 7 ft. 11.5 in. (H)
(3) North: 14 ft. 10 in. (N-S) x 16 ft. 5 in. (E-W)
(4) South: 14 ft. 9 in. (N-S) x 16 ft. 1 in. (E-W)
