## Slave Housing Data Base

**Building Name:** Tuckahoe Plantation, Quarter A

**Historical Site Name:** Tuckahoe Plantation

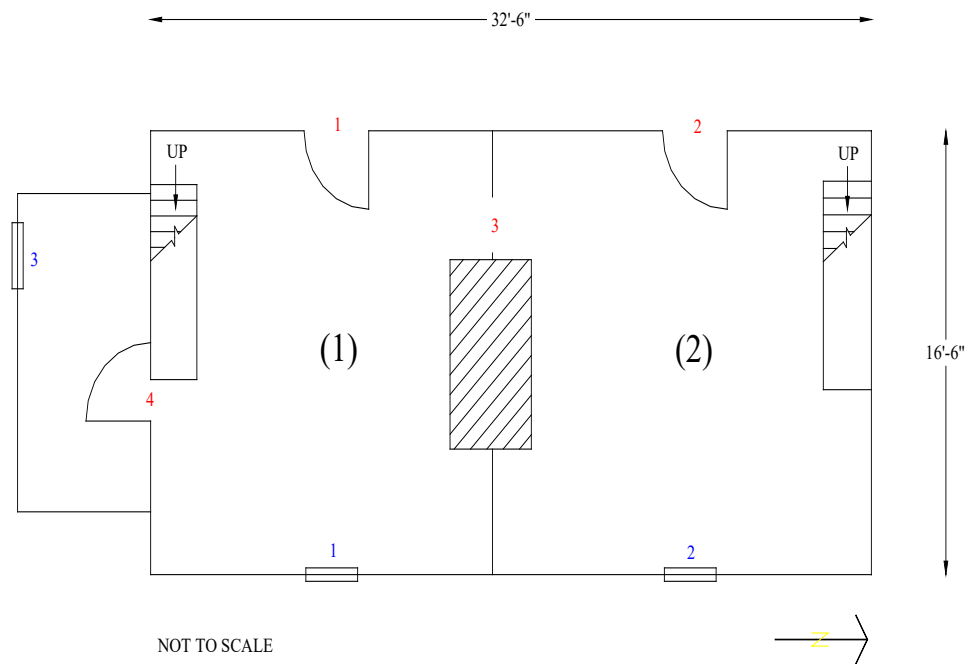
**Footprint:**

**Number of Rooms:** 4 (2 up, 2 down)

**Dimensions:** (1) 15'-4" (E-W) x 15'-5"; height 10'-3"  
 (2) 15'-7" (E-W) x 15'-6 1/2"; height 10'-1"  
 (3) 10'-0" (E-W) x 13'-9"; height 6'-4 1/2", 6'-4" to collar (bottom)  
 (4) 9'-11" (E-W) x 17'-0 1/2"; height 6'-3 1/2"  
 1 shed added (5) 10'-11" (E-W) x 5'-8 1/2"
