Slave Housing Data Base

Building Name: Walnut Valley Plantation outbuilding

Site ID: 44YO262; DHR no. 090-0023 Historical Site Name: Walnut Valley City or Vicinity: Chippokes State Park

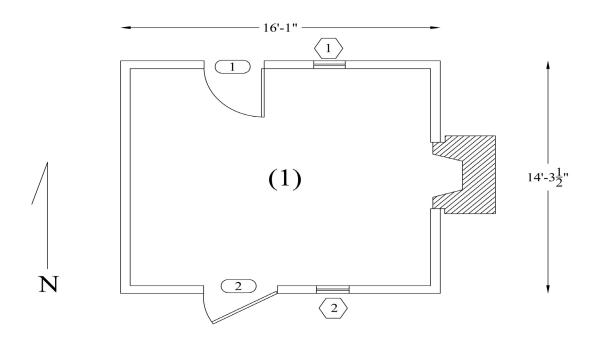
Footprint:

Number of Rooms: 3 rooms; 1 down, 2 up (garret rooms have been altered by moving partition; stairs originally at western end vs. current eastern end location)

Dimensions: (1) 15 ft. 2.5 in. (E-W) x 13 ft. 1.5 in. (N-S); 6 ft. 11 in. from floor to bottom of joists.
