Slave Housing Data Base

Building Name: Glendale Kitchen-Quarter

Historical Site Name: Glendale Farm

County: Clarke State: Virginia

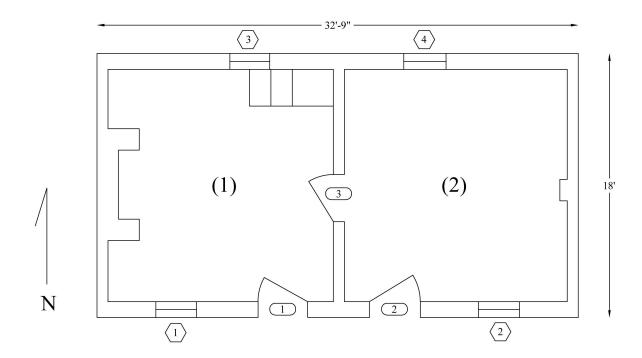
Footprint:

The Glendale Kitchen-Quarter is a brick, side-gable-roofed duplex structure, with end chimneys, one and one-half stories in height, measuring @32'9" by 18'1". It is located roughly 26 feet to the northwest of the main house, which was built circa 1847-50. The walls are laid in 5:1 common bond, with a corbelled cornice, and jack arches above all of the openings; the relatively low-pitched gable roof is covered with standing-seam sheet metal. The symmetrical four-bay façade features two centered doorways flanked on either side by a single window; two windows are in the rear wall. Two windows flank the chimney in the west gable; a single window is positioned to the north of the chimney on the east.

The two first-floor rooms are almost equal in size, each with a doorway and window on the façade and a window in the rear, with plastered walls and exposed ceiling joists. A doorway in the brick partition allows direct access between the rooms; an enclosed staircase is positioned in the NE corner of the west room leading to the room above. The two rooms in the half-story match those below in size; a doorway in the partition allows access to the east room. In both rooms the ceilings are covered with tongue-and-grooved boards and the partition and knee walls are plastered. The first-floor rooms seem to have served non-domestic functions: the substantial fireplace (7'7½") centered on the end wall of the west room likely indicates its use as a kitchen; given the direct access between the spaces the east room may have served as a laundry. The east room on the first floor was heated via a stove connected to a flue centered on the end wall; the two upstairs rooms also likely had been heated by stoves (stove hole in east room; west chimney rebuilt).
