Slave Housing Data Base

Building Name: Elk Hill Duplex Quarter – Building 2 (to south of Bldg. 1)

Historical Site Name: Elk Hill

Institutions: Virginia Slave Housing Project

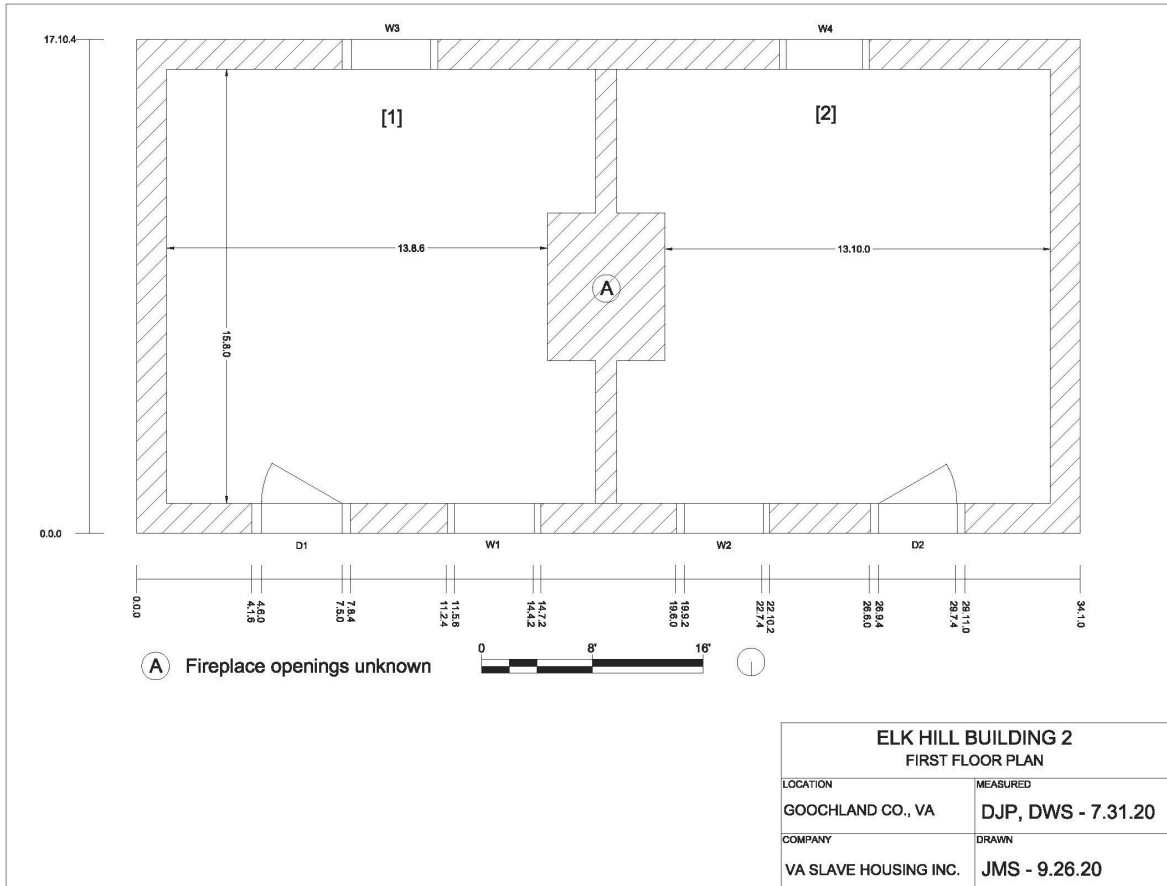
Footprint:

Number of Rooms: 4 total (2 down, 2 up)

- Dimensions:**
- (1) Downstairs, east: 15.10.1 (N-S) x 13.8.3 (E-W), 8.5.2 (H)
 - (2) Downstairs, west: 15.8.0 (N-S) x 13.10.0 (E-W), 8.5.2 (H)
 - (3) Upstairs, east: 15.9.3 (N-S) x 13.9.0 (E-W), 7.11.3 (H)
 - (4) Upstairs, west: 15.9.3 (N-S) x 13.11.2 (E-W), 7.11.3 (H)
